# Troubleshooting Guide

Causes, Repair  
& Prevention

March 2020

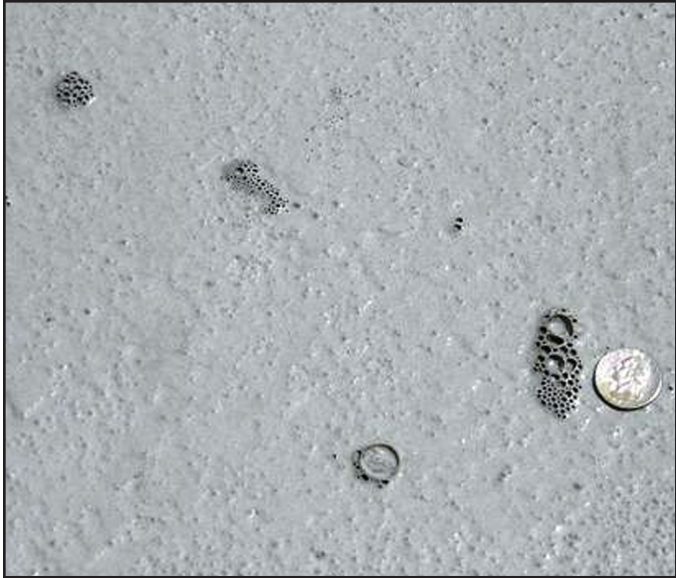
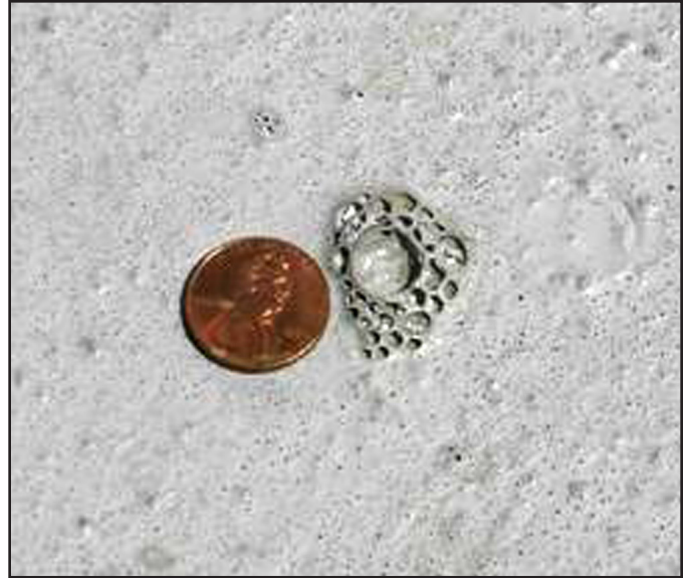
## Craters Due To Moisture Contamination

Craters due to moisture will typically occur in clusters.

Moisture from relative humidity or moisture contaminated aggregate will react with the coating material and cause a bubbling effect as shown above. This is caused by a chemical reaction between moisture and the urethane coating material.

1. Grind affected areas smooth.
2. Clean surface and solvent wipe if necessary.
3. Apply additional coating to match adjacent areas.

- Ensure that the deck is completely dry before coating. Moisture may not be readily apparent, particularly if aggregate has been introduced into the system. Conduct a moisture test before coating application to ensure that there is no contamination.
- Keep aggregate dry as it can be a source of moisture contamination.
- Ambient surface temperature should be more than 5°F above dew point. See Dew Point of Moist Air in the Support Information section of this manual for ambient temperature and relative humidity guidelines.

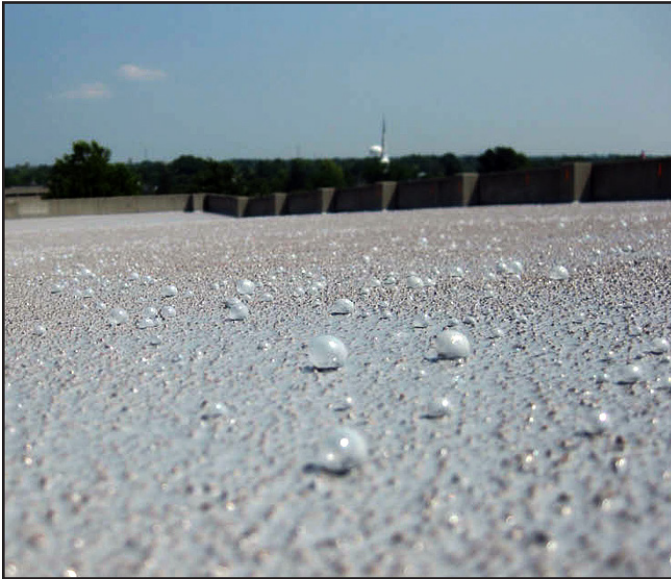
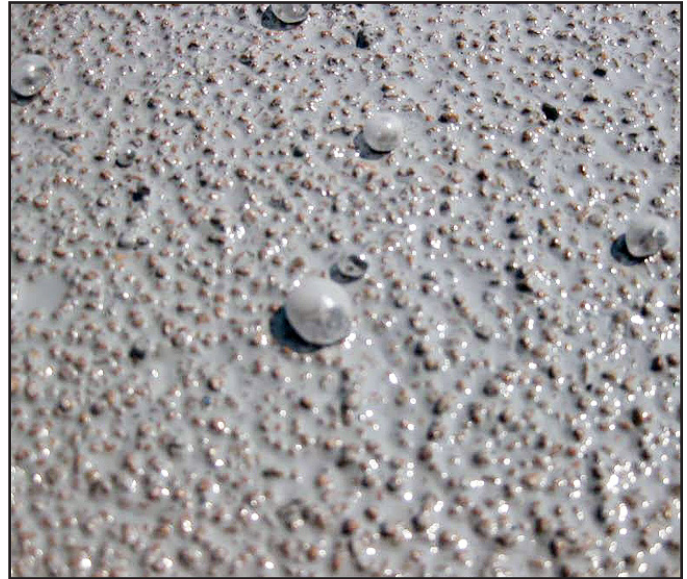
# Pinholes

Pinholes appear as tiny blisters or bubbles. When these blisters pop they usually leave a round crater and the pinhole should be easily seen through the film.

- Porous Concrete: Concrete releases air and moisture vapor that expands as temperatures rise. Also, aggressive shot-blasting or scarifying can open concrete pores and bug holes.
- Excessive Aggregate: Air entrapped in wear coat when aggregate is applied too heavily, leaving air pockets.
- Excessive Additives: When over accelerated, coating rapidly forms a film, trapping air from the substrate, preventing escape during the curing process. Adding solvents can result in surface pinhole blisters if the solvent is not allowed to escape prior to gel.

- Porous Concrete:
  - Begin application as temperatures are dropping and continuing to drop. Rising temperatures result in expansion of the moisture and air in the concrete. Falling temperatures cause the air and moisture to contract within the concrete.

- Excessive Aggregate: Apply wear coat at specified rates, taking care to prevent aggregate from leaving entrapped air pockets.
- Excessive additives: Avoid using accelerators during hot temperatures. See Weather Impact on Coating Materials in the Support Information section of this guide.

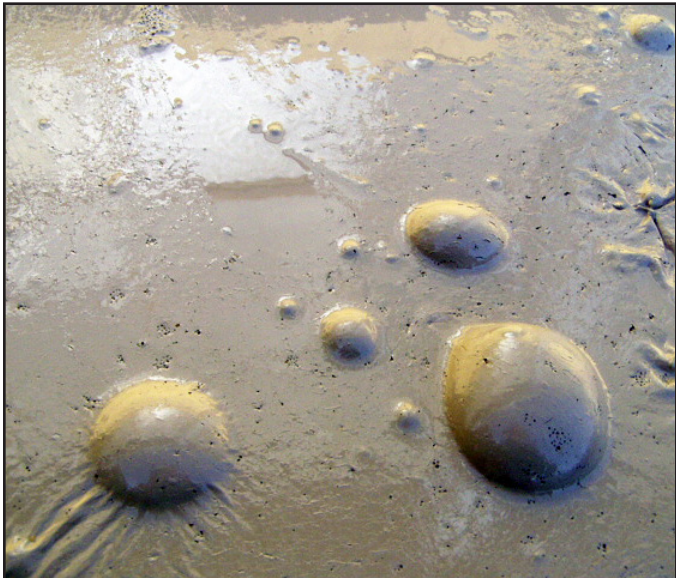
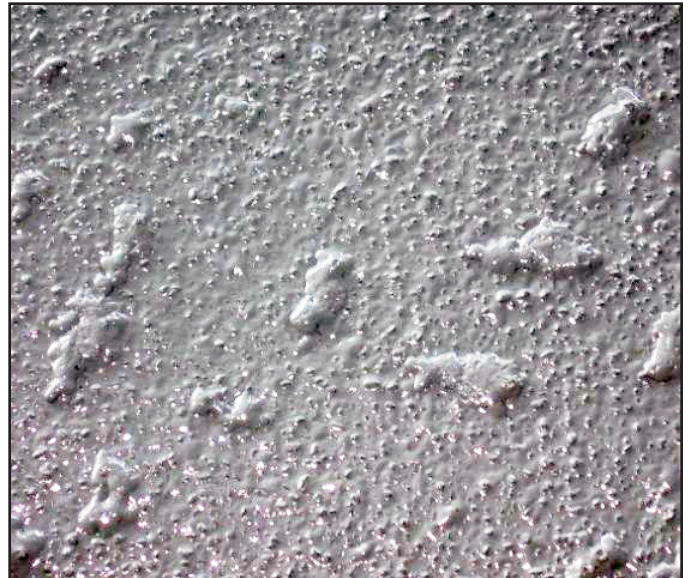
Blisters look like bubbles in the coating surface. The blisters will have a trace of water or moisture trapped inside them. Moisture between the aggregated wear coat and topcoat leaves an orange peel texture on the backside of the blister, mirroring the sand coat texture.

Water from rain, dew or other sources, mixed or rolled into wet, uncured coating. The urethane coating reacts with the water and attempts to cure on the surface, forming blisters and stress wrinkled areas.

- Do not apply coating if rain is imminent.
- Ensure that sprinkler/lawn systems remain off for the duration of the cure.
- Ambient temperature should be more than 5° above dew point. See Dew Point of Moist Air in the Support Information section of this guide for ambient temperature and relative humidity guidelines.
- Ensure that the deck is completely dry before coating. Moisture may not be readily apparent, particularly if aggregate has been introduced into the system. Conduct a moisture test before application to ensure that there is no water contamination.

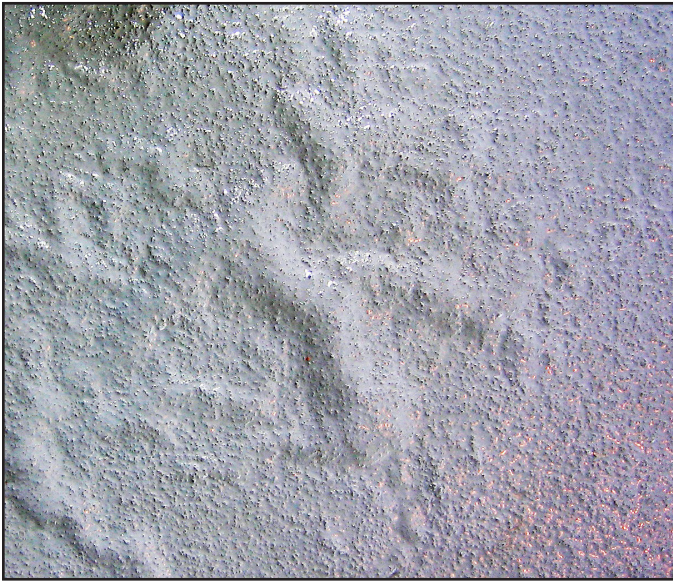
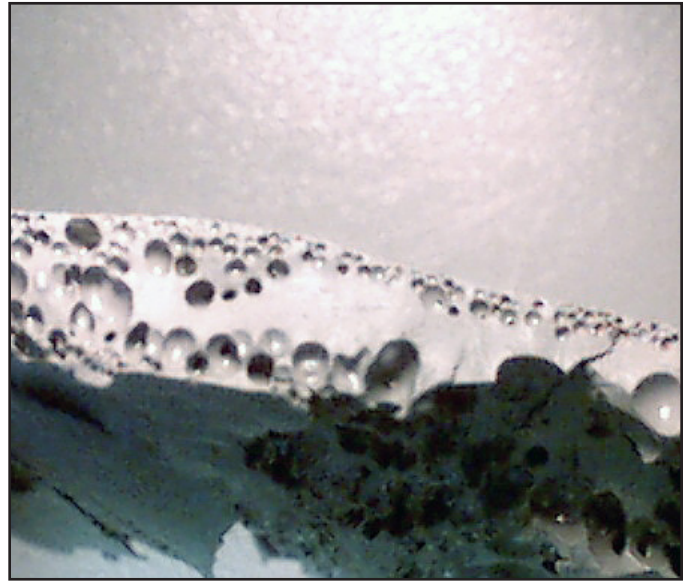
Blisters look like small to large unbroken bubbles in the coating surface and can appear round or oblong. Depending on the state of cure, they can feel spongy or fluid beneath the surface.

Coating was applied at a rate greater than application instructions.

1. Completely remove affected areas down to cured coating or substrate.
2. Reapply coating system per Neogard specifications and recommendations.

- During installation of coating, frequently check the wet film thickness by use of recommended mil gauges.
- Laying out the job prior to coating by gridding out the area will help to maintain proper and uniform coating thicknesses.
- During application, backroll to eliminate low spot areas where self-leveling coating may pool.

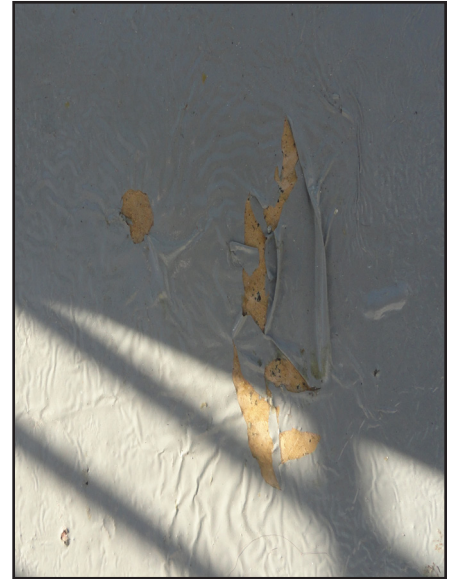
Coating is wrinkled in appearance. Multiple lines of parallel wrinkling may occur.

- Previous Coat is Uncured or Off-Ratio: Material applied over uncured or off-ratio coating, causing stress on topcoat.
- Coating Too Thick: Coating applied at a thickness that exceeds application instructions.

- Previous Coat is Uncured: Ensure that coatings are completely cured before applying additional coats.
- Previous Coat is Off-Ratio: Mix all materials thoroughly, following mix ratios printed on product labels or the Product Data Sheet. See Product Mixing Instructions in the Support Information section of this guide.
- Coating Too Thick: Apply coatings at recommended coverage rates.

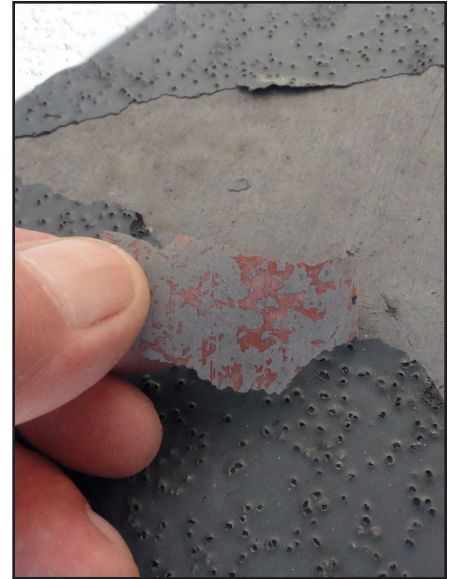
**Delamination due to incompatible materials**

- **Improper Surface Profile:** Surface was not shot-blasted or abraded prior to applying membrane, or the base coat was applied over epoxy primer after the 24-hour window.
- **Contamination from Moisture:** There was dew or other moisture on the surface that was coated.
- **Contamination from Dust, Dirt, Etc.:** Coating over contaminated surfaces will lead to coating failures such as loss of bond.
- **Incompatible Materials:** Materials that are incompatible with the coating will cause many issues including delamination.
- **Thin Topcoat Application:** A final topcoat applied too thin may delaminate and peel from the coating system.

1. Remove all loosely bonded material.
2. If substrate is exposed, abrasion may be necessary.
3. Clean repair area.
4. Re-apply material as specified and per Neogard recommendations.

- **Improper Surface Profile:** Substrate should be shot-blasted or abraded and cleaned prior to application of primer. Shot-blast surface ICRI CSP3 to CSP4 to remove contamination or laitance, and for optimal bonding. Base coat must be applied within 24 hours of primer application. If base coat cannot be applied within 24 hours, clean and re-apply primer.
- **Contamination:** Ensure deck is clean and dry prior to application of material.
- **Incompatible Materials:** Perform field adhesion test prior to application of the coating when installing coating over existing coating system. See the Field Adhesion Testing section of this guide.
- **Apply coating at specified rates and per Neogard recommendations.**

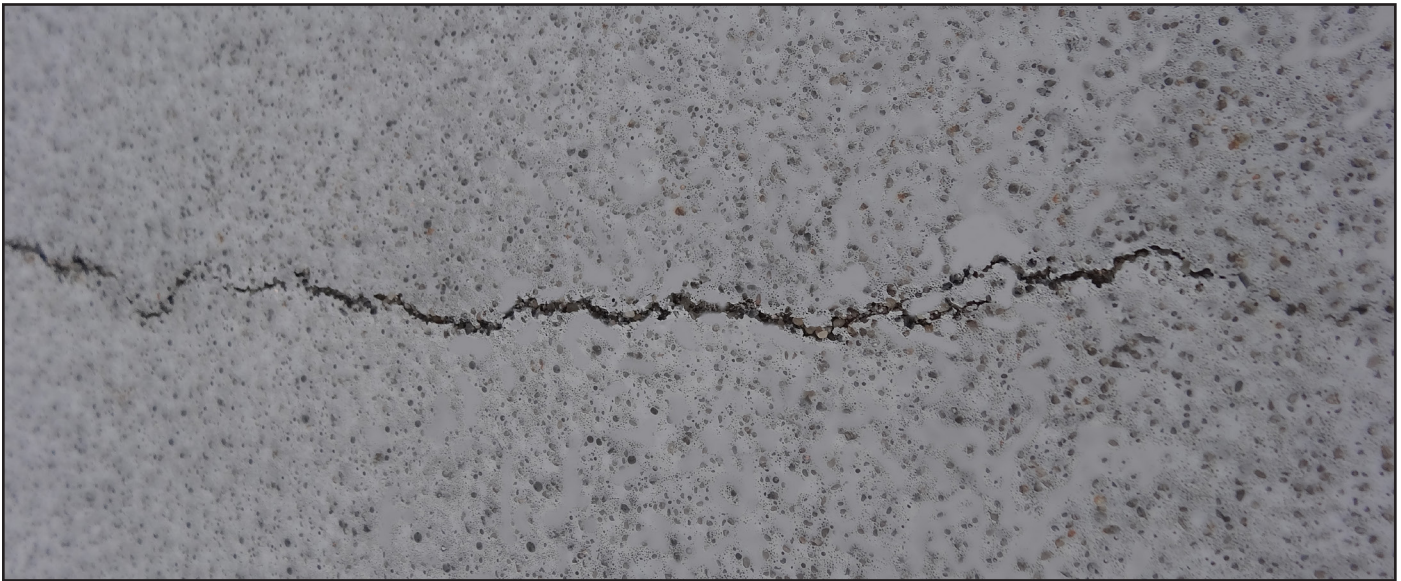
# Cracks

Cracks in concrete substrate may telegraph through the coating and become clearly visible. Over time, these cracks may increase in number as well as in size.

- Settling: Substrate cracks are caused by shifting and settling of the structure after original construction.
- Expansion/Contraction: Concrete structures continually experience expansion and contraction driven by temperature, moisture and load. All cracks should receive detail treatment prior to application of the base coat.

1. Route cracks.
2. Fill with Neogard 70991 polyurethane sealant and strike flush. Allow sealant to fully cure.
3. Clean repair area with Neogard 8500 BioDegradable Cleaner or solvent wipe. Extend cleaning 6"–8" beyond the affected area.
4. Prime any exposed concrete.
5. Install a detail coat of base coat material extended to a minimum of 2" on either side of the crack to yield a thickness of 30 dry mils. Allow to cure and then apply required system.
  - Optional: Apply base coat material extended to a minimum of 3" on either side of the crack at 30 dry mils and embed reinforcing fabric into wet coating. Center fabric over urethane sealant and allow to fully cure. Apply additional base coat material as necessary to fully encapsulate reinforcing fabric. Allow detail coats to cure, then apply required system.

- Prior to application of the coating system, perform proper surface preparation including crack detail:
- Hairline cracks below 1/16" should receive a 30 mil detail coat utilizing base coat material, a minimum of 2" on either side of crack.
- Large cracks above 1/16" should be routed and filled with Neogard 70991 polyurethane sealant. After sealant is fully cured, apply a 30 mil detail coat utilizing base coat material extended to a minimum of 2" on either side of the crack. Reinforcing fabric is optional.

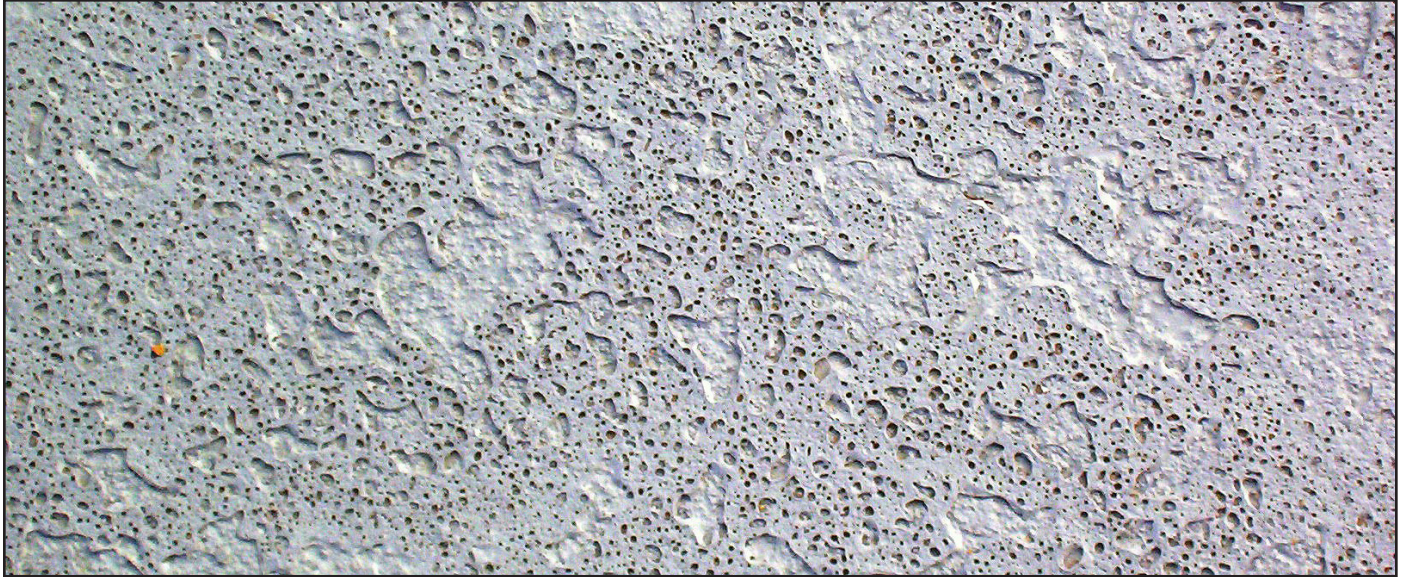
# Water Damage To Uncured Coating

Surface has areas of sponge-like, cratered patterns where water has come in contact with uncured coating.

Heavy rain, sprinklers or other water source caused damage to uncured coating.

1. Grind all affected areas to eliminate ridges in the cratered areas.
2. Clean and allow to completely dry.
3. Re-apply coating as specified and according to Neogard recommendations.
4. In severe situations, the coating may have to be totally removed prior to re-coating.

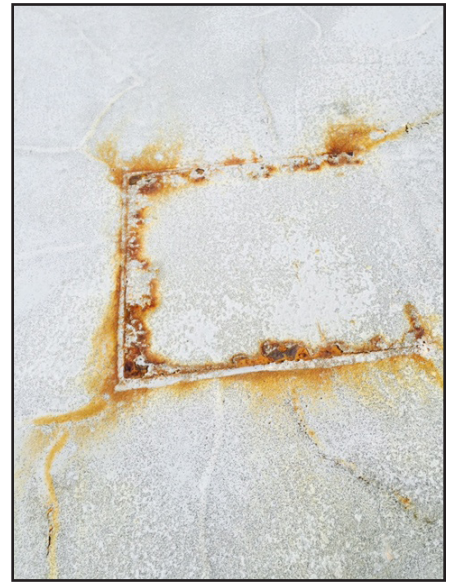
# Rust/Metal Contamination

There are rusty, reddish-brown stains in the coating. The presence of rust can be purely aesthetic, or it may indicate a condition which affects the integrity of the coating system.

- Shotblast Beads: Rust stains develop when shot-blast beads utilized during surface preparation are not properly removed. Rust stains will bleed through the entire system if metal is not removed prior to applying the coating system.
- Metal in Aggregate: Rust may also develop from metal fines contained in the aggregate.
- Rebar or Mesh: Rust from rebar or mesh too close to the surface can also appear.

If the contamination source is from the surface, power washing along with the use of a rust neutralizer may remove stained area.

1. If the contamination source is located in the substrate, remove the coating down to the substrate and abrade the surface to remove all rust.
2. Apply Ureprime HS2 or HS4 at a rate of 300 sf/gal to properly prepared area and allow to cure.
3. Apply 70714/70715 Series epoxy at a rate of 100 sf/gal (16 WFT/16 DFT).
4. Re-apply coating per specifications and Neogard recommendations in the Waterproofing Application Manual.

- Shotblast Beads: Remove all iron and metal residue from the substrate, including cracks and joints.
- Metal in Aggregate: Use Neogard or Neogard-approved aggregates.
- Rebar or Mesh: After the deck is cleaned and shot-blasting completed, inspect for rebar and/or mesh near the surface. If rebar or mesh is near the surface, it may be necessary for the owner to consult with a structural engineer.

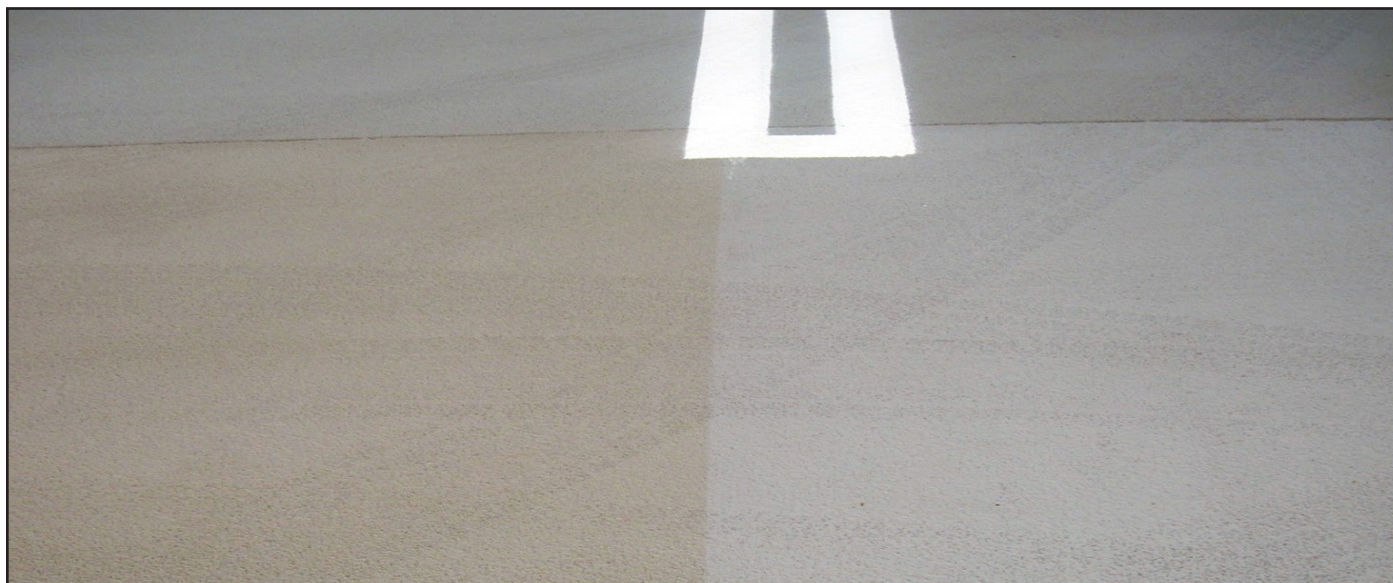
Finished waterproofing surface shows different shades of color. While considered less than aesthetically appealing, this condition does not affect the integrity of the waterproofing system.

- Different Batches of Topcoat: There may be slight shade variation from batch to batch of material.
- Deck Coated at Different Times: Older coating material has weathered and appears different than newer coating material.
- Improper Mixing: Product not mixed sufficiently to disperse pigment. See Product Mixing Instructions in this guide.

1. Apply an additional wear coat and topcoat.
2. Allow sufficient time for weathering.

- Different Batches of Topcoat: Always purchase or set aside enough topcoat from the same production batch to coat the entire surface area. Use odd batches elsewhere such as in the wear coat if applicable. If there is not enough topcoat of a single batch to complete the project, “boxing” batches is an alternative. Boxing is the process of combining all the coating you will be using as the topcoat into one large container. This is especially important when coating a large surface area or if there is insufficient coating from a single batch, where a color variation from one batch to another is likely.

- Improper Mixing: Always mix material sufficiently to properly disperse the pigment. See Product Mixing Instructions in the Support Information section of this guide.

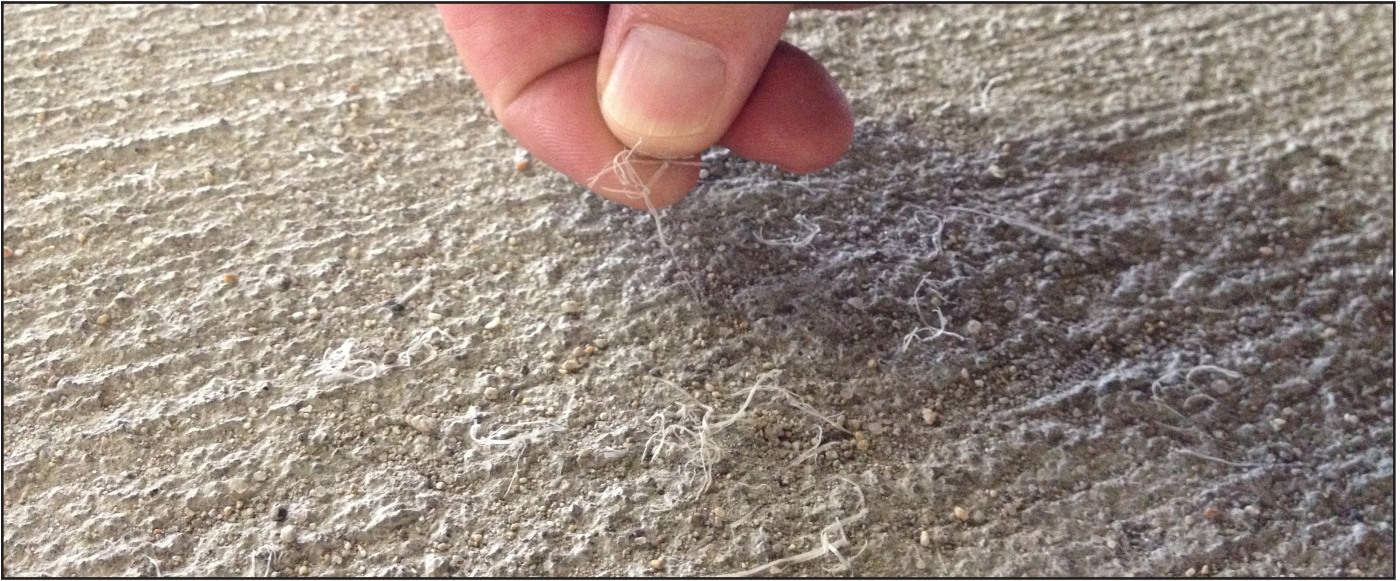
Fibers have been added to the concrete mix to control shrinkage cracks and to improve other physical properties. These fibers will protrude and breach the coating system and may cause future leaks.

Fibers added to the concrete mix will protrude through the concrete surface.

1. Mechanically prepare surface by shot-blasting to industry-standard texture (ICRI CSP3–CSP4) without causing defects to substrate.
2. Remove fibers by burning with a propane torch.
3. Remove any remaining residue prior to coating application.

It is not recommended to use fibers in the concrete mix when a coating is to be applied. If fibers are present, remove them before applying coating.

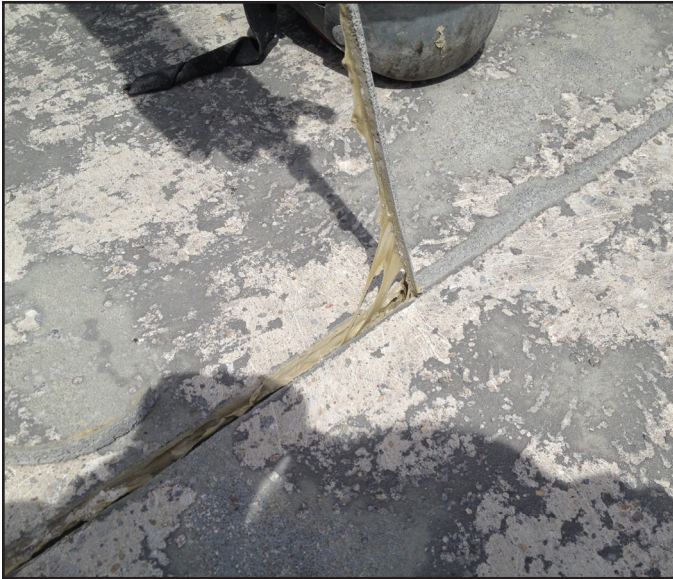
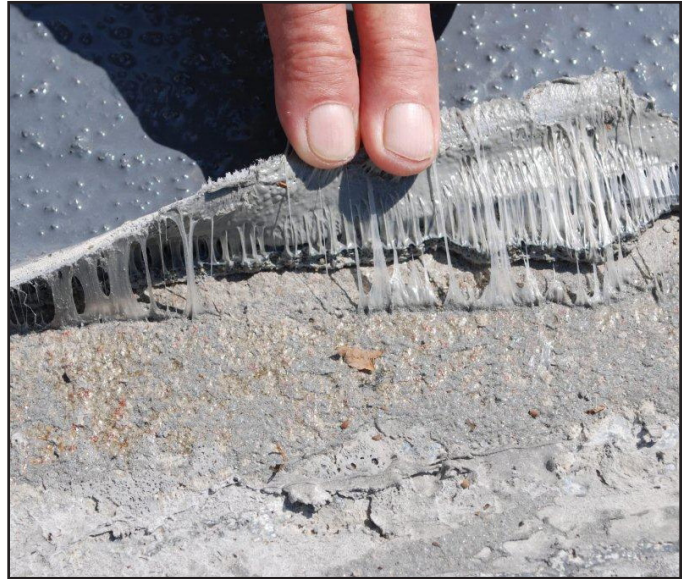
# Delamination Caused By Sealant

Coating delamination has occurred due to off-ratio, uncured sealant.

Two-component sealant was improperly mixed or was contaminated.

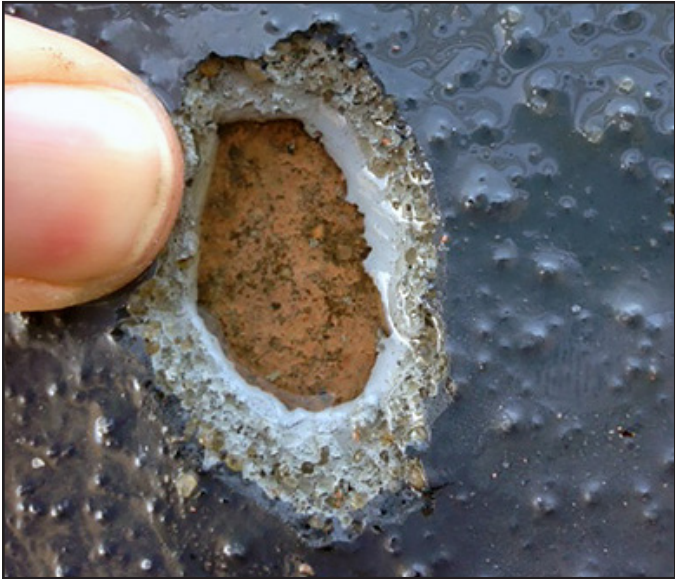
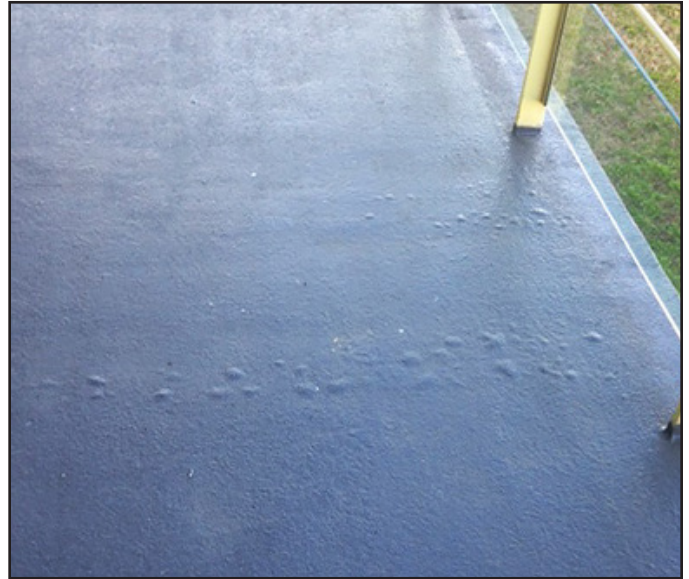
# Blisters Caused By Trapped Moisture

The coating system fails due to delamination caused by moisture migration in the concrete substrate.

Trapped excess moisture in or below the concrete substrate.

1. Identify the source of the moisture.
2. Remove coating in affected areas down to clean substrate.
3. Re-apply coating as specified and according to Neogard recommendations.

- **Moisture Contamination:** Ensure that the deck is completely dry prior to coating. Moisture may not be readily apparent, particularly if aggregate has been introduced into the system. Monitor the ambient surface temperature for the entire duration of the application process. See Dew Point Chart in the Support Information section of this manual for ambient temperature and relative humidity guidelines.
- **Moisture Test:** Ensure that the deck is completely dry before coating. Moisture may not be readily apparent, particularly if aggregate has been introduced into the system. Conduct a moisture test before application to ensure that there is no water contamination.

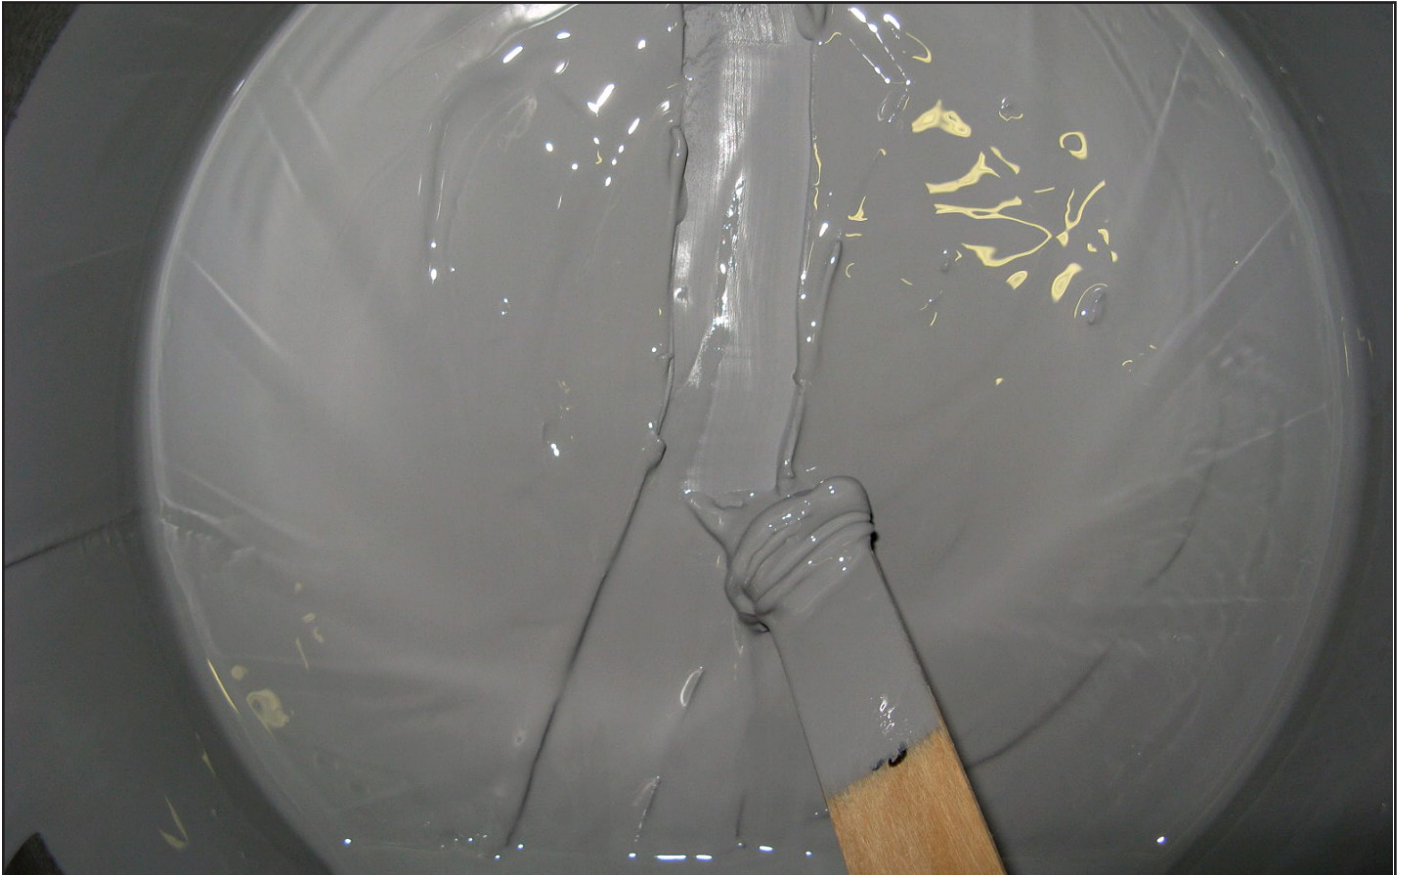
Solid material settles in the bottom of the bucket. This typically occurs in the pigmented/color side of a product.

Some products have a tendency to settle over time.

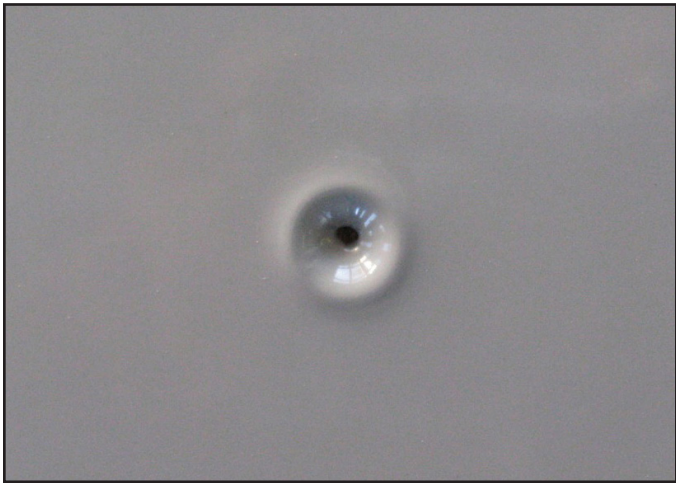
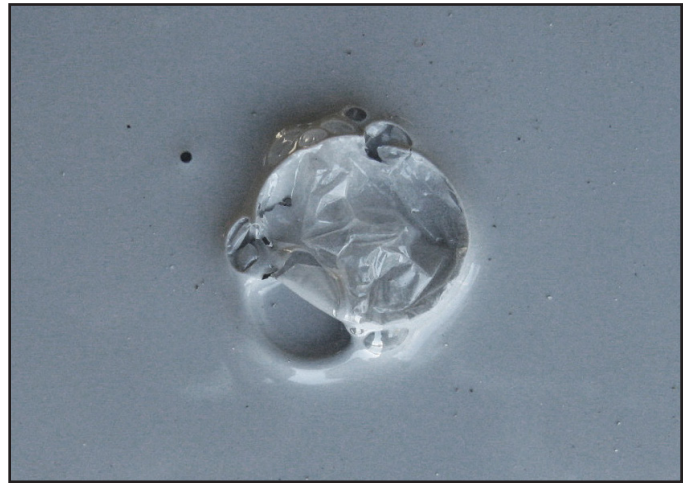
Pinholes appear as tiny blisters or bubbles. When these blisters pop they usually leave a round crater and the pinhole should be easily seen through the film.

- Outgassing: Air escapes from porous concrete and becomes trapped in the coating.
- Air Movement: Excessive air movement from vents, doors, or other sources may cause flash drying and prevent necessary air release from coating.
- Temperature/Humidity: High temperatures or humidity can cause rapid drying, entrapping air in coating.
- Direct Sunlight: Coating exposed to direct sunlight can tack off before releasing air, forming bubbles.
- Improper Mixing: Mixing at high speed and improper mixing procedures may result in entrapped air.
- Roller Covers: Too short or too long of a nap roller can introduce air into the coating.
- Surface Prep: Aggressive shot-blasting or sandblasting will open pores in the concrete, causing air to become trapped when coating is applied.

- Air Movement: Avoid generating fast air movement across the coating. When providing ventilation, always exhaust air rather than blowing with fans.
- Temperature/Humidity: Wait to apply material until temperature and humidity are within the ranges specified in the Product Data Sheets.

- Direct Sunlight: Prevent direct sunlight exposure during initial cure.
- Improper Mixing: Use slow speed mixing equipment with a paddle-type blade. If air is introduced into the material, let stand until air is visibly released.

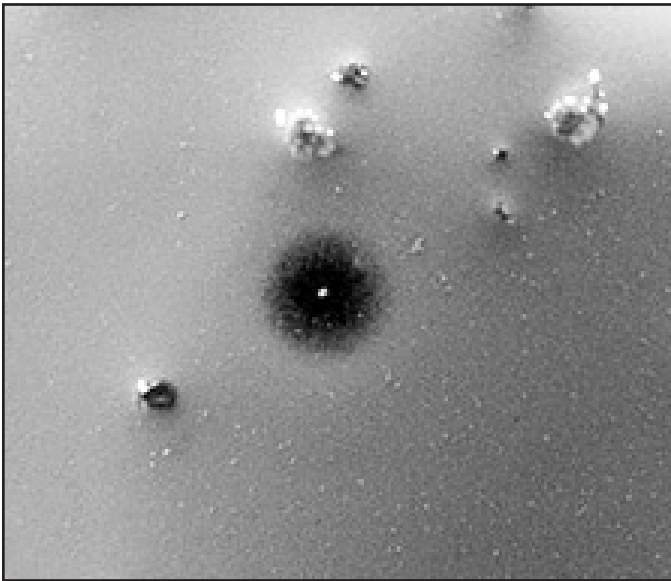
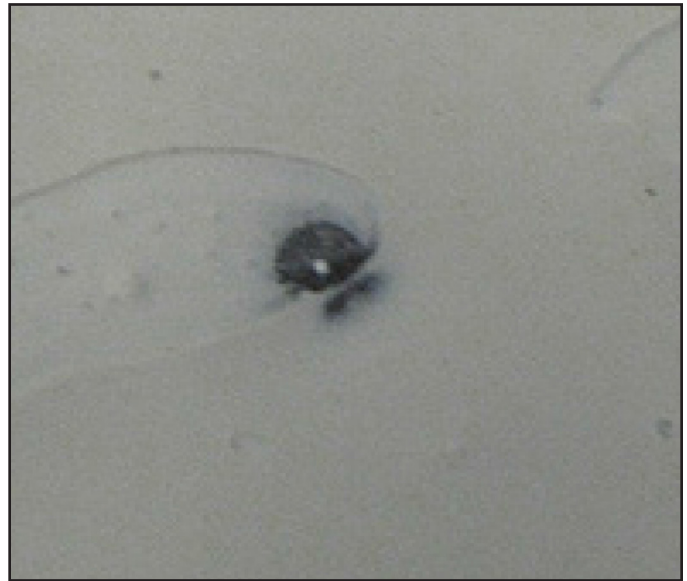
Fish eyes are round indentations or separation in the coating finish. Upon closer examination, they look like a crater with a rim around the perimeter of the defect along with a very small dot in the center.

**Silicone Contaminants:** Certain manufacturing processes such as welding or spraying can deposit silicones on the floor causing fish eyes to appear.

**Oil/Grease Contaminants:** Oil or grease contaminants can cause the coating to function improperly and fish eyes to appear.

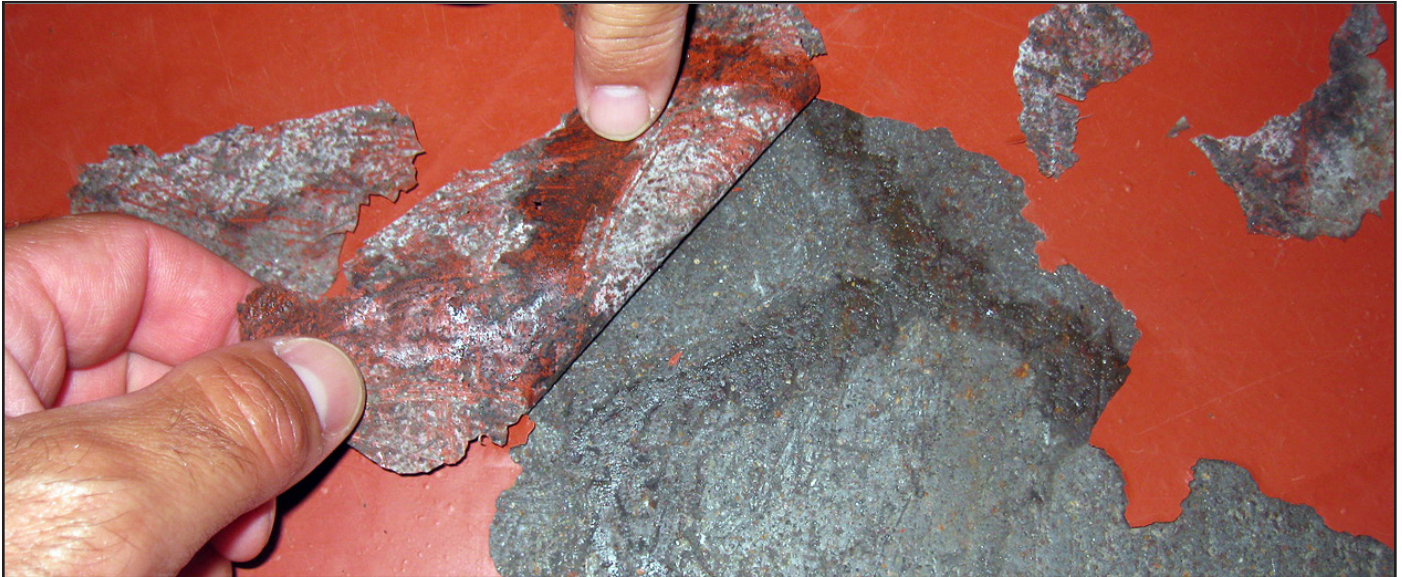
Coating is peeling or de-bonding from the substrate.

- Inadequate Cleaning: Coating will not adhere to oil, grease or other contaminants.
- No Primer Used: Without primer, peeling/delamination may occur.
- Moisture Vapor Transmission: Water vapor penetrating through the substrate can cause peeling/delamination. After removing delaminated areas, moisture may be visible or the concrete may be dark in appearance.

1. Remove any coating that is not tightly bonded by stripping, shot-blasting, or other suitable means.
2. Consult Neogard Technical Services if this condition exists.

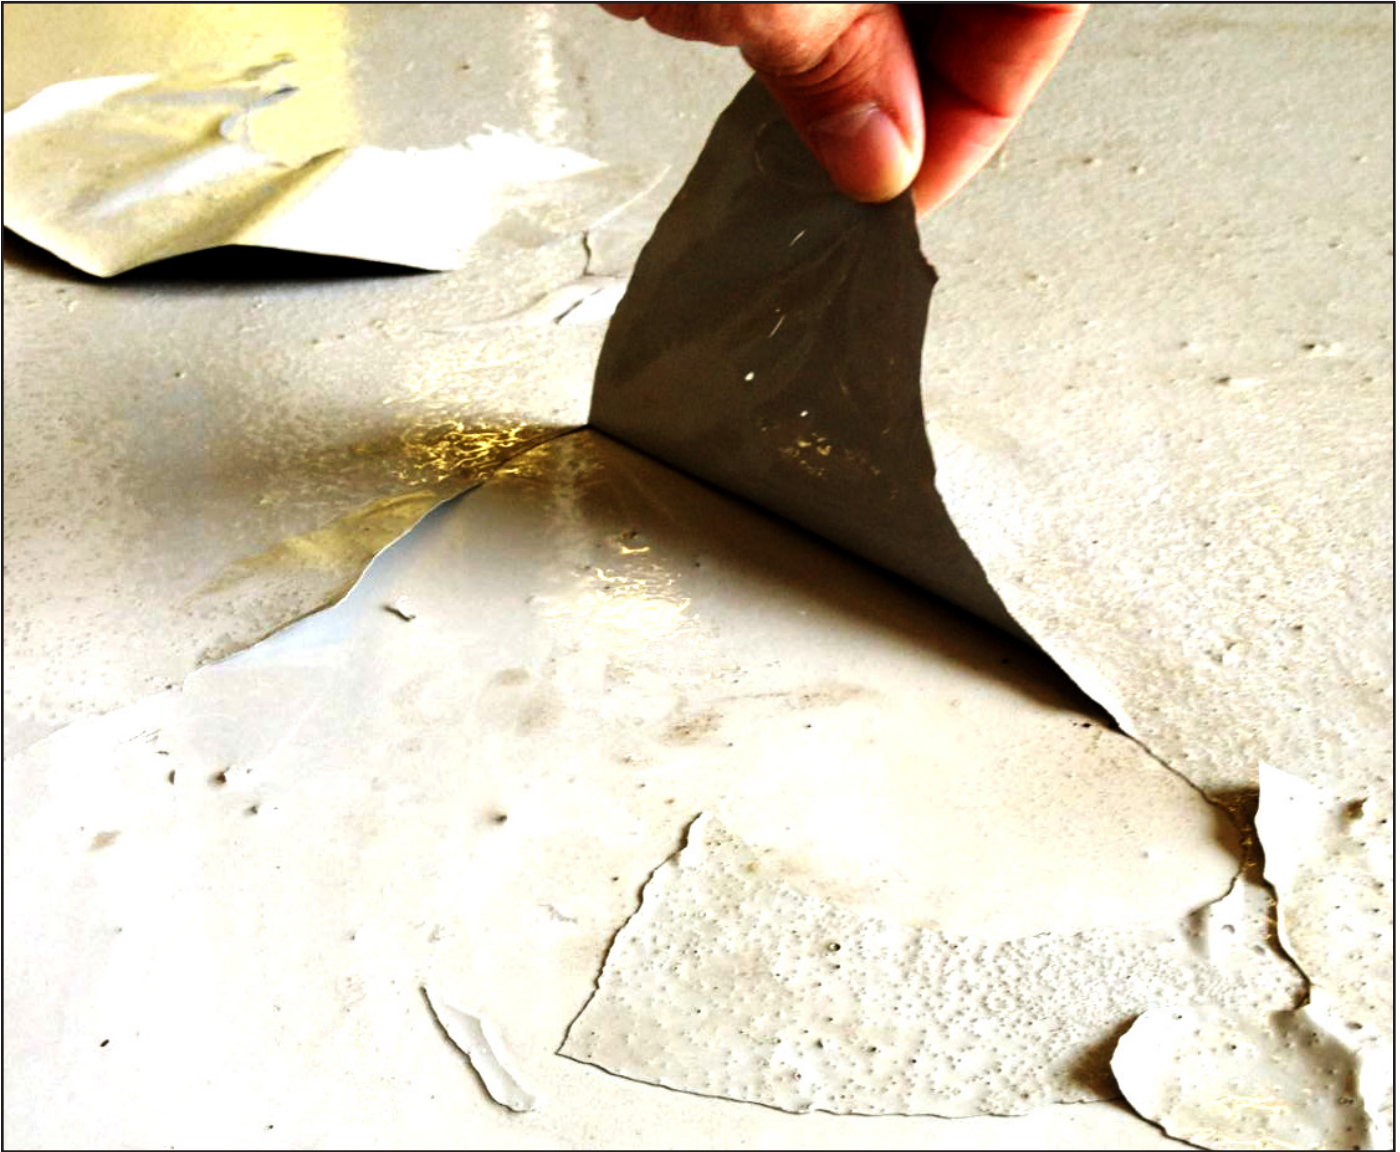
Coating is peeling or de-bonding between layers of coating.

- Beyond Recoat Window: Coating was not applied within 24 hours of previous coat.
- Surface Contamination: Surface was contaminated by water, humidity, oil, grease, or dust.
- Improper Mixing: Coating was not mixed at proper mix ratio, or not mixed for a minimum of 3 minutes.

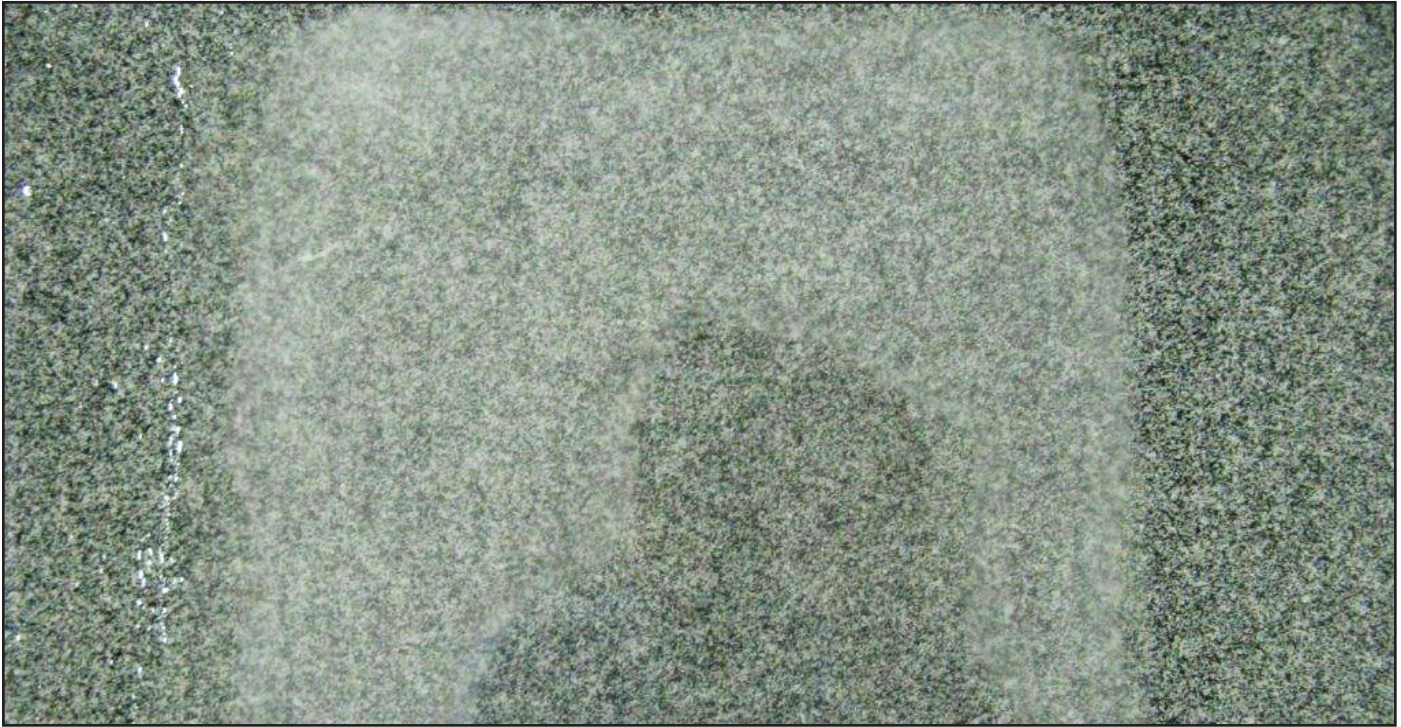
There is a milky or cloudy appearance in wet or cured coating material.

- **Moisture:** Moisture in the concrete or high humidity levels can cause moisture to be present on the surface when the material is applied, or before it is fully cured. This can result in a milky appearance or greasy film. This condition is sometimes referred to as “blush” and is more prevalent with certain epoxies.
- **Thick Application:** A milky or cloudy appearance may result from the coating being applied too thick. In this case, the milky appearance will be more noticeable if the coating is clear.

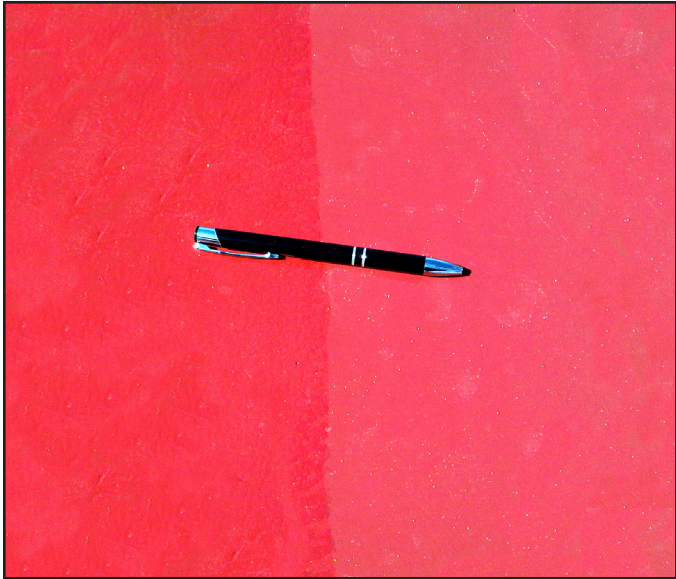
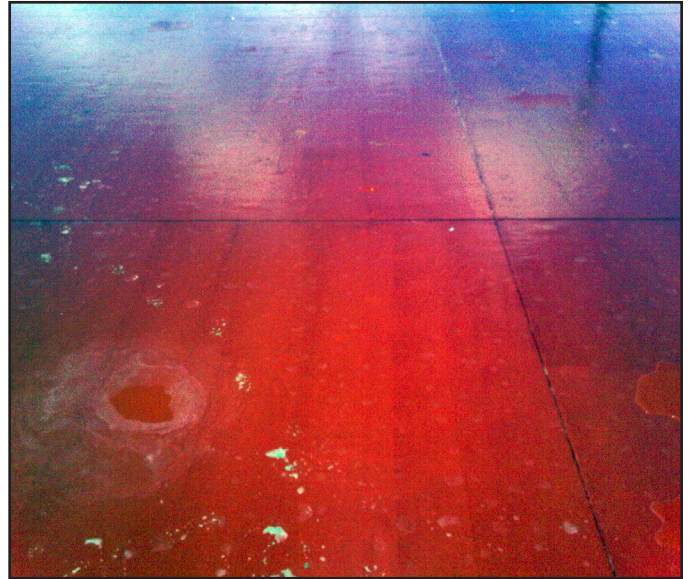
Coated surface has different shades of color.

- Retouching After 15 Minutes: Color float occurs when a pigmented material has been applied and it is retouched after it has been sitting for 15 minutes or longer. Different shades in color may appear.
- Different Batch Numbers: Color can vary from batch to batch. Using different batch numbers at a job site can also cause differences in color appearance.

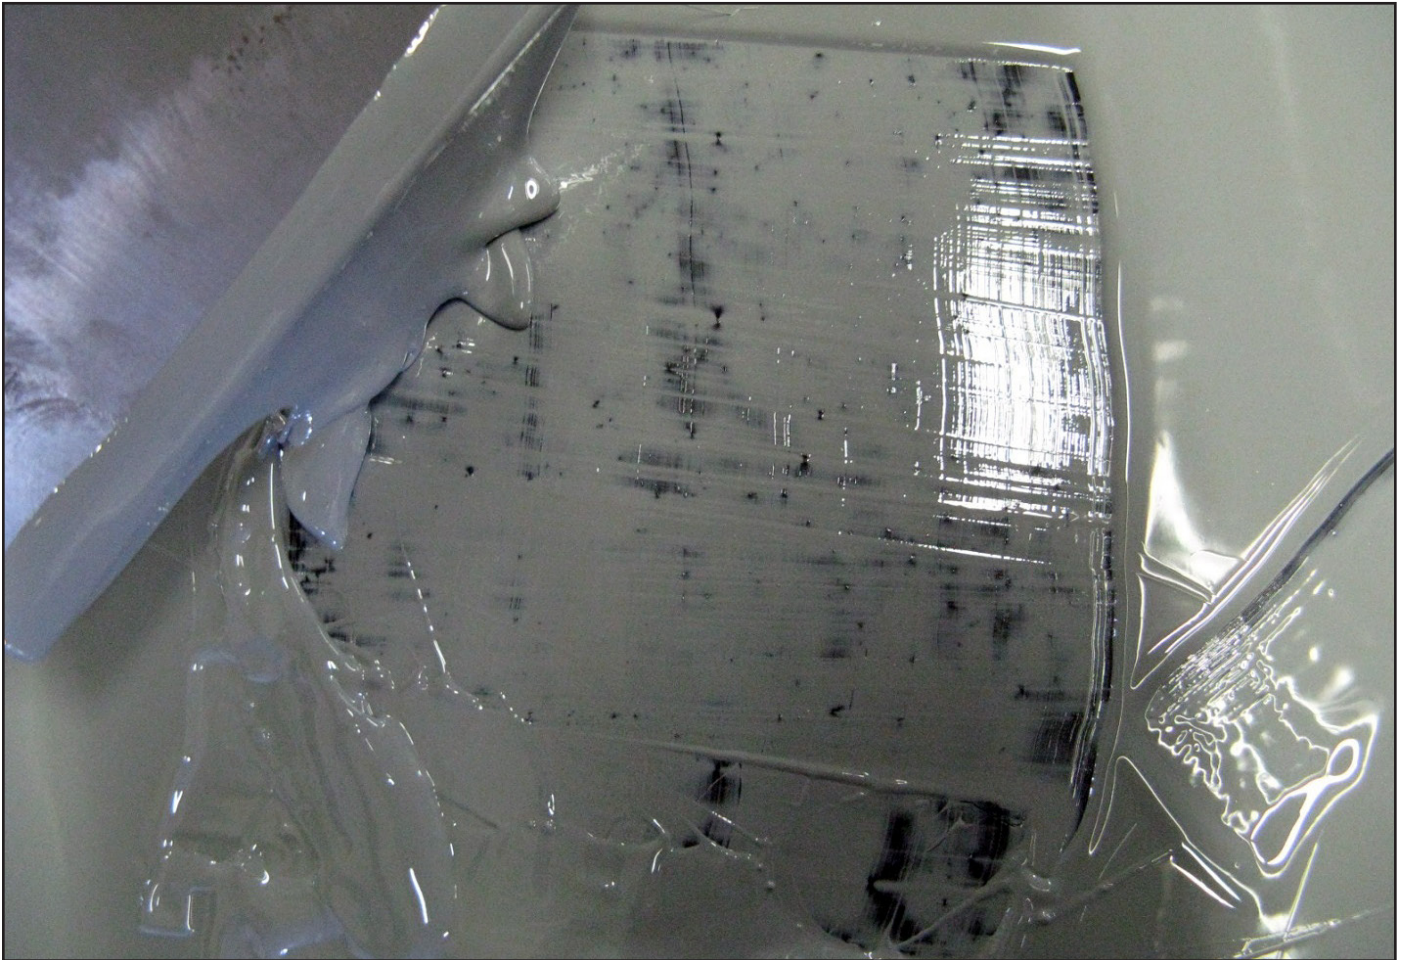
The material does not fully cure or is still soft after 24 hours.

- Improper Mix Ratio
- Improper Mixing
- Cold Materials
- Cold Ambient Temperatures
- Cold Surface Temperatures

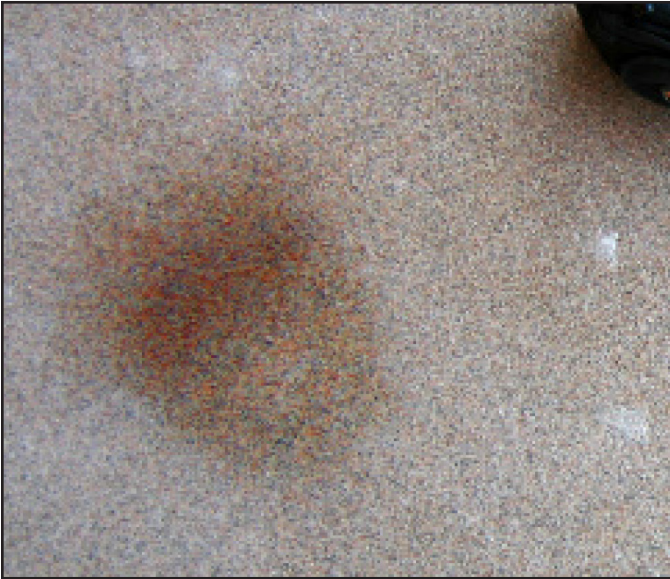
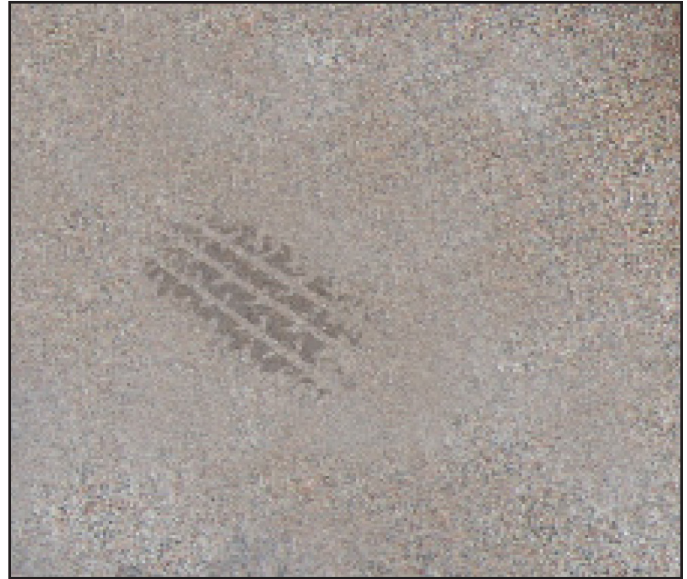
There are dark or discolored spots in the coating system.

- Chemical Exposure or Spills: Floor has been exposed to chemicals.
- Tire Marks: Floor has been exposed to vehicular traffic.
