# Troubleshooting Guide

Causes, Repair  
& Prevention

March 2020

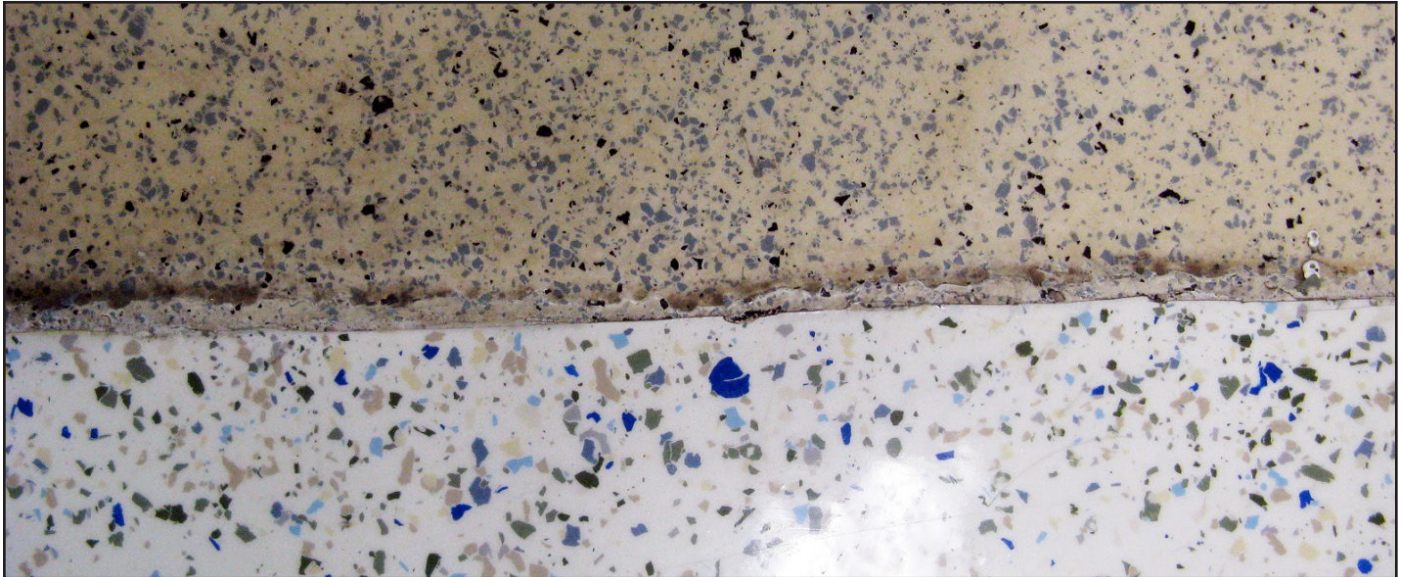
Topcoat has developed a yellow hue. This problem will affect epoxies regardless if the epoxy is clear or not.

Epoxy has been exposed to partial or direct sunlight.

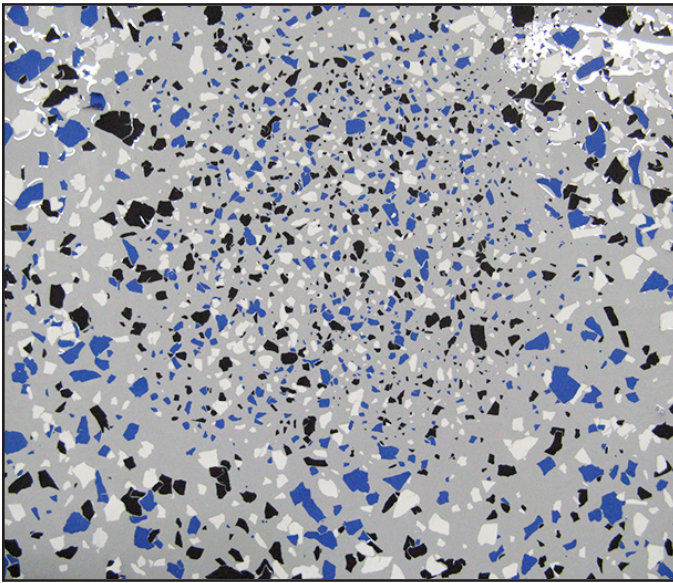
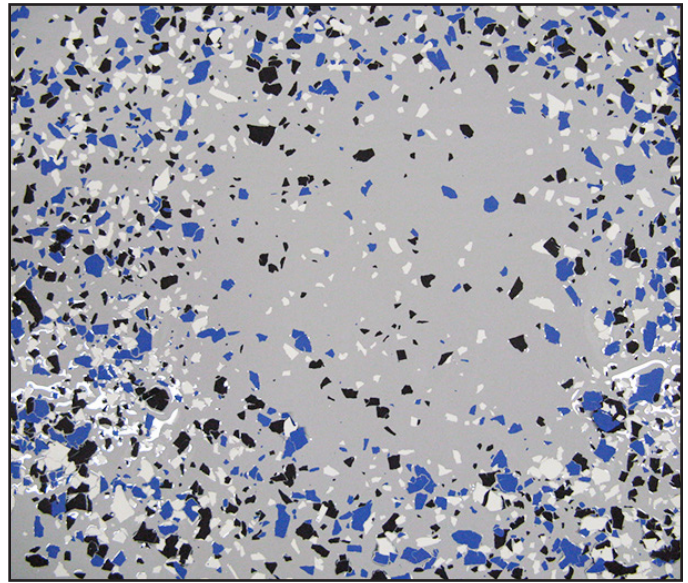
Even flake disbursement is a key factor in the aesthetics of a random flake flooring system. Having the same size and coverage of flakes is key to a uniform appearance.

- Flakes Broadcast Too Quickly: This leaves an uneven disbursement in the base coat. To ensure uniform coverage, make certain the broadcaster takes their time.
- Flakes Crushed During Broadcast: This causes variations in the size of flakes. Size variation of flakes in the floor is caused by crushing the flakes in hand as they are broadcast. Also, reaching for the flakes in the bucket, they are inadvertently crushed.
- Clumped Flakes: If clumped flakes are introduced into the wet base coat, they will dry in a clumped formation.

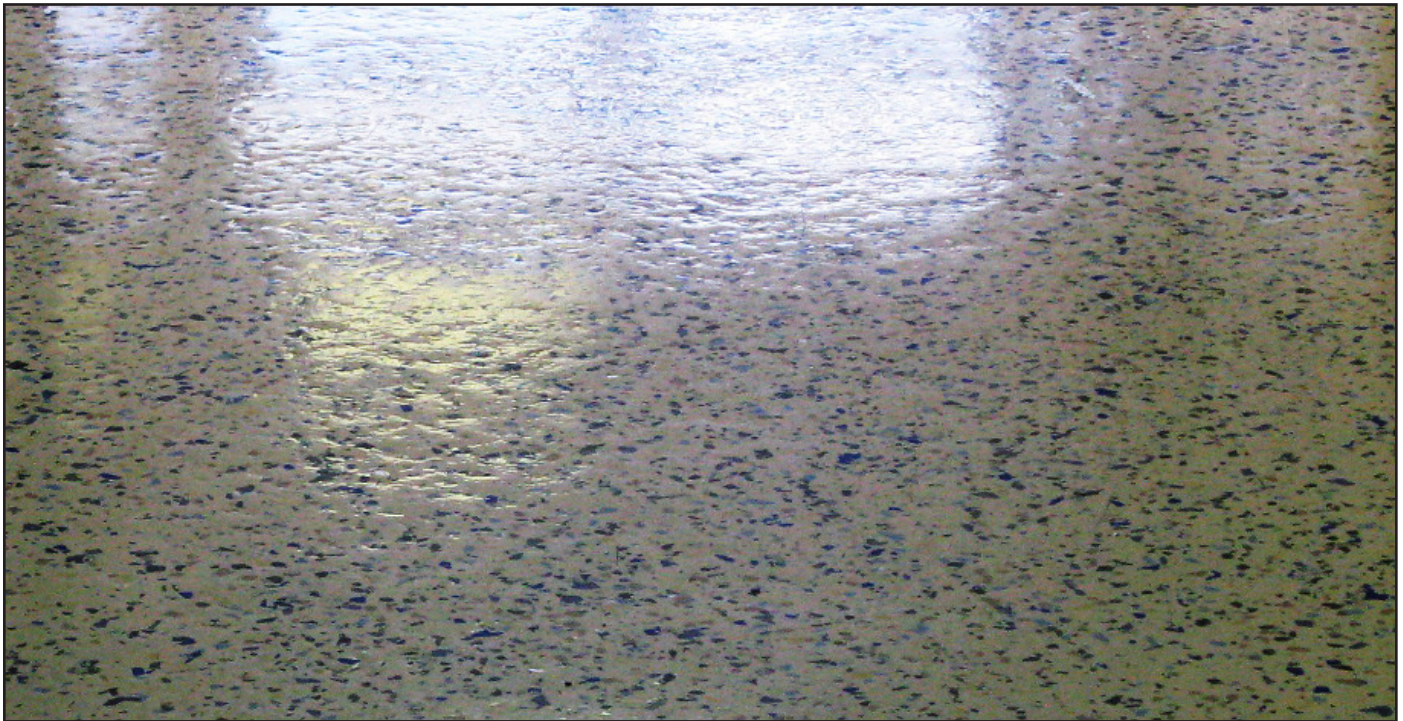
Orange peel is a stipple finish appearance in the final topcoat of epoxy or urethane flooring system. Some flooring manufacturers offer this finish; however, it is not always desirable to the customer.

- **Cold Substrate/Materials:** If the substrate temperature is below 50°F/10°C, the epoxy or urethane will not flow and level out, and can produce the orange peel finish. This will be more prevalent if the topcoat is applied in a thin layer, somewhere between 3–6 wet mils. The combination of a cold substrate and cold materials can readily produce this type of finish.
- **Hot Substrate/Materials:** Hot temperatures can also result in an orange peel finish. If the substrate is above 90°F/32°C, the topcoat may cure too quickly. This rapid curing will cause the material not to flow and level out. Just as in cold temperatures, thin topcoat layers, hot substrate temperatures and hot material can produce an orange peel finish.

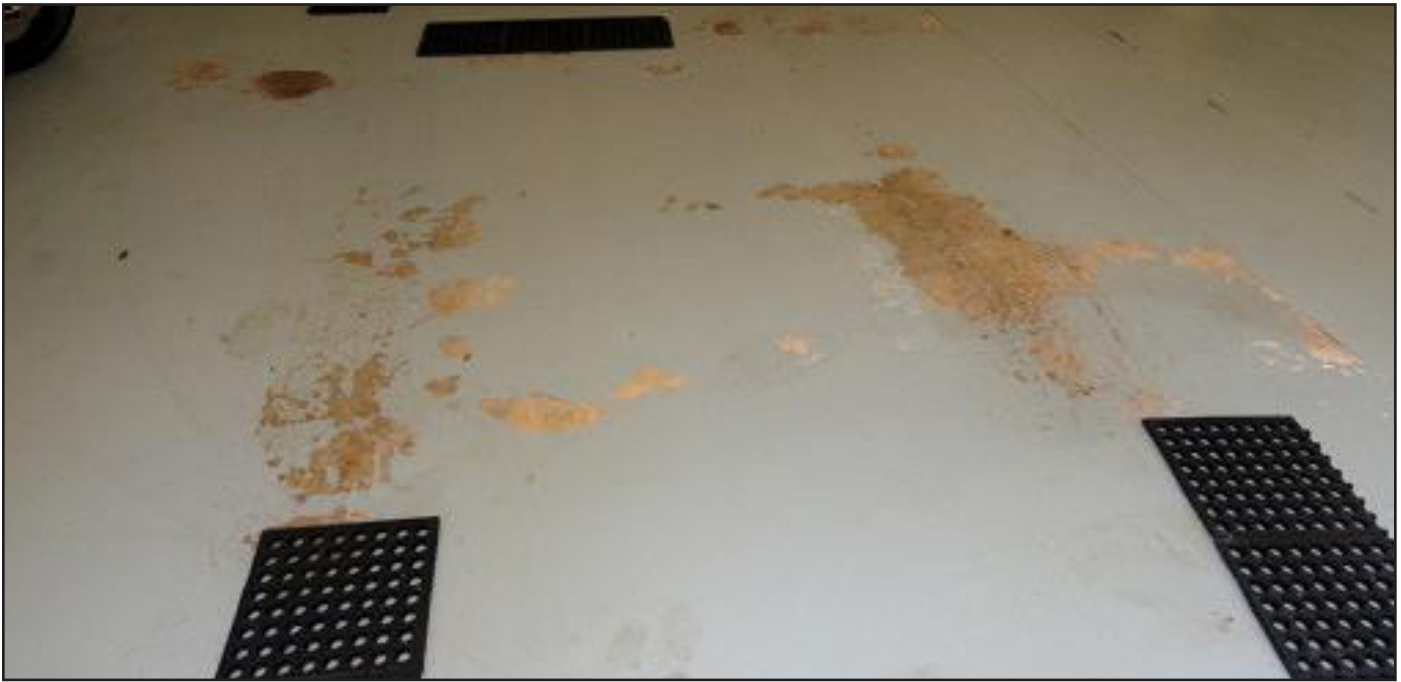
Flooring system is delaminating and peeling in areas where tires are consistently in contact with the coating.

- Thin System Application: A floor coating system applied at insufficient coverage rates may delaminate.
- Project Specification: The applied system was not designed for project conditions.
- Poor Surface Preparation: Substrate was not properly prepared for acceptance of coating system.
- Improper Cure Time: Coating was not fully cured.

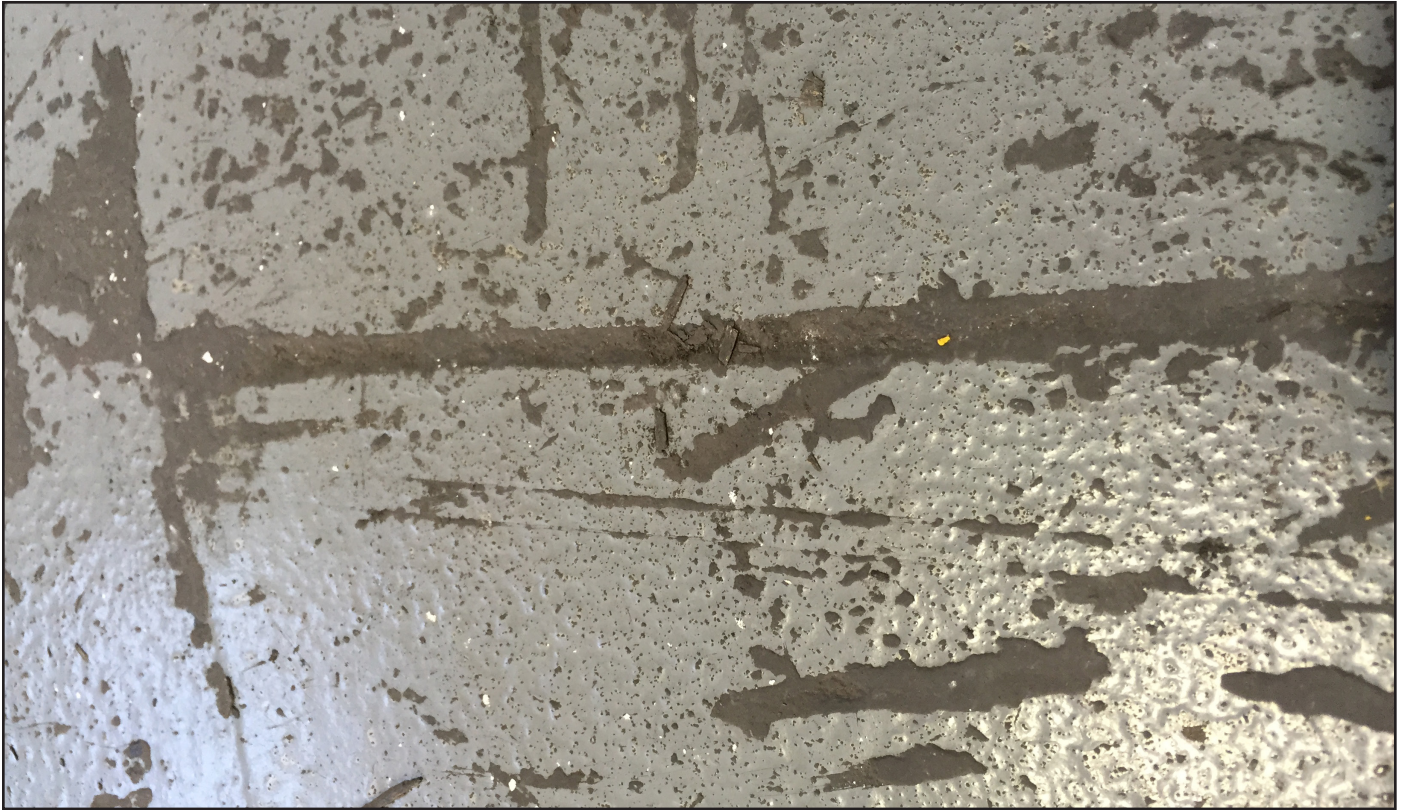
Flooring system has been scratched and/or gouged.

- Pallets have been dragged or pushed across the floor.
- Heavy loads have been dropped onto the floor.
- Forklift forks have scraped the floor.

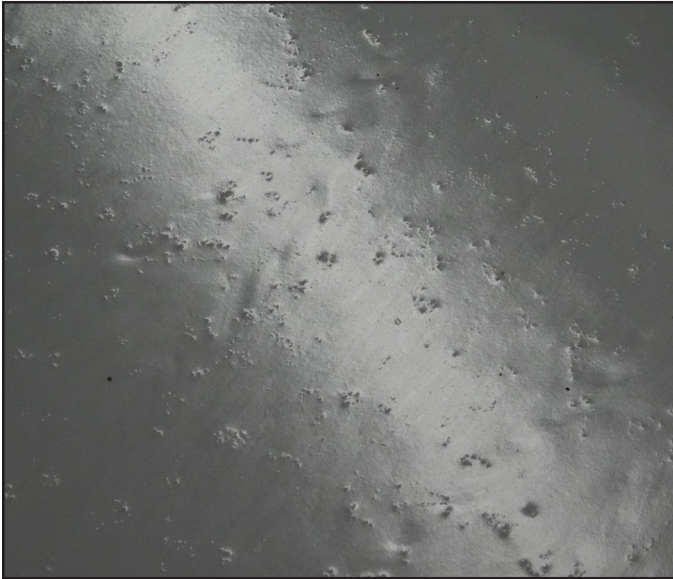
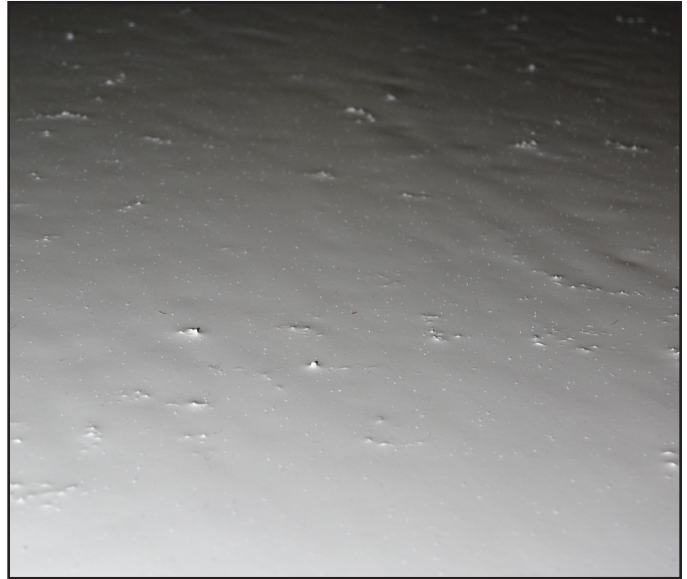
Roller lint is embedded in the coating after application.

- Low-quality roller covers were used.
- Roller nap was too long.

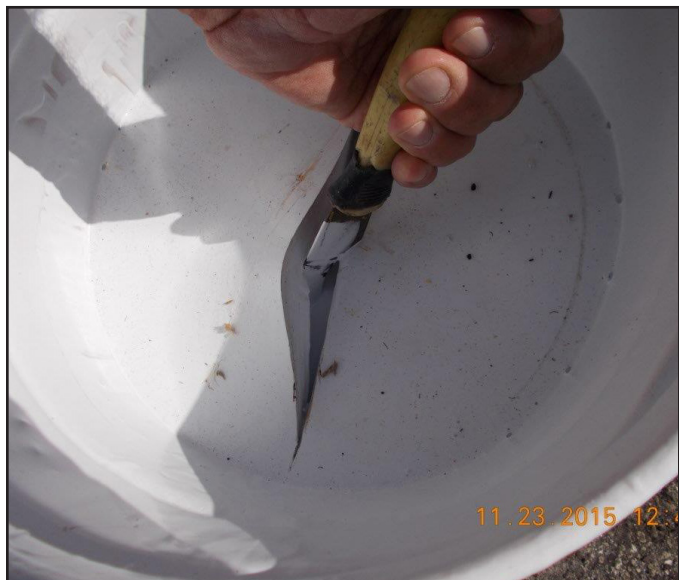
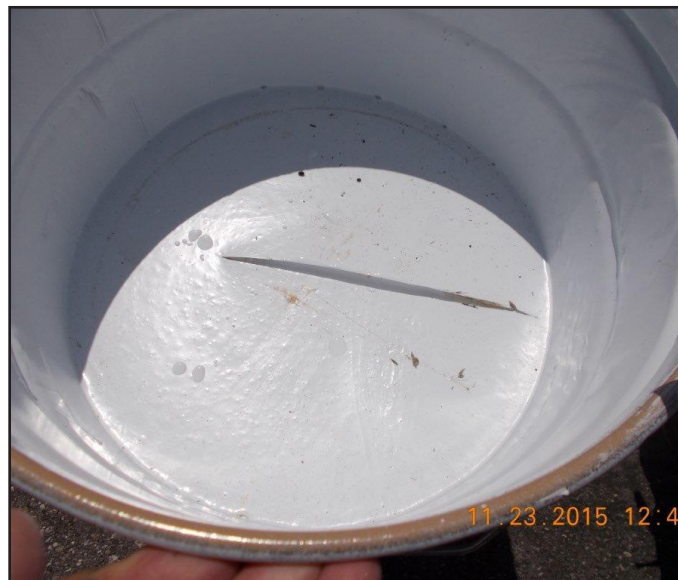
A skin forms on the top of the Material in a pail or barrel.

Single-component urethanes are moisture-cured. The pail or barrel has been opened, allowing moisture to be introduced to the coating material, and the curing process begins.

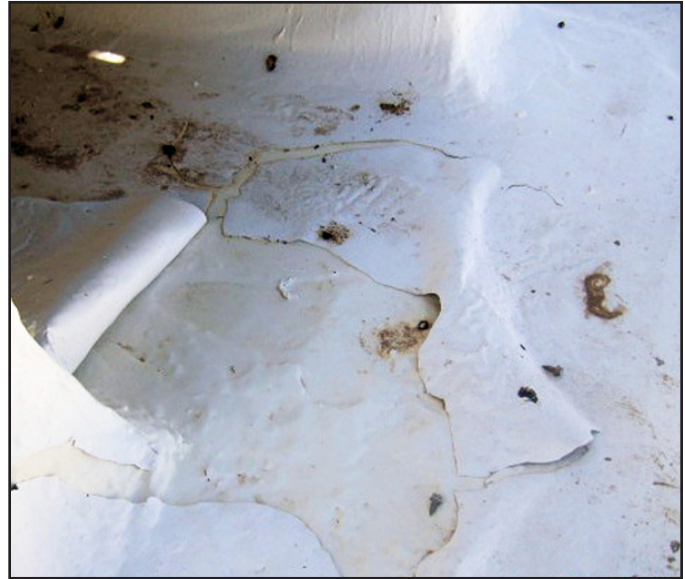
**Delamination due to thin topcoat and ponding**

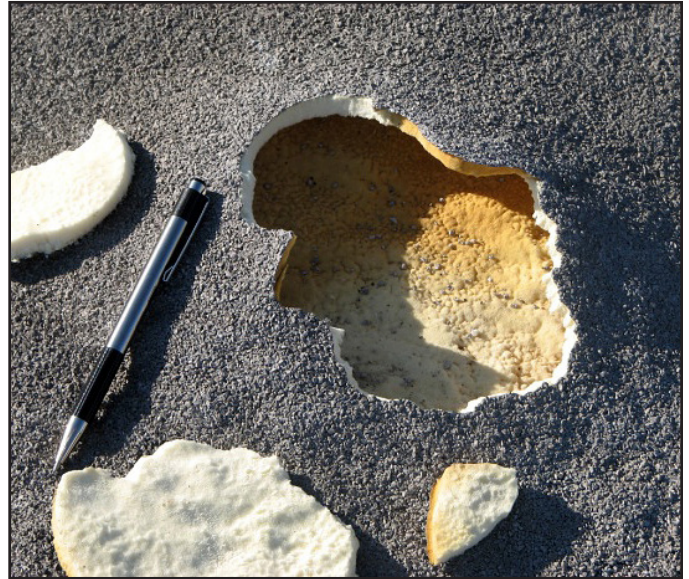
**Typical unopened foam blister**

**Foam blister that has been cut open**

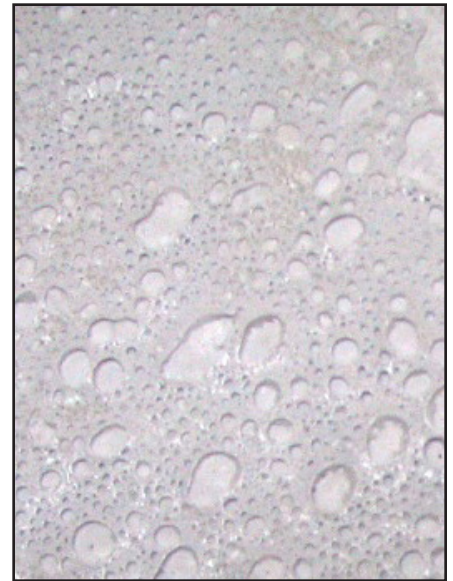
Roof with moisture contamination

Magnified view of darker area

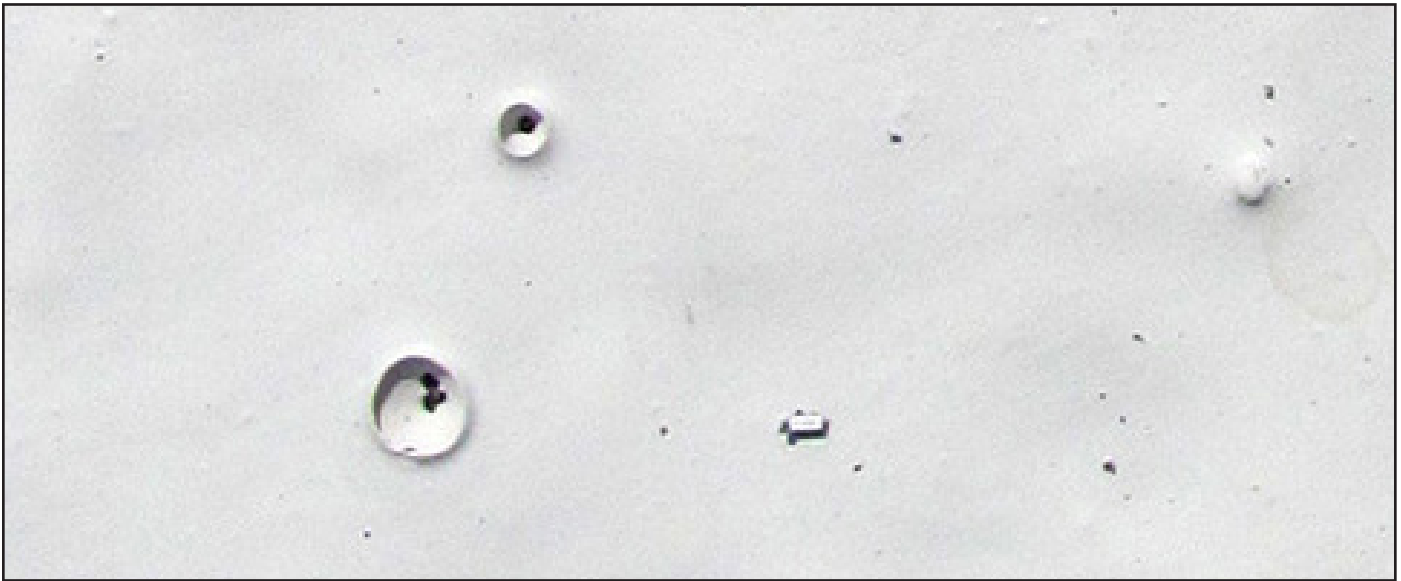
Appear as tiny blisters or bubbles. When these blisters pop they usually leave a round crater. The pinhole should be easily seen through the film. Concrete decks are susceptible to this condition.

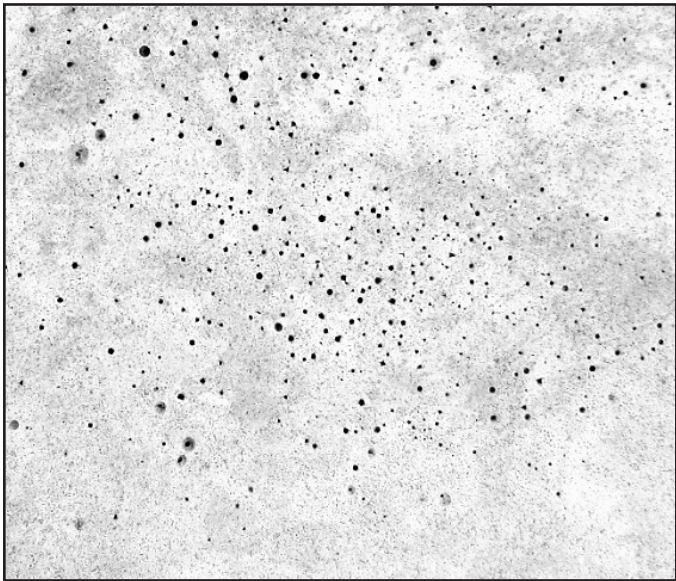
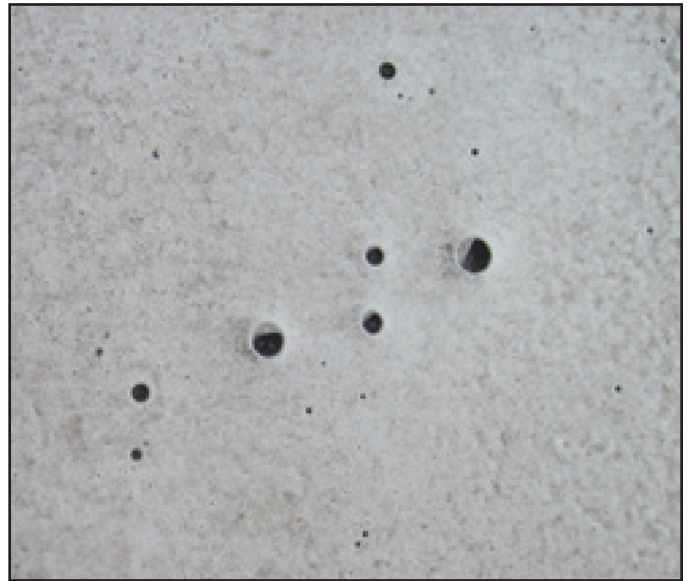
Small voids which penetrate through the coating. A crosscut will show intact base coat material, with the voids contained only in the topcoat.

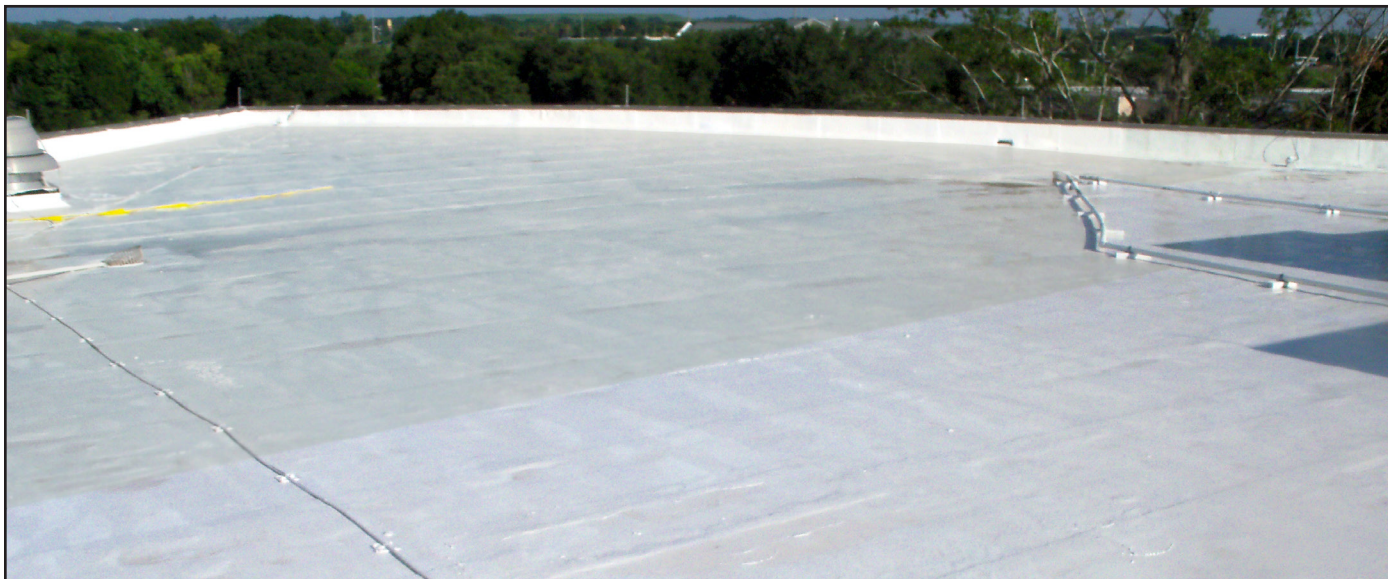
The coating appears to be different shades. This is most often noticeable in white products.

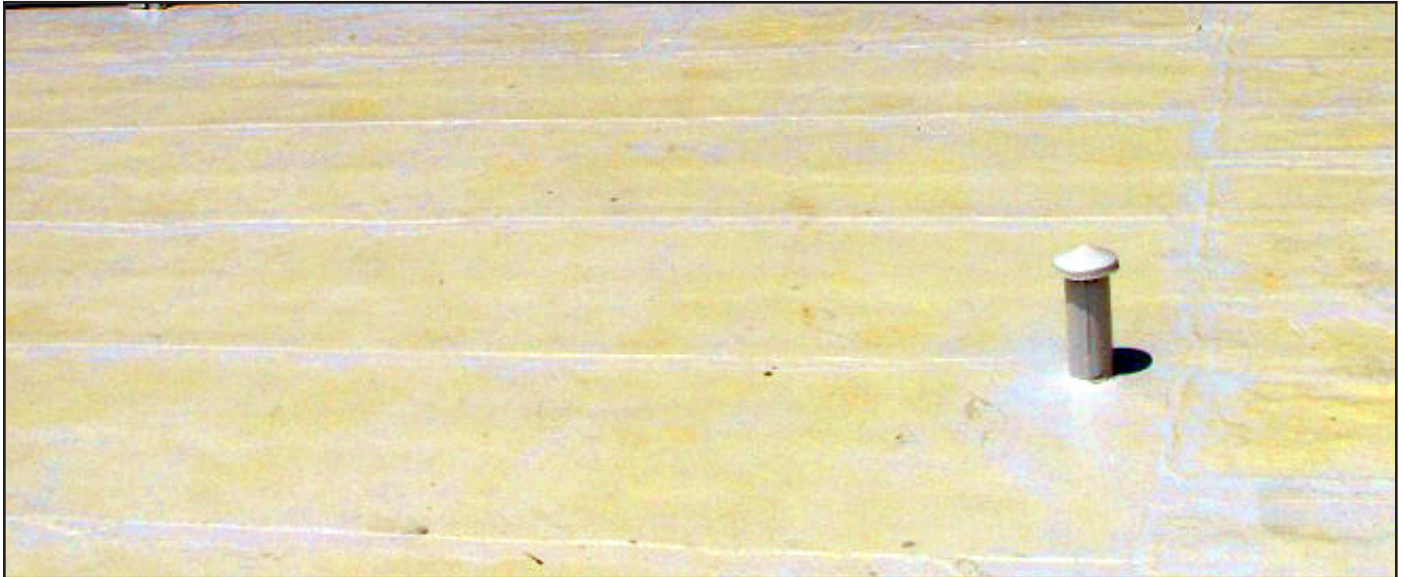
Surface of coating has taken on a yellow hue. Yellowing may be splotchy.

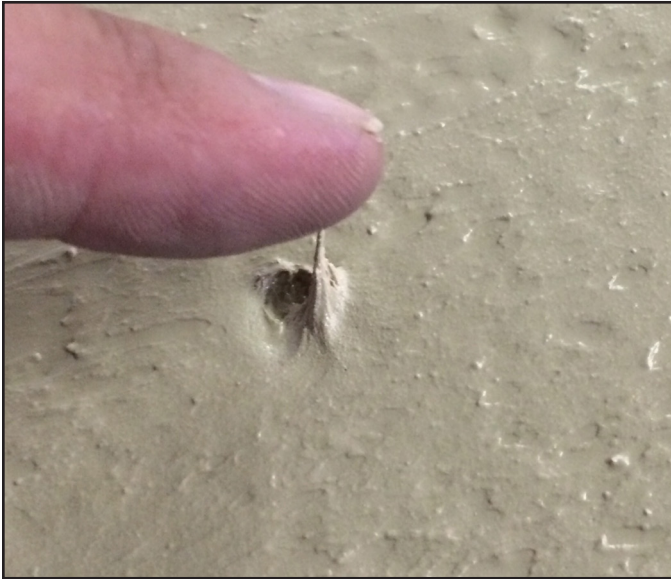
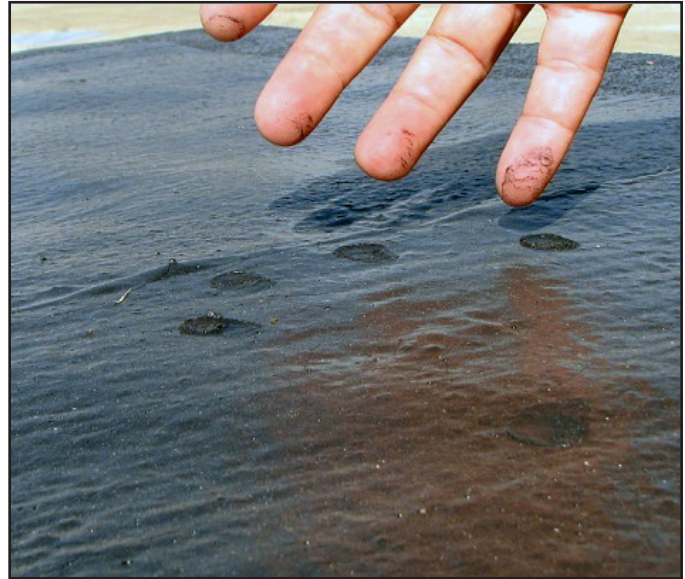
After expected curing time has elapsed, coating is still soft and may transfer when touched.

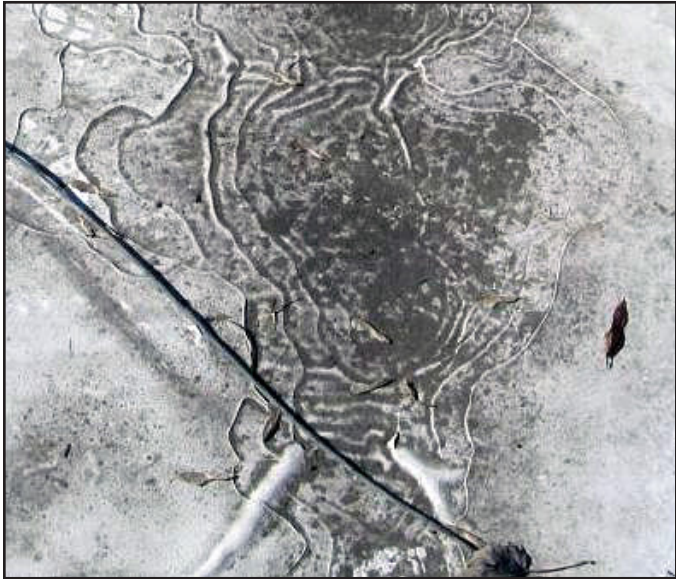
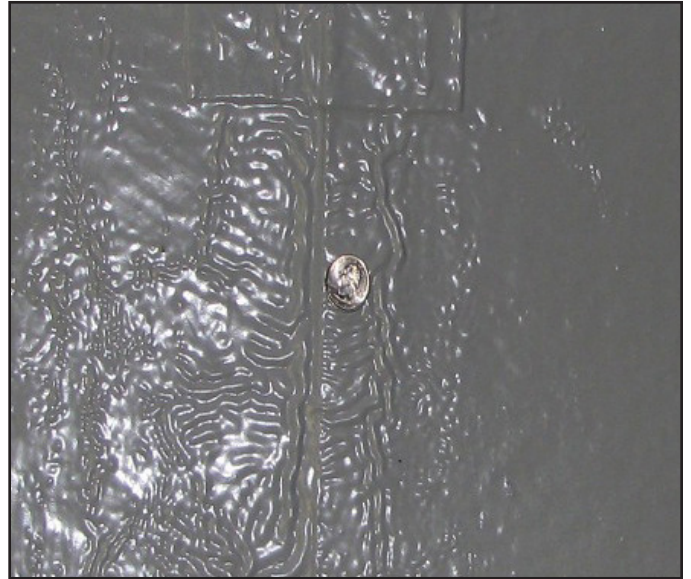
Areas of the coating appear wrinkled.

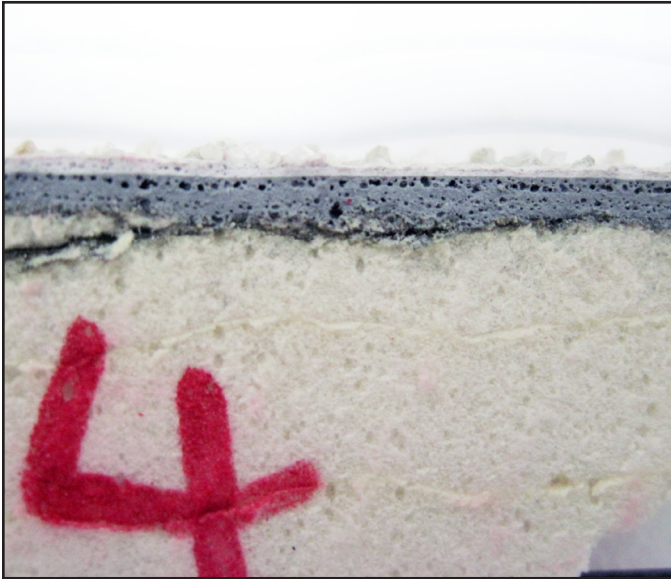
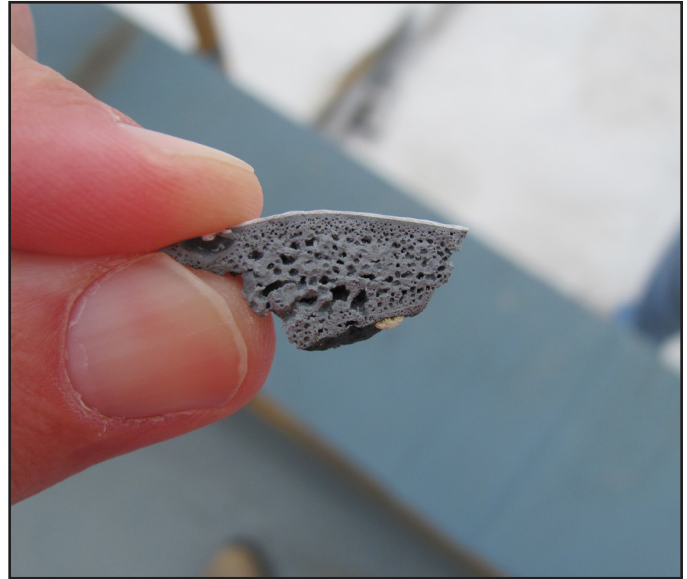
A cross section reveals a large number of open cells in the coating.

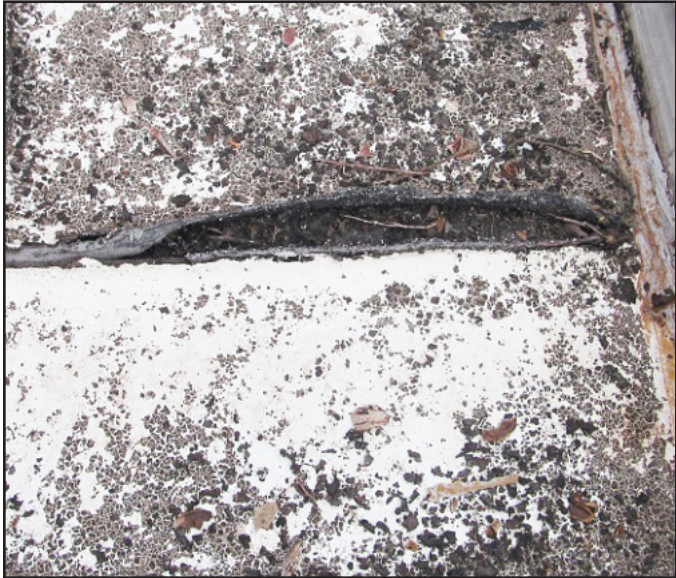
Coatings initially display a crack, transforming into a small blister-type opening. The coating will then form a fish mouth, and finally the sheet will separate and pull back to form a curled edge. Split seams typically occur in modified bitumen and asphalt cap sheets, and are compounded by ponding water.

**Curled seam edge**

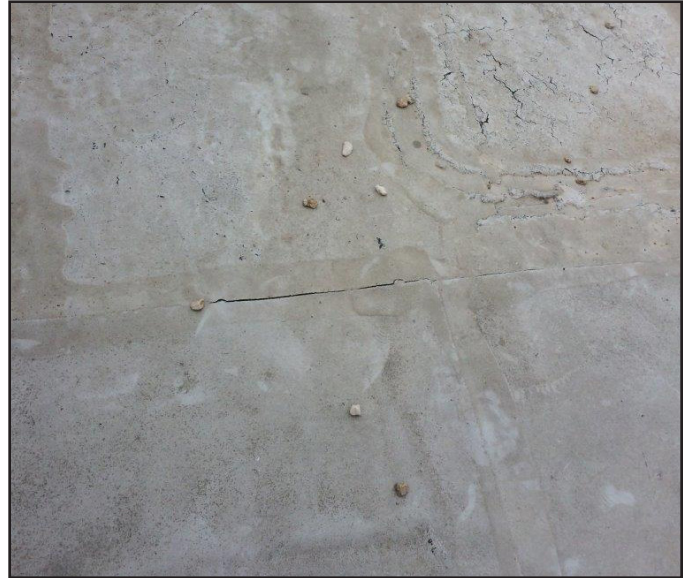
**Split seam**

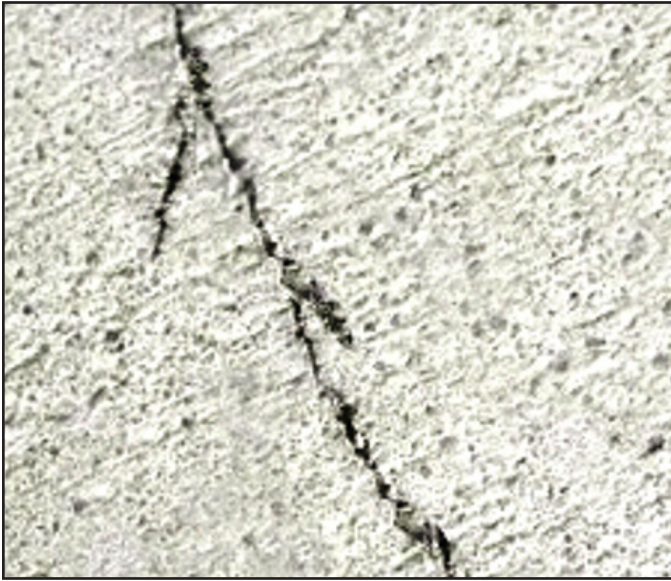
**Crack before coating**

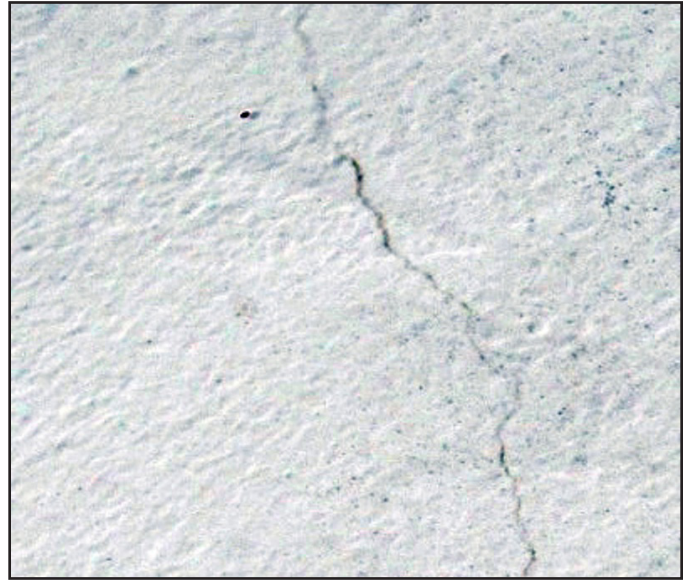
Cracks in concrete substrate may telegraph through the coating and become clearly visible. Over time, these cracks may increase in number as well as in size.

**Crack in coating telegraphed from concrete**

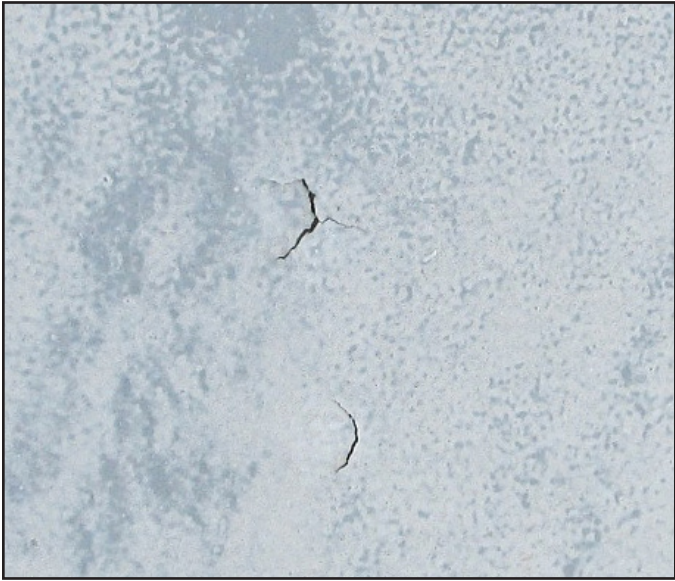
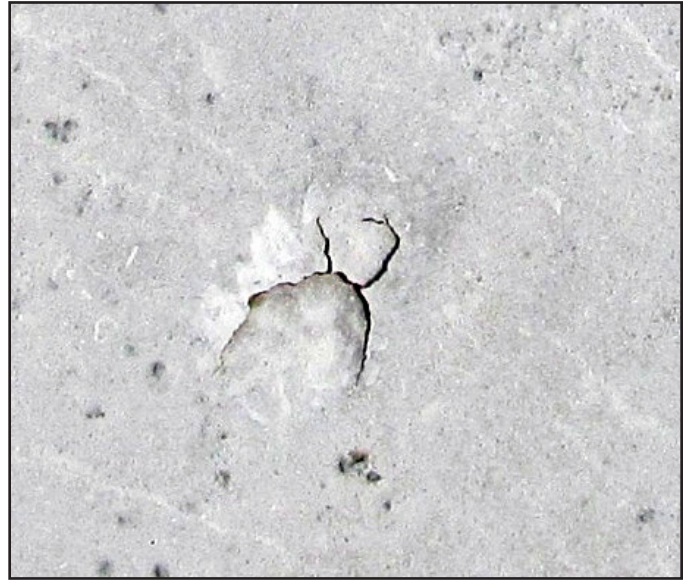
A random pattern of damage which ranges in size from ½–1", repeated throughout large areas of the roof and not limited to single occurrences.

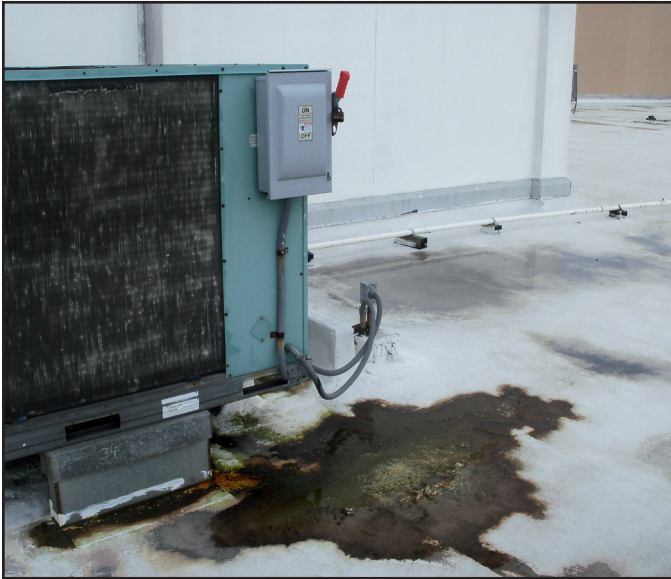
Discharge from condensation lines of rooftop equipment causes contamination of the coating.

**Disconnected condensate drain lines**

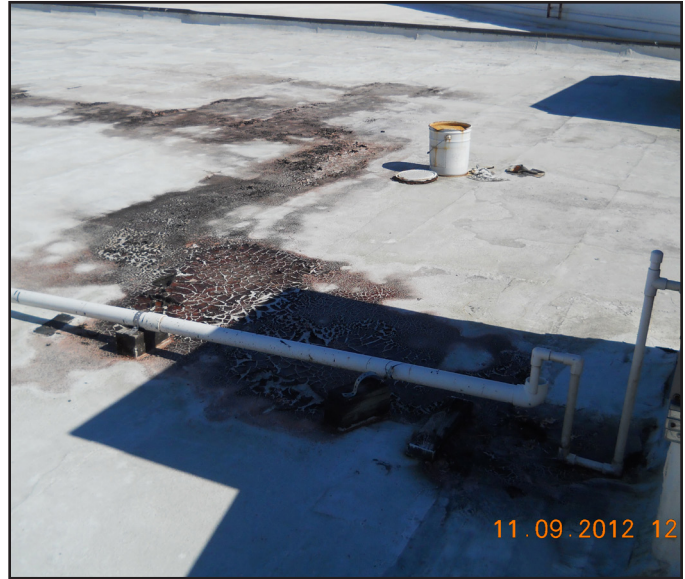
**Poorly maintained condensate drain lines**

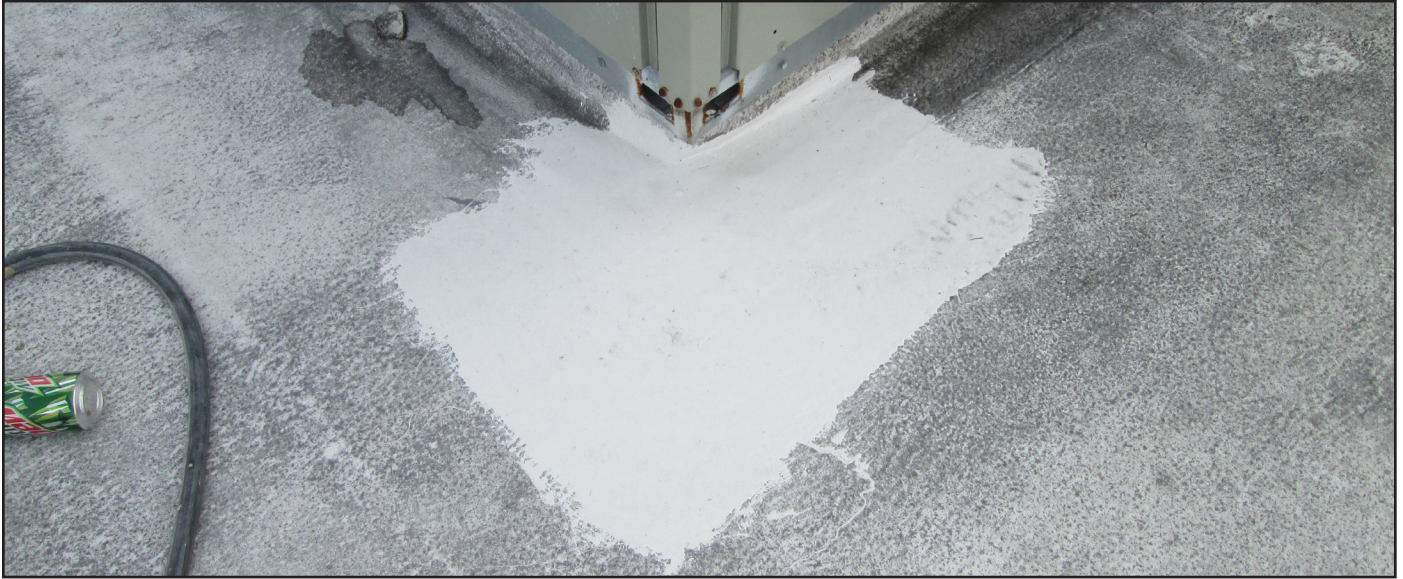
Surface not cleaned properly and does not extend 6"–8" beyond the affected area.

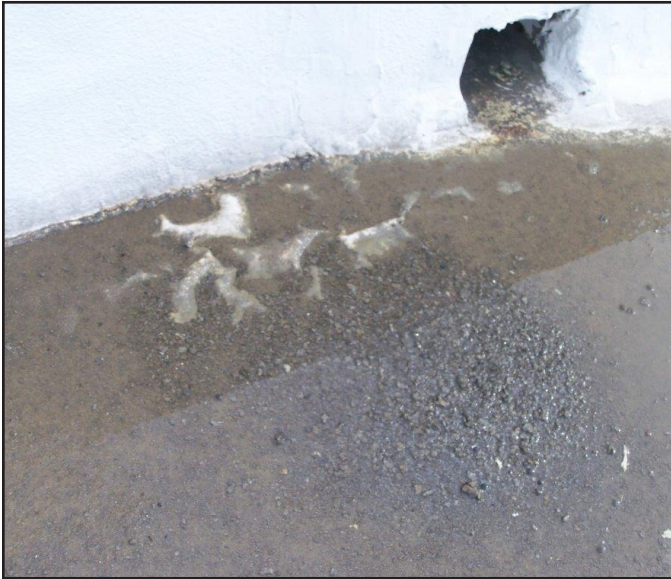
Water has ponded on the roof and has damaged the coating.

**Scupper installed too high**

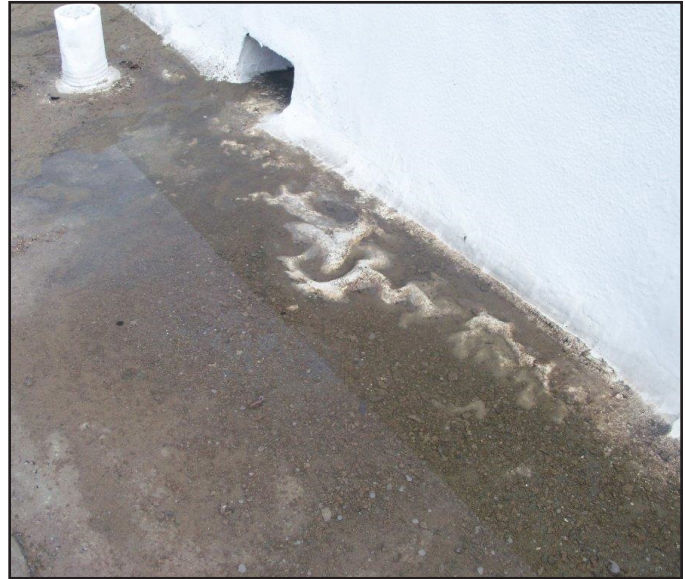
**Clogged roof drain**

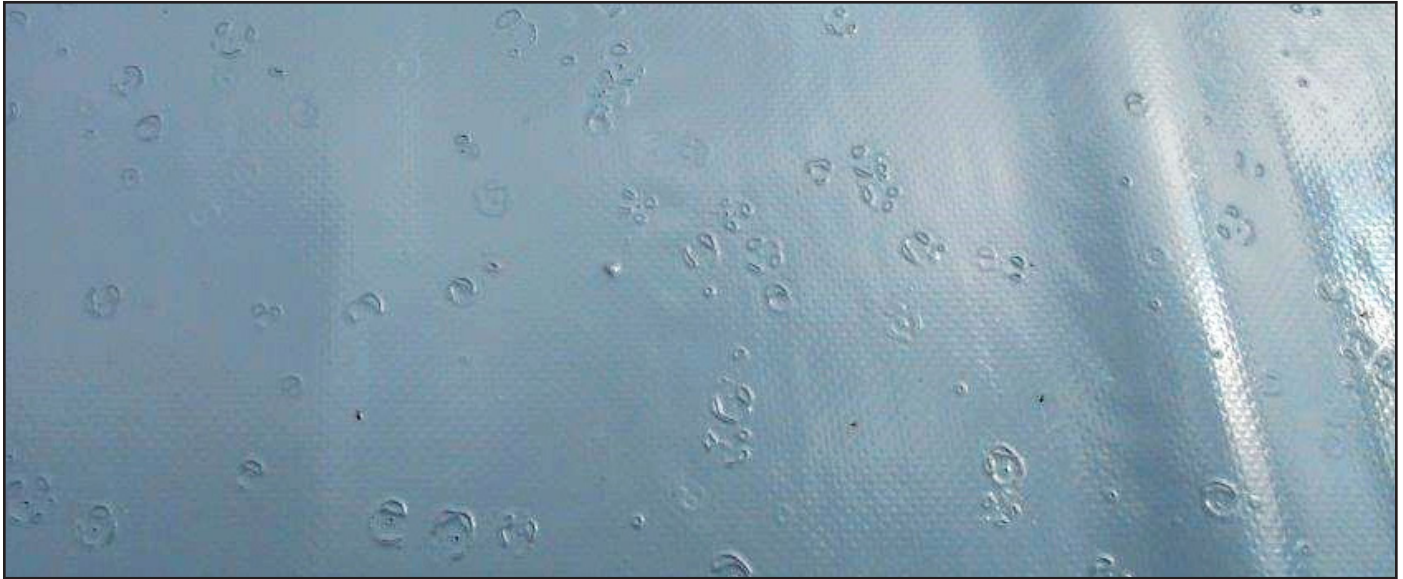
Surface has craters or dimples where rain has fallen on uncured coating.

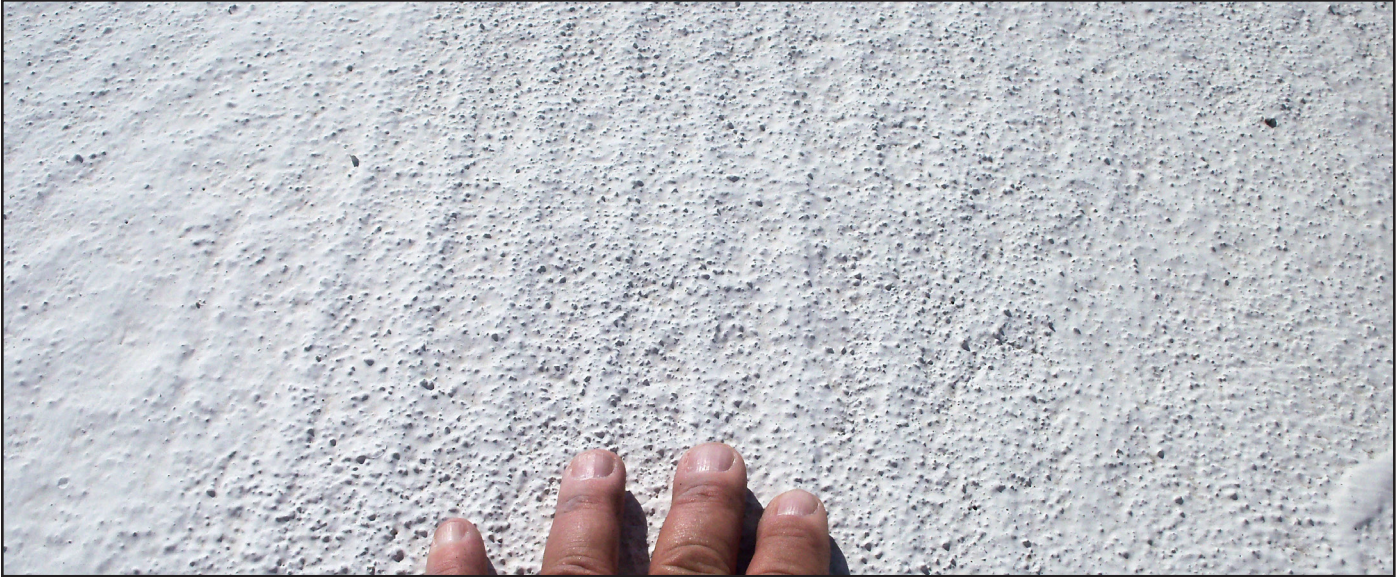
A 1/4" notched squeegee was used to apply coating, and the coating was not backrolled.
