# Troubleshooting Guide

Causes, Repair  
& Prevention

December 2023

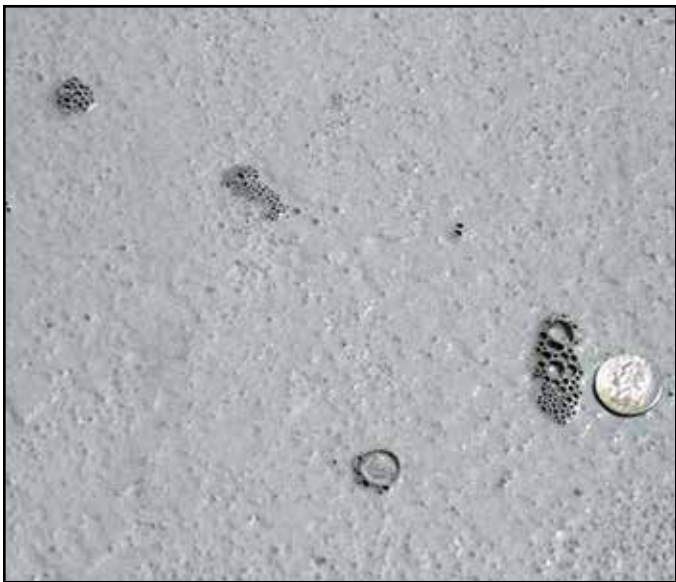
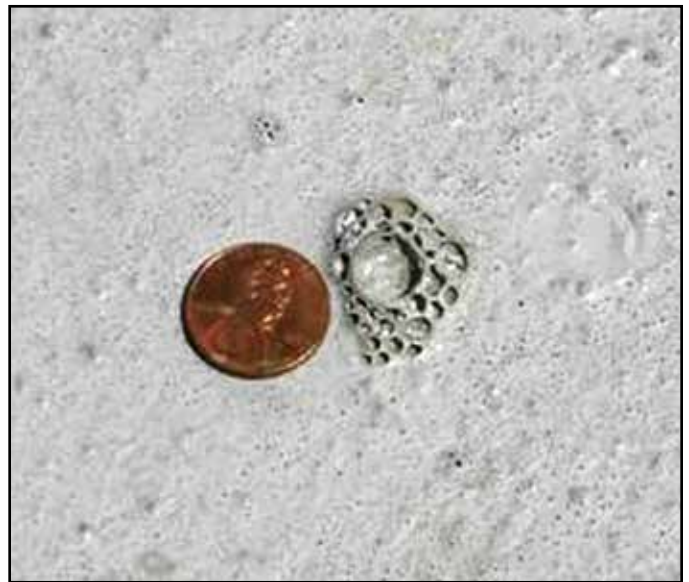
## Craters Due To Moisture Contamination

Craters due to moisture will typically occur in clusters.

Moisture from relative humidity or moisture contaminated aggregate will react with the coating material and cause a bubbling effect as shown above. This is caused by a chemical reaction between moisture and the urethane coating material.

- Ensure that the deck is completely dry before coating. Moisture may not be readily apparent, particularly if aggregate has been introduced into the system. Conduct a moisture test before coating application to ensure that there is no contamination.
- Keep aggregate dry as it can be a source of moisture contamination.
- Ambient surface temperature should be more than 5°F above dew point. See Dew Point of Moist Air in the Support Information section of this manual for ambient temperature and relative humidity guidelines.

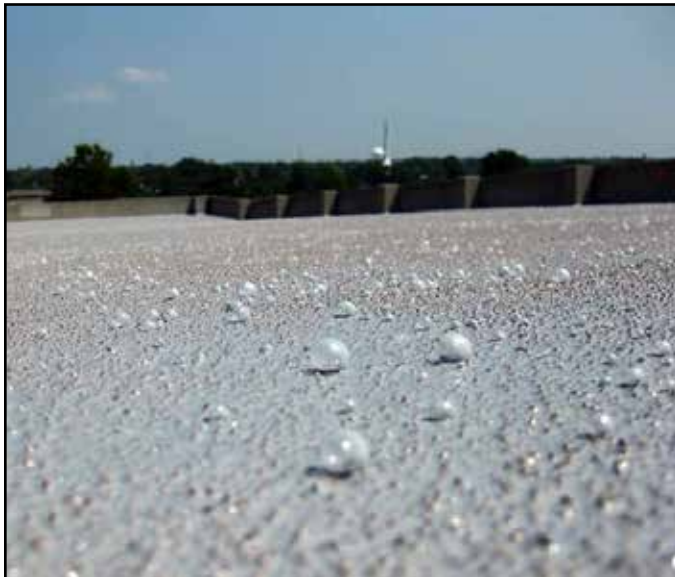
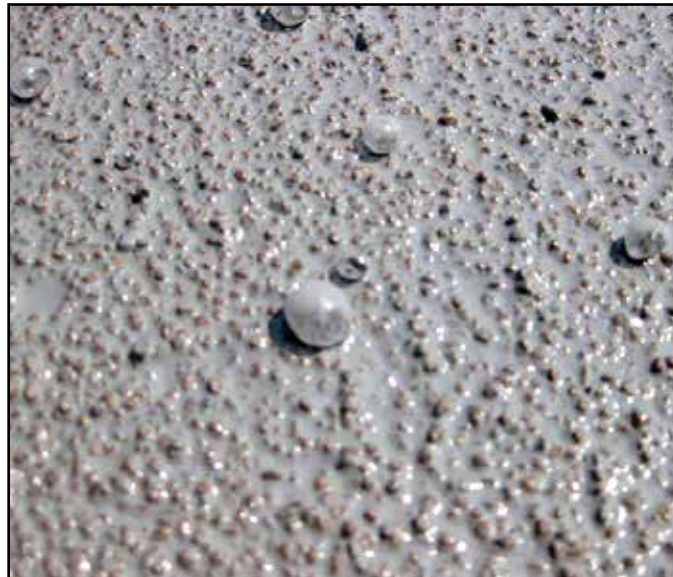
Pinholes appear as tiny blisters or bubbles. When these blisters pop they usually leave a round crater and the pinhole should be easily seen through the film.

- Porous Concrete: Concrete releases air and moisture vapor that expands as temperatures rise. Also, aggressive shot-blasting or scarifying can open concrete pores and bug holes.
- Excessive Aggregate: Air entrapped in wear coat when aggregate is applied too heavily, leaving air pockets.
- Excessive Additives: When over accelerated, coating rapidly forms a film, trapping air from the substrate, preventing escape during the curing process. Adding solvents can result in surface pinhole blisters if the solvent is not allowed to escape prior to gel.

- Porous Concrete:
  - Begin application as temperatures are dropping and continuing to drop. Rising temperatures result in expansion of the moisture and air in the concrete. Falling temperatures cause the air and moisture to contract within the concrete.

- Excessive Aggregate: Apply wear coat at specified rates, taking care to prevent aggregate from leaving entrapped air pockets.
- Excessive additives: Avoid using accelerators during hot temperatures. See Weather Impact on Coating Materials in the Support Information section of this guide.

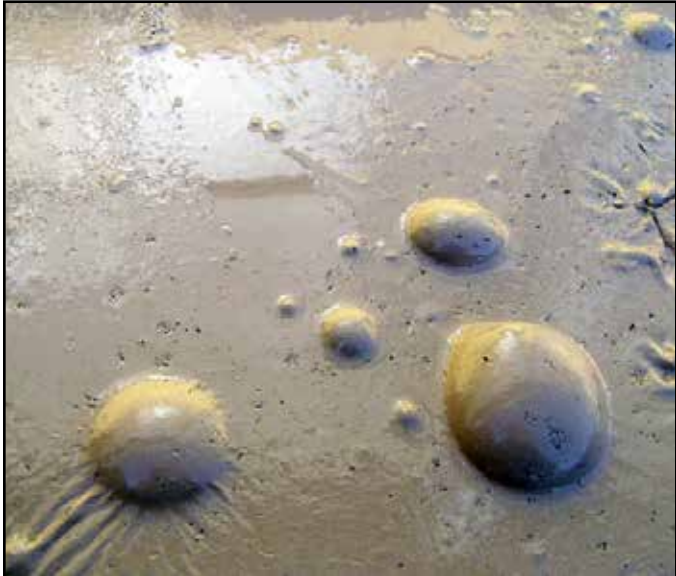
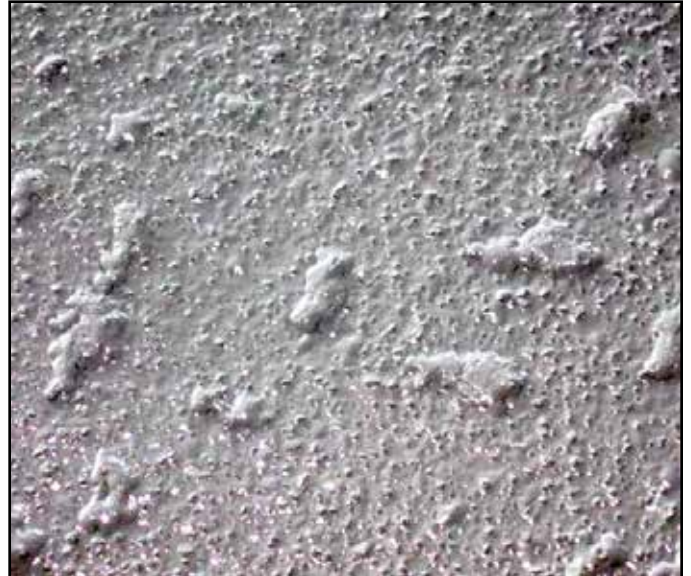
Blisters look like bubbles in the coating surface. The blisters will have a trace of water or moisture trapped inside them. Moisture between the aggregated wear coat and topcoat leaves an orange peel texture on the backside of the blister, mirroring the sand coat texture.

Water from rain, dew or other sources, mixed or rolled into wet, uncured coating. The urethane coating reacts with the water and attempts to cure on the surface, forming blisters and stress wrinkled areas.

- Do not apply coating if rain is imminent.
- Ensure that sprinkler/lawn systems remain off for the duration of the cure.
- Ambient temperature should be more than 5° above dew point. See Dew Point of Moist Air in the Support Information section of this guide for ambient temperature and relative humidity guidelines.
- Ensure that the deck is completely dry before coating. Moisture may not be readily apparent, particularly if aggregate has been introduced into the system. Conduct a moisture test before application to ensure that there is no water contamination.

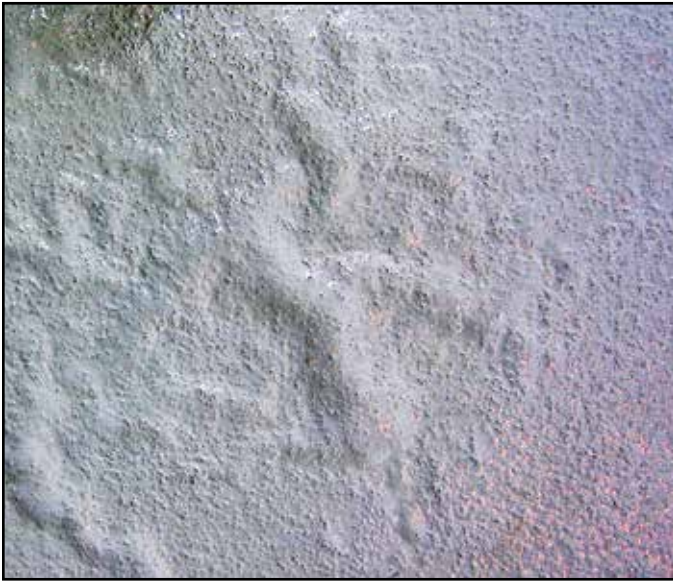
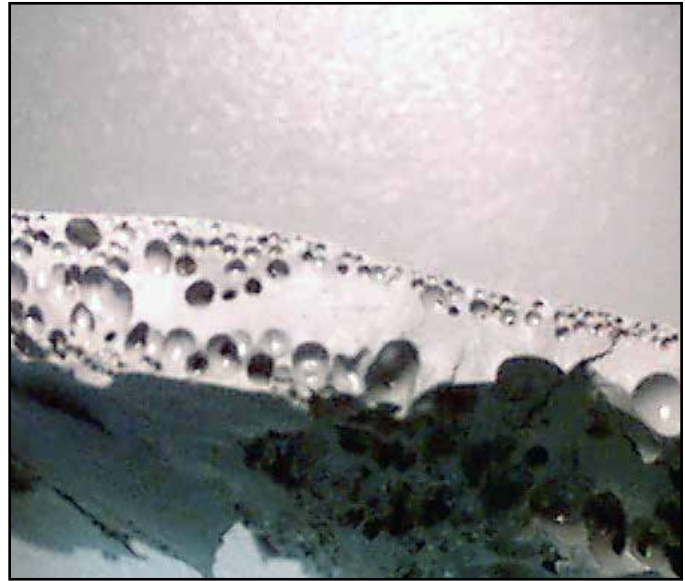
Blisters look like small to large unbroken bubbles in the coating surface and can appear round or oblong. Depending on the state of cure, they can feel spongy or fluid beneath the surface.

Coating was applied at a rate greater than application instructions.

1. Completely remove affected areas down to cured coating or substrate.
2. Reapply coating system per Neogard specifications and recommendations.

- During installation of coating, frequently check the wet film thickness by use of recommended mil gauges.
- Laying out the job prior to coating by gridding out the area will help to maintain proper and uniform coating thicknesses.
- During application, backroll to eliminate low spot areas where self-leveling coating may pool.

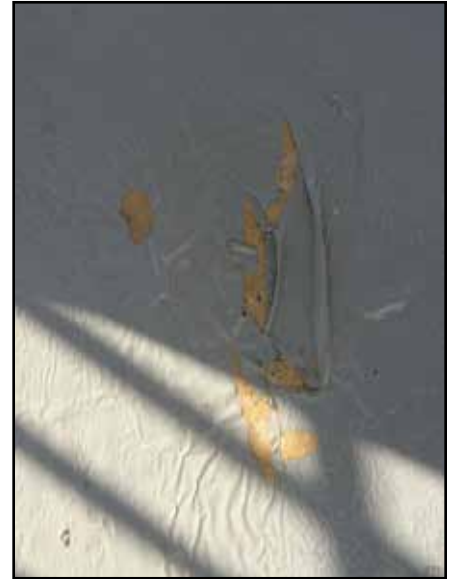
Coating is wrinkled in appearance. Multiple lines of parallel wrinkling may occur.

- Previous Coat is Uncured or Off-Ratio: Material applied over uncured or off-ratio coating, causing stress on topcoat.
- Coating Too Thick: Coating applied at a thickness that exceeds application instructions.

- Previous Coat is Uncured: Ensure that coatings are completely cured before applying additional coats.
- Previous Coat is Off-Ratio: Mix all materials thoroughly, following mix ratios printed on product labels or the Product Data Sheet. See Product Mixing Instructions in the Support Information section of this guide.
- Coating Too Thick: Apply coatings at recommended coverage rates.

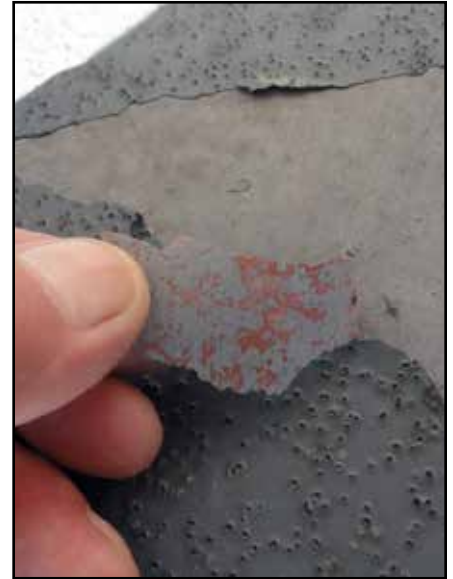
**Delamination due to incompatible materials**

- **Improper Surface Profile:** Surface was not shot-blasted or abraded prior to applying membrane, or the base coat was applied over epoxy primer after the 24-hour window.
- **Contamination from Moisture:** There was dew or other moisture on the surface that was coated.
- **Contamination from Dust, Dirt, Etc.:** Coating over contaminated surfaces will lead to coating failures such as loss of bond.
- **Incompatible Materials:** Materials that are incompatible with the coating will cause many issues including delamination.
- **Thin Topcoat Application:** A final topcoat applied too thin may delaminate and peel from the coating system.

1. Remove all loosely bonded material.
2. If substrate is exposed, abrasion may be necessary.
3. Clean repair area.
4. Re-apply material as specified and per Neogard recommendations.

- **Improper Surface Profile:** Substrate should be shot-blasted or abraded and cleaned prior to application of primer. Shot-blast surface ICRI CSP3 to CSP4 to remove contamination or laitance, and for optimal bonding. Base coat must be applied within 24 hours of primer application. If base coat cannot be applied within 24 hours, clean and re-apply primer.
- **Contamination:** Ensure deck is clean and dry prior to application of material.
- **Incompatible Materials:** Perform field adhesion test prior to application of the coating when installing coating over existing coating system. See the Field Adhesion Testing section of this guide.
- **Apply coating at specified rates and per Neogard recommendations.**

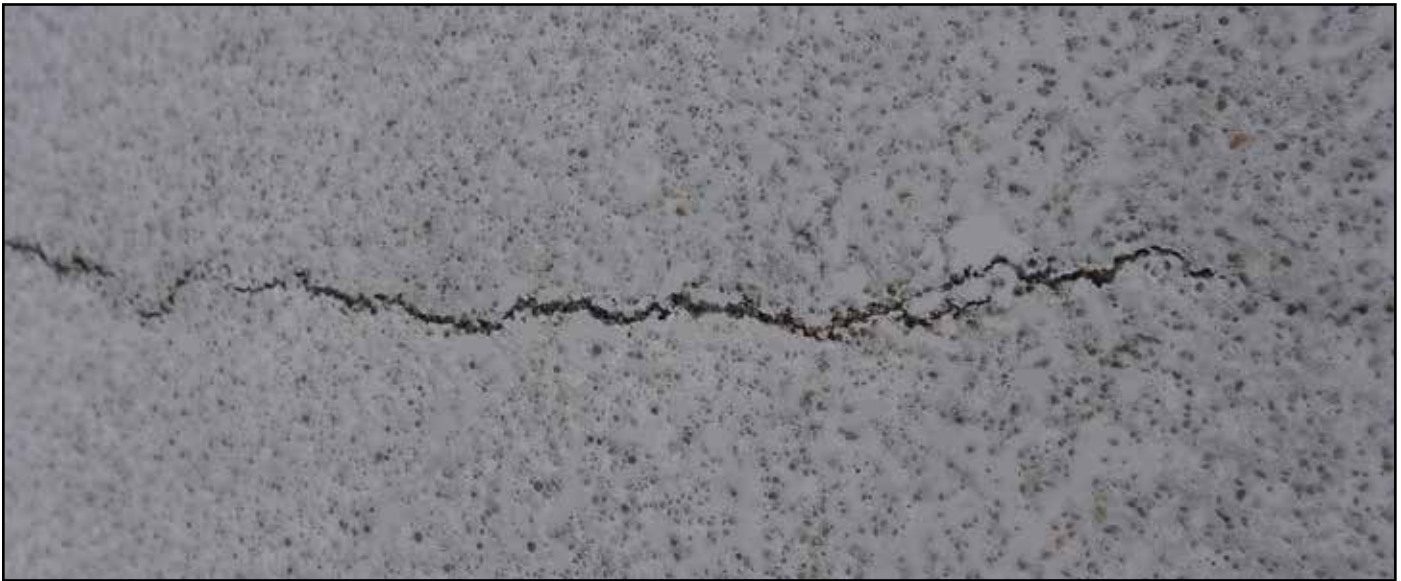
# Cracks

Cracks in concrete substrate may telegraph through the coating and become clearly visible. Over time, these cracks may increase in number as well as in size.

- Settling: Substrate cracks are caused by shifting and settling of the structure after original construction.
- Expansion/Contraction: Concrete structures continually experience expansion and contraction driven by temperature, moisture and load. All cracks should receive detail treatment prior to application of the base coat.

1. Route cracks.
2. Fill with Neogard 70991 polyurethane sealant and strike flush. Allow sealant to fully cure.
3. Clean repair area with Neogard 8500 BioDegradable Cleaner or solvent wipe. Extend cleaning 6"–8" beyond the affected area.
4. Prime any exposed concrete.
5. Install a detail coat of base coat material extended to a minimum of 2" on either side of the crack to yield a thickness of 30 dry mils. Allow to cure and then apply required system.
  - Optional: Apply base coat material extended to a minimum of 3" on either side of the crack at 30 dry mils and embed reinforcing fabric into wet coating. Center fabric over urethane sealant and allow to fully cure. Apply additional base coat material as necessary to fully encapsulate reinforcing fabric. Allow detail coats to cure, then apply required system.

- Prior to application of the coating system, perform proper surface preparation including crack detail:
- Hairline cracks below 1/16" should receive a 30 mil detail coat utilizing base coat material, a minimum of 2" on either side of crack.
- Large cracks above 1/16" should be routed and filled with Neogard 70991 polyurethane sealant. After sealant is fully cured, apply a 30 mil detail coat utilizing base coat material extended to a minimum of 2" on either side of the crack. Reinforcing fabric is optional.

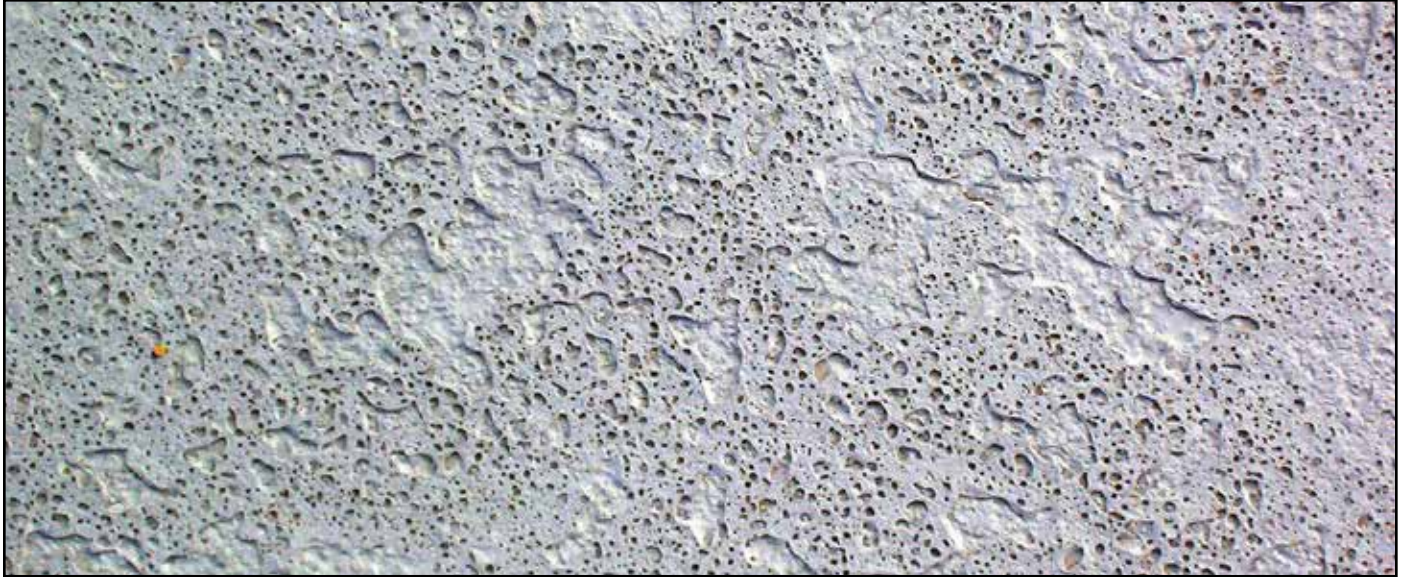
# Water Damage To Uncured Coating

Surface has areas of sponge-like, cratered patterns where water has come in contact with uncured coating.

Heavy rain, sprinklers or other water source caused damage to uncured coating.

1. Grind all affected areas to eliminate ridges in the cratered areas.
2. Clean and allow to completely dry.
3. Re-apply coating as specified and according to Neogard recommendations.
4. In severe situations, the coating may have to be totally removed prior to re-coating.

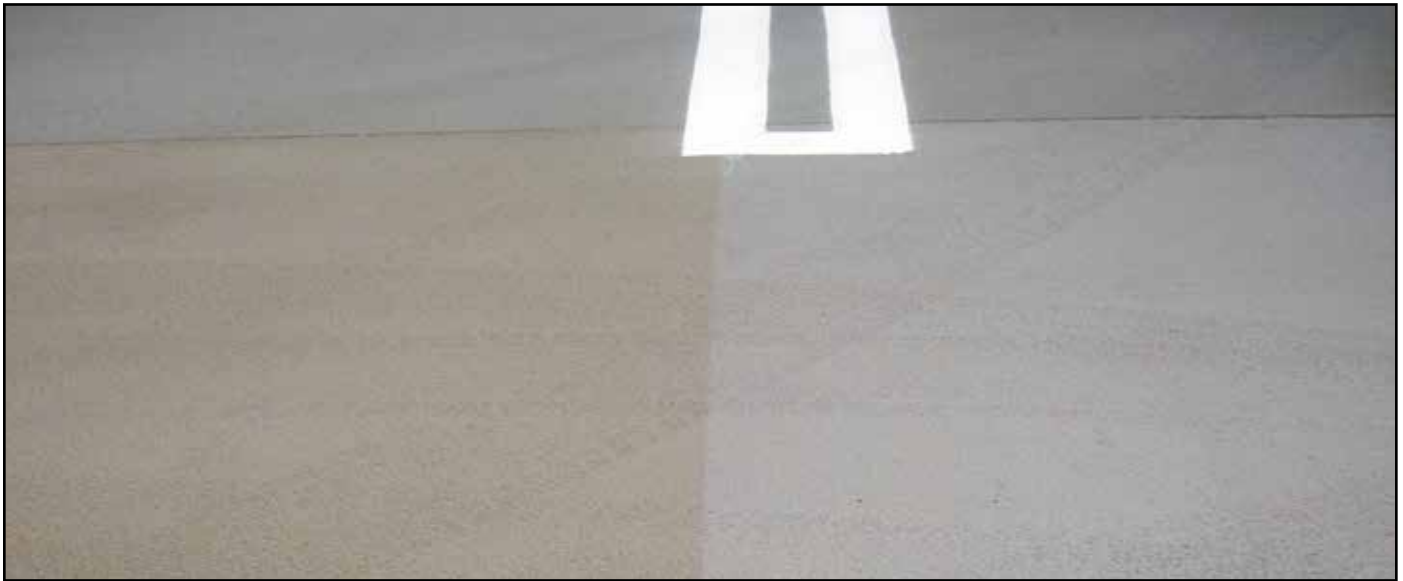
Finished waterproofing surface shows different shades of color. While considered less than aesthetically appealing, this condition does not affect the integrity of the waterproofing system.

- Different Batches of Topcoat: There may be slight shade variation from batch to batch of material.
- Deck Coated at Different Times: Older coating material has weathered and appears different than newer coating material.
- Improper Mixing: Product not mixed sufficiently to disperse pigment. See Product Mixing Instructions in this guide.

1. Apply an additional wear coat and topcoat.
2. Allow sufficient time for weathering.

- Different Batches of Topcoat: Always purchase or set aside enough topcoat from the same production batch to coat the entire surface area. Use odd batches elsewhere such as in the wear coat if applicable. If there is not enough topcoat of a single batch to complete the project, “boxing” batches is an alternative. Boxing is the process of combining all the coating you will be using as the topcoat into one large container. This is especially important when coating a large surface area or if there is insufficient coating from a single batch, where a color variation from one batch to another is likely.

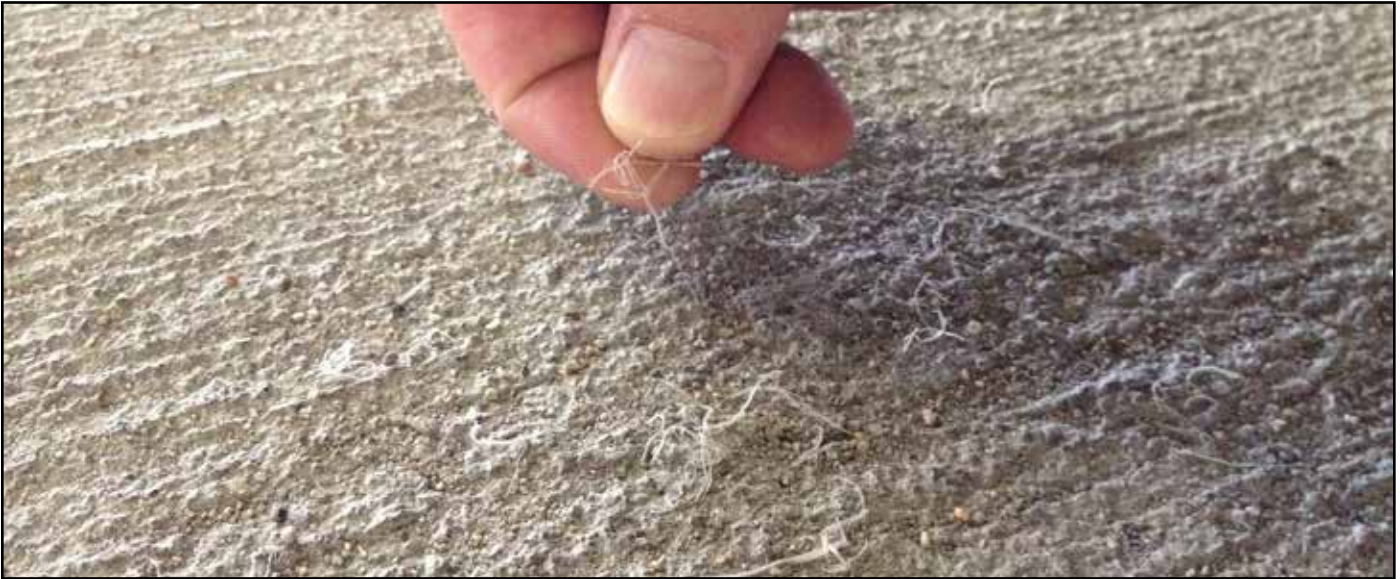
Fibers have been added to the concrete mix to control shrinkage cracks and to improve other physical properties. These fibers will protrude and breach the coating system and may cause future leaks.

Fibers added to the concrete mix will protrude through the concrete surface.

1. Mechanically prepare surface by shot-blasting to industry-standard texture (ICRI CSP3–CSP4) without causing defects to substrate.
2. Remove fibers by burning with a propane torch.
3. Remove any remaining residue prior to coating application.

It is not recommended to use fibers in the concrete mix when a coating is to be applied. If fibers are present, remove them before applying coating.

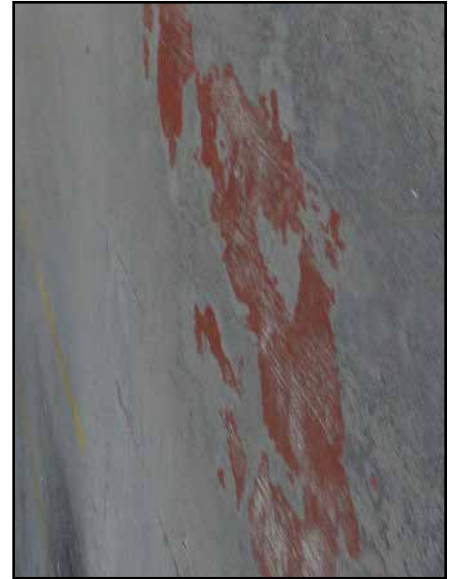
# Excessive Wear

Coating is worn, exposing primer and bare concrete.

- Inappropriate Application: Excess aggregate in wear coat and insufficient topcoat material led to premature wear.
- Wrong System Specified: Applied system not designed for heavy duty areas such as drive lanes, turns, ticket splitters, etc.
- Moisture Contamination: Premature wear due to moisture contamination during application.
- Improper Mixing: Failure to mix components properly prior to installation, scraping unmixed material from walls of buckets, insufficient mixing time for proper dispersion, or a contaminated mixing paddle, resulting in off-ratio components and poor physical properties.

1. Remove all loosely bonded material. In areas where primer is exposed, grind to expose substrate.
2. Clean repair area with Neogard 8500 BioDegradable Cleaner and solvent wipe.
3. Reapply coating as specified and according to Neogard recommendations.

- Inappropriate Application: Apply system as recommended by Neogard; include heavy duty application in designated areas.
- Wrong System Specified: Ensure that the appropriate system is specified for existing project conditions and use.

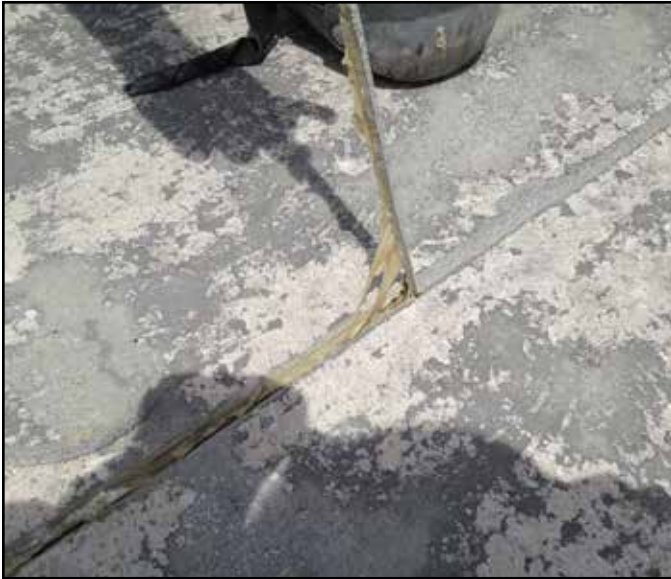
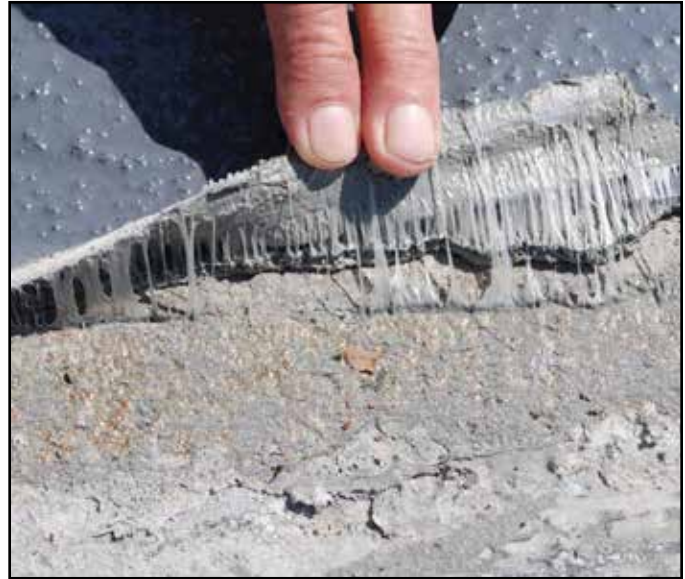
# Delamination Caused By Sealant

Coating delamination has occurred due to off-ratio, uncured sealant.

Two-component sealant was improperly mixed or was contaminated.

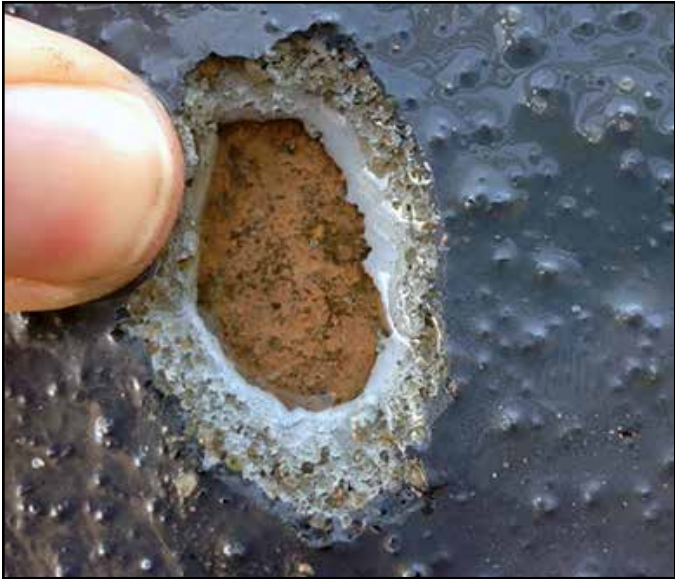
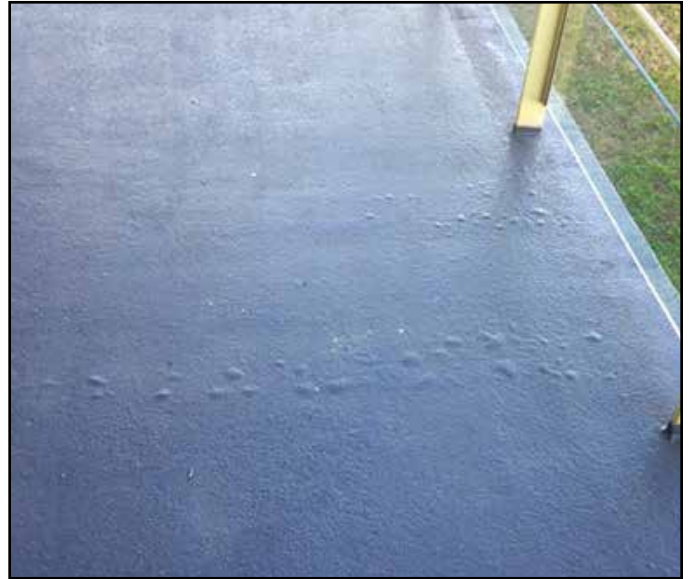
# Blisters Caused By Trapped Moisture

The coating system fails due to delamination caused by moisture migration in the concrete substrate.

Trapped excess moisture in or below the concrete substrate.

1. Identify the source of the moisture.
2. Remove coating in affected areas down to clean substrate.
3. Re-apply coating as specified and according to Neogard recommendations.

- **Moisture Contamination:** Ensure that the deck is completely dry prior to coating. Moisture may not be readily apparent, particularly if aggregate has been introduced into the system. Monitor the ambient surface temperature for the entire duration of the application process. See Dew Point Chart in the Support Information section of this manual for ambient temperature and relative humidity guidelines.
- **Moisture Test:** Ensure that the deck is completely dry before coating. Moisture may not be readily apparent, particularly if aggregate has been introduced into the system. Conduct a moisture test before application to ensure that there is no water contamination.

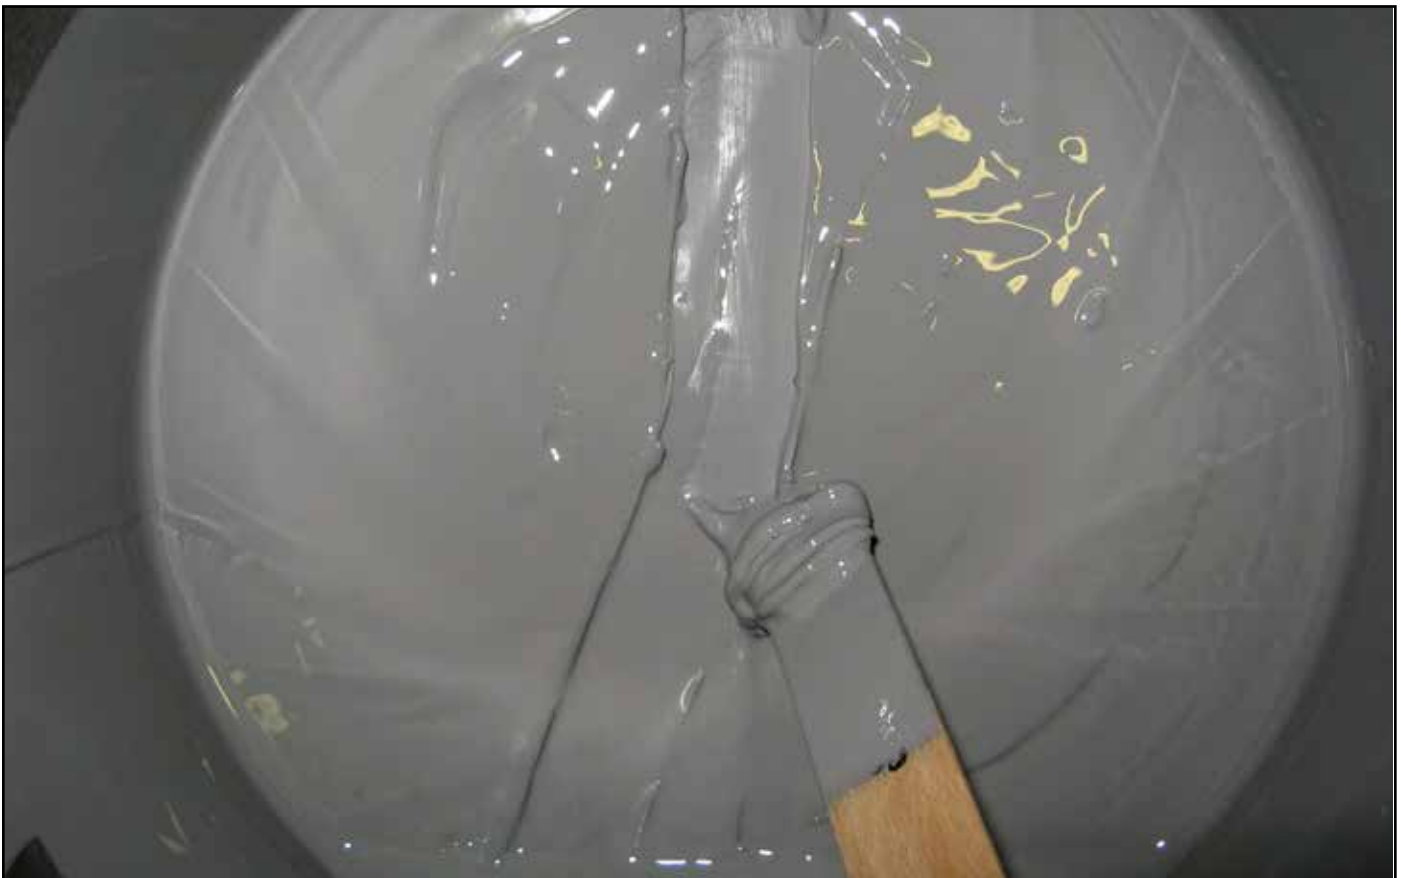
Solid material settles in the bottom of the bucket. This typically occurs in the pigmented/color side of a product.

Some products have a tendency to settle over time.

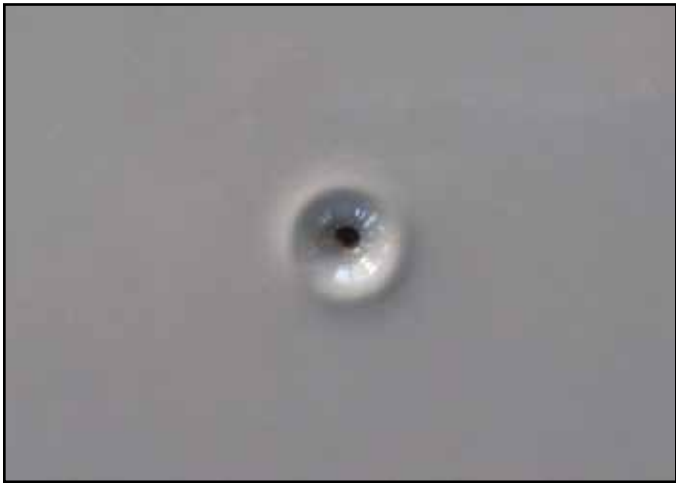
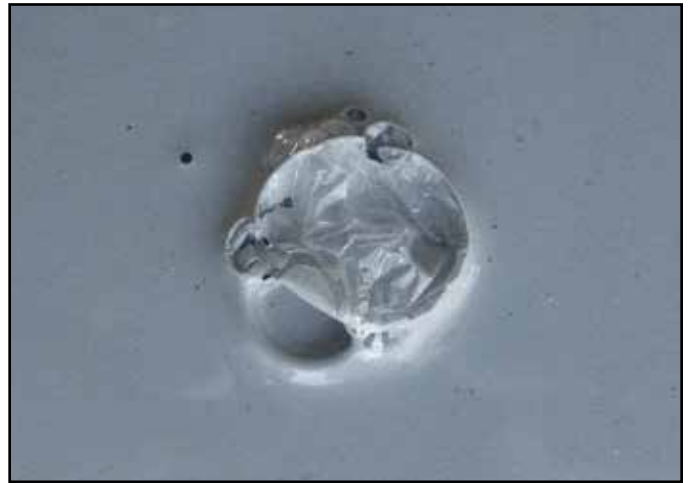
Pinholes appear as tiny blisters or bubbles. When these blisters pop they usually leave a round crater and the pinhole should be easily seen through the film.

- Outgassing: Air escapes from porous concrete and becomes trapped in the coating.
- Air Movement: Excessive air movement from vents, doors, or other sources may cause flash drying and prevent necessary air release from coating.
- Temperature/Humidity: High temperatures or humidity can cause rapid drying, entrapping air in coating.
- Direct Sunlight: Coating exposed to direct sunlight can tack off before releasing air, forming bubbles.
- Improper Mixing: Mixing at high speed and improper mixing procedures may result in entrapped air.
- Roller Covers: Too short or too long of a nap roller can introduce air into the coating.
- Surface Prep: Aggressive shot-blasting or sandblasting will open pores in the concrete, causing air to become trapped when coating is applied.

- Air Movement: Avoid generating fast air movement across the coating. When providing ventilation, always exhaust air rather than blowing with fans.
- Temperature/Humidity: Wait to apply material until temperature and humidity are within the ranges specified in the Product Data Sheets.

- Direct Sunlight: Prevent direct sunlight exposure during initial cure.
- Improper Mixing: Use slow speed mixing equipment with a paddle-type blade. If air is introduced into the material, let stand until air is visibly released.

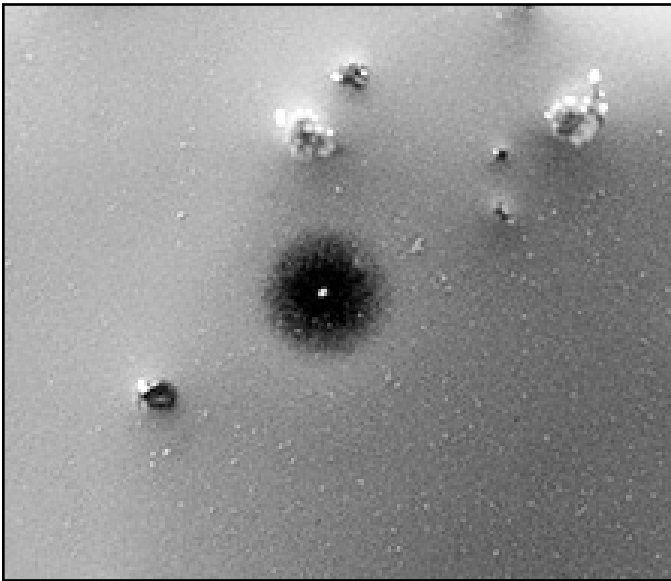
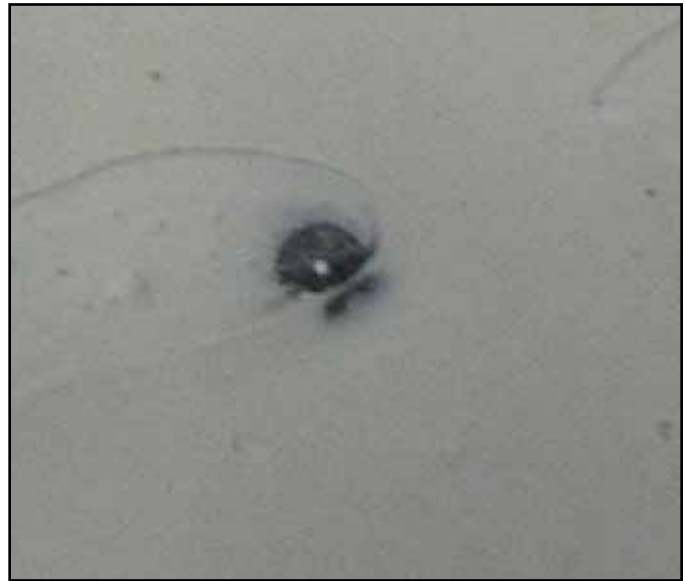
Fish eyes are round indentations or separation in the coating finish. Upon closer examination, they look like a crater with a rim around the perimeter of the defect along with a very small dot in the center.

**Silicone Contaminants:** Certain manufacturing processes such as welding or spraying can deposit silicones on the floor causing fish eyes to appear.

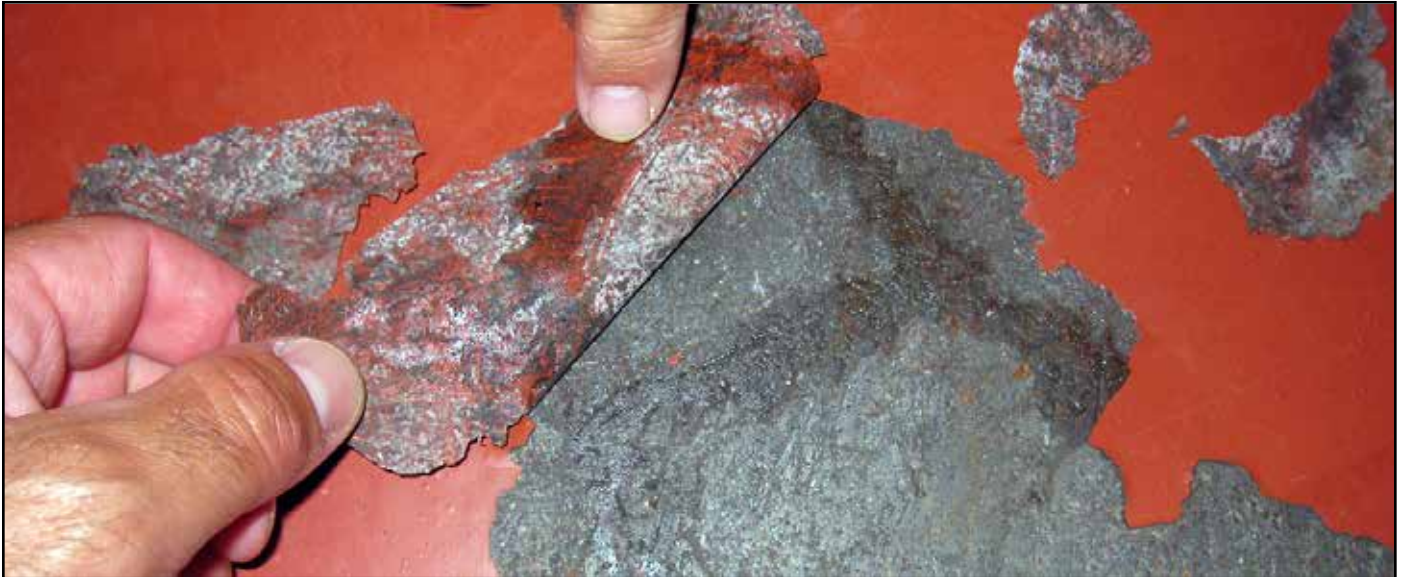
Coating is peeling or de-bonding from the substrate.

- Inadequate Cleaning: Coating will not adhere to oil, grease or other contaminants.
- No Primer Used: Without primer, peeling/delamination may occur.
- Moisture Vapor Transmission: Water vapor penetrating through the substrate can cause peeling/delamination. After removing delaminated areas, moisture may be visible or the concrete may be dark in appearance.

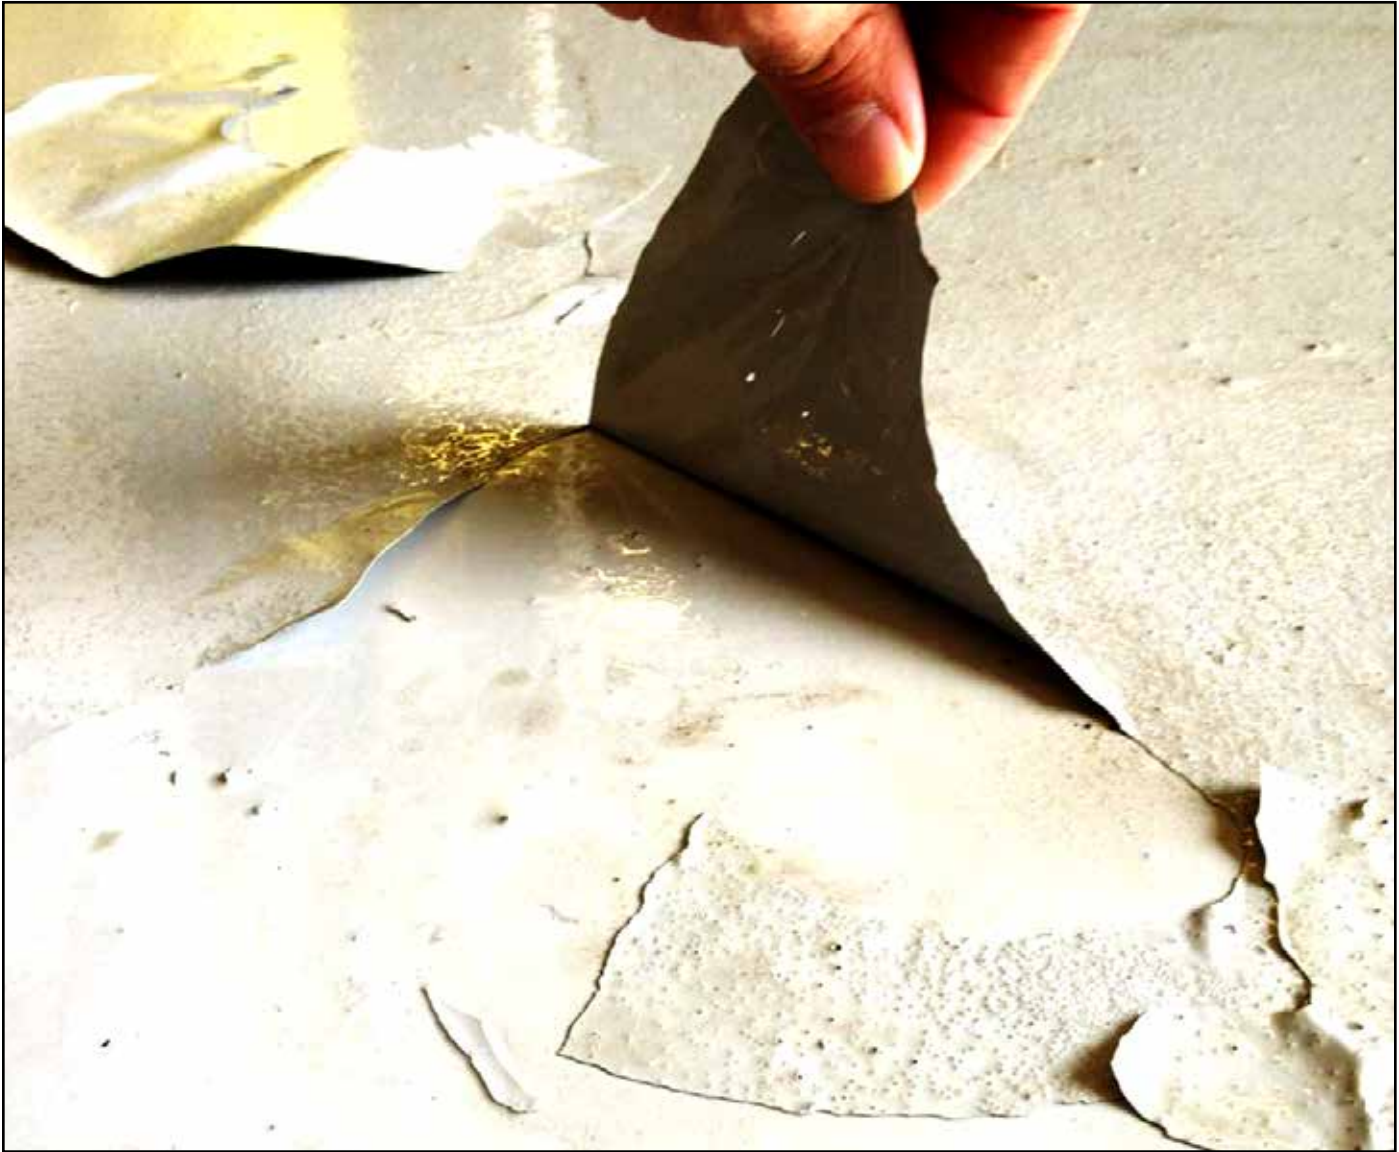
Coating is peeling or de-bonding between layers of coating.

- Beyond Recoat Window: Coating was not applied within 24 hours of previous coat.
- Surface Contamination: Surface was contaminated by water, humidity, oil, grease, or dust.
- Improper Mixing: Coating was not mixed at proper mix ratio, or not mixed for a minimum of 3 minutes.

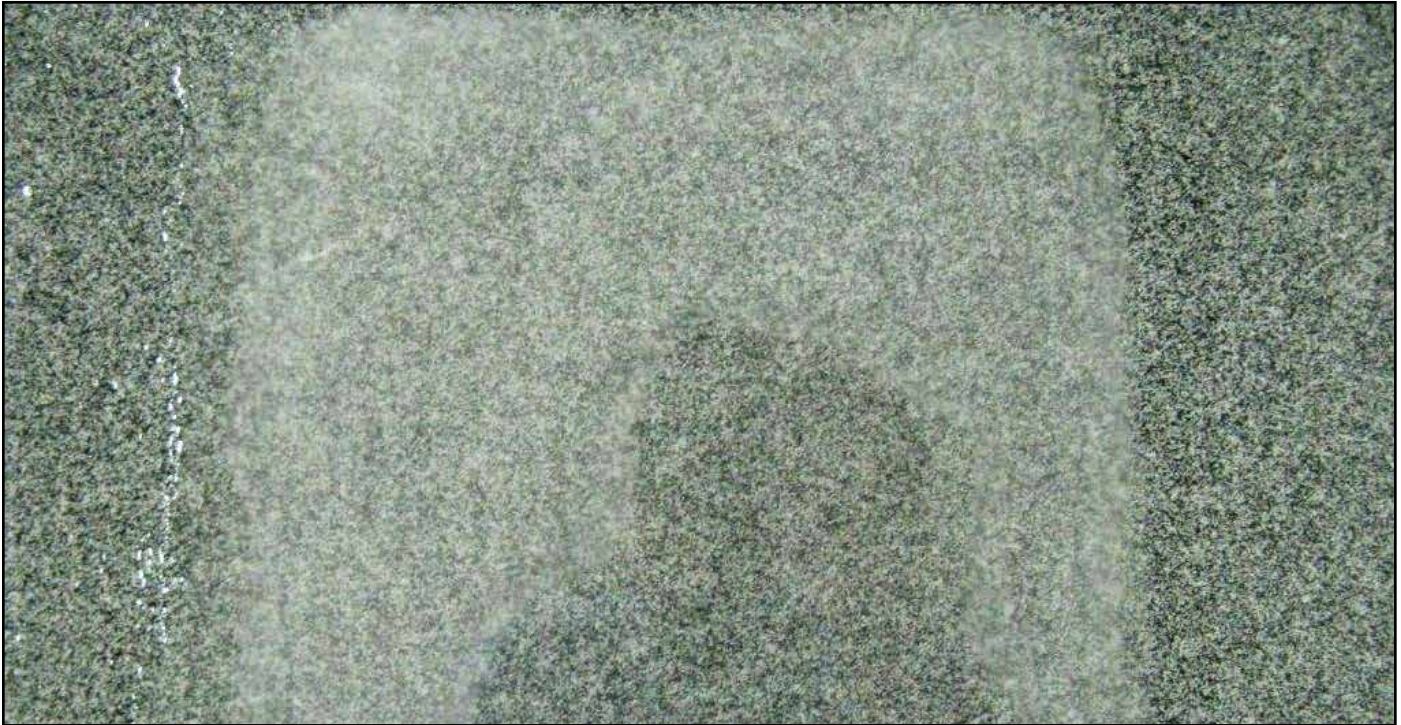
There is a milky or cloudy appearance in wet or cured coating material.

- **Moisture:** Moisture in the concrete or high humidity levels can cause moisture to be present on the surface when the material is applied, or before it is fully cured. This can result in a milky appearance or greasy film. This condition is sometimes referred to as “blush” and is more prevalent with certain epoxies.
- **Thick Application:** A milky or cloudy appearance may result from the coating being applied too thick. In this case, the milky appearance will be more noticeable if the coating is clear.

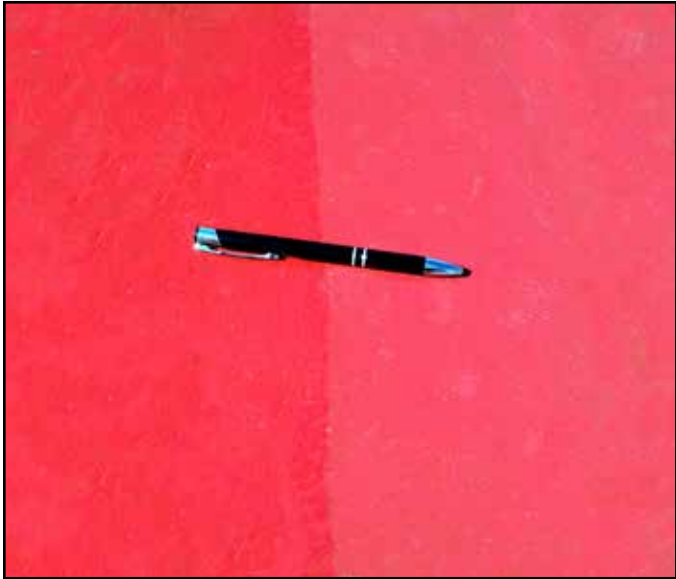
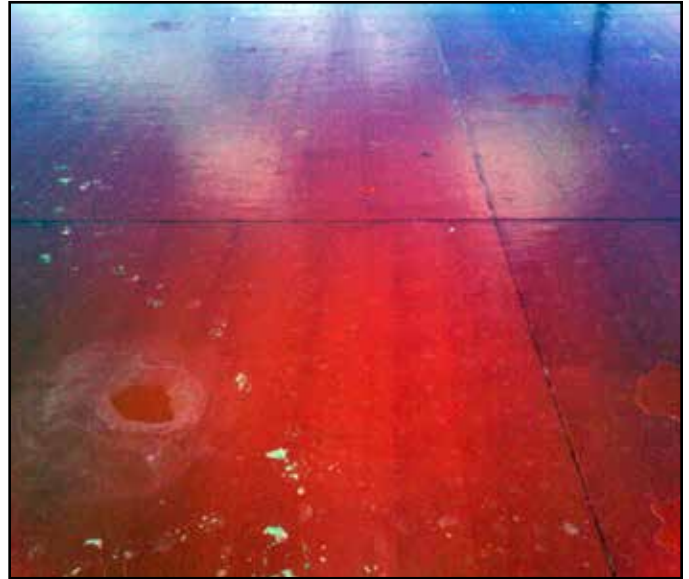
Coated surface has different shades of color.

- Retouching After 15 Minutes: Color float occurs when a pigmented material has been applied and it is retouched after it has been sitting for 15 minutes or longer. Different shades in color may appear.
- Different Batch Numbers: Color can vary from batch to batch. Using different batch numbers at a job site can also cause differences in color appearance.

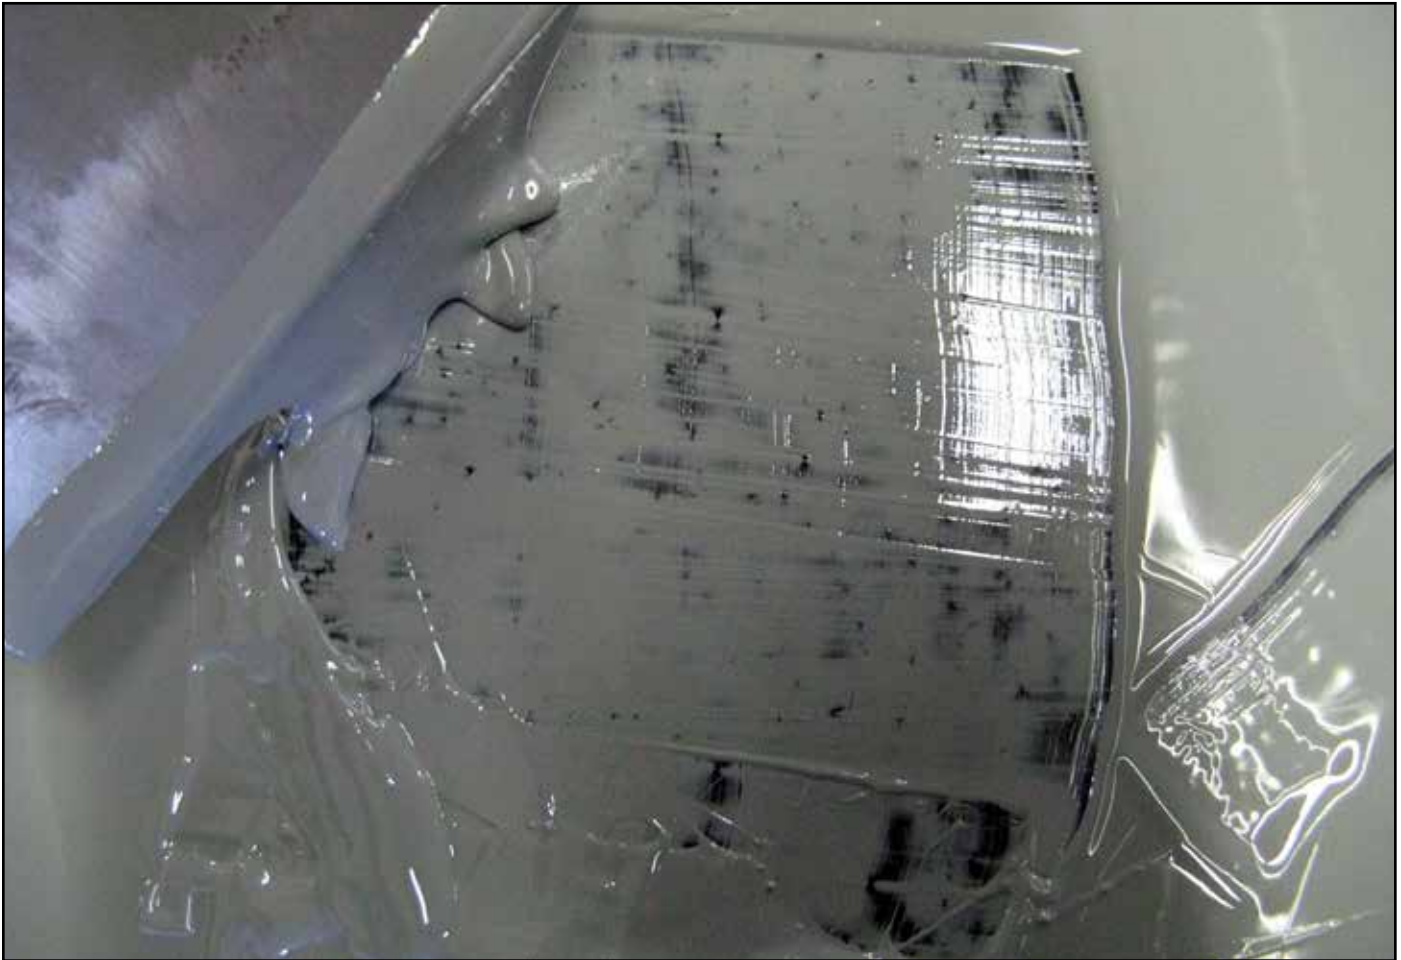
The material does not fully cure or is still soft after 24 hours.

- Improper Mix Ratio
- Improper Mixing
- Cold Materials
- Cold Ambient Temperatures
- Cold Surface Temperatures

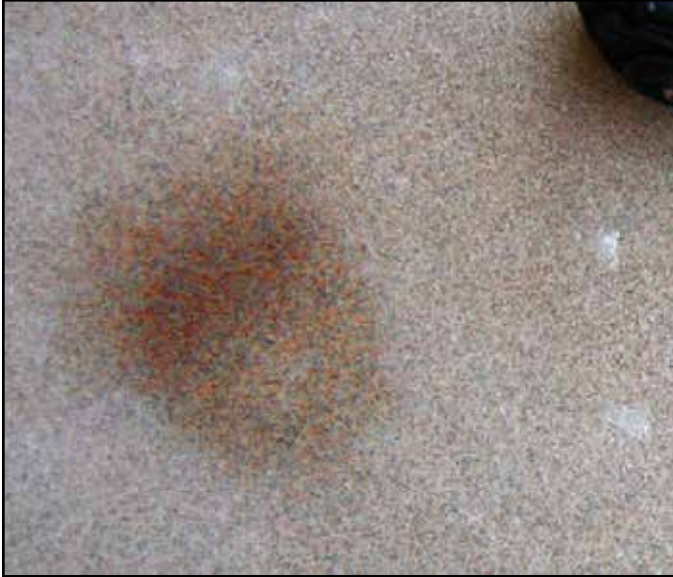
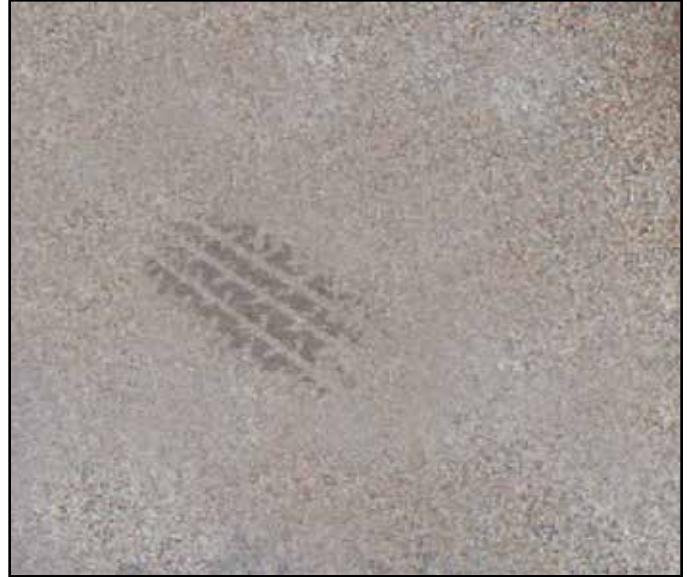
There are dark or discolored spots in the coating system.

- Chemical Exposure or Spills: Floor has been exposed to chemicals.
- Tire Marks: Floor has been exposed to vehicular traffic.
