# Troubleshooting Guide

Causes, Repair  
& Prevention

December 2023

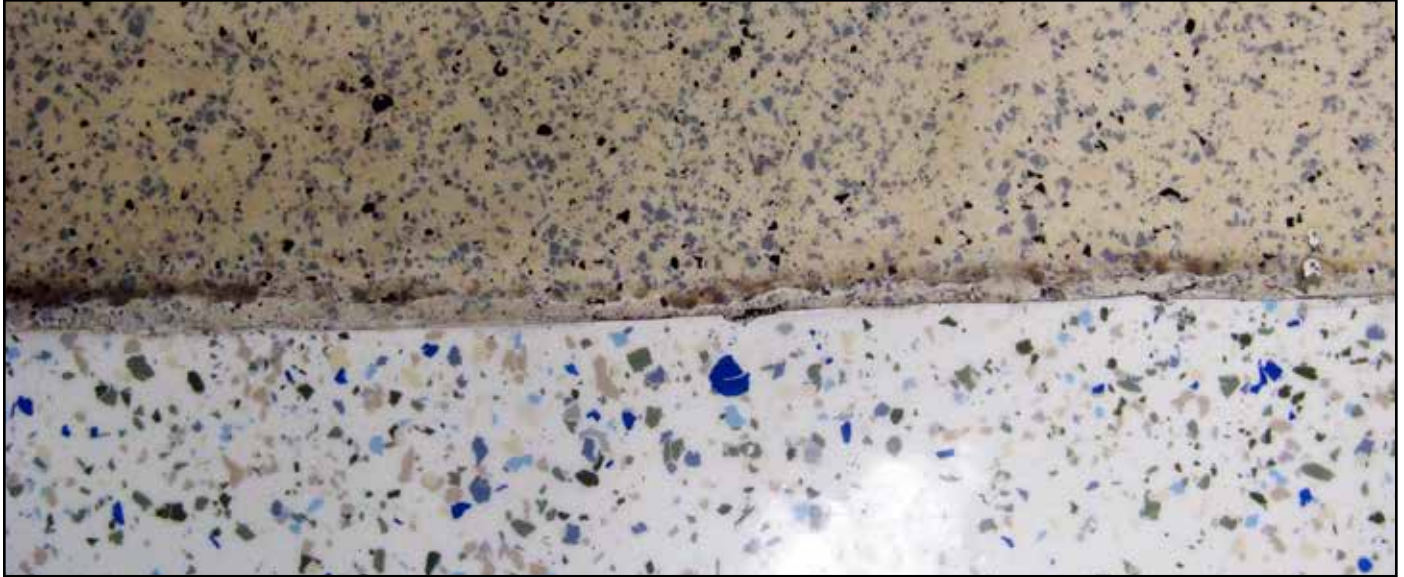
Topcoat has developed a yellow hue. This problem will affect epoxies regardless if the epoxy is clear or not.

Epoxy has been exposed to partial or direct sunlight.

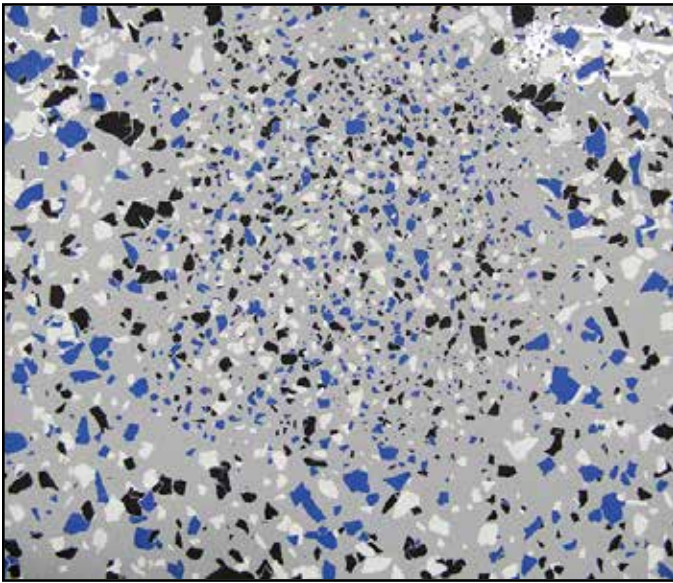
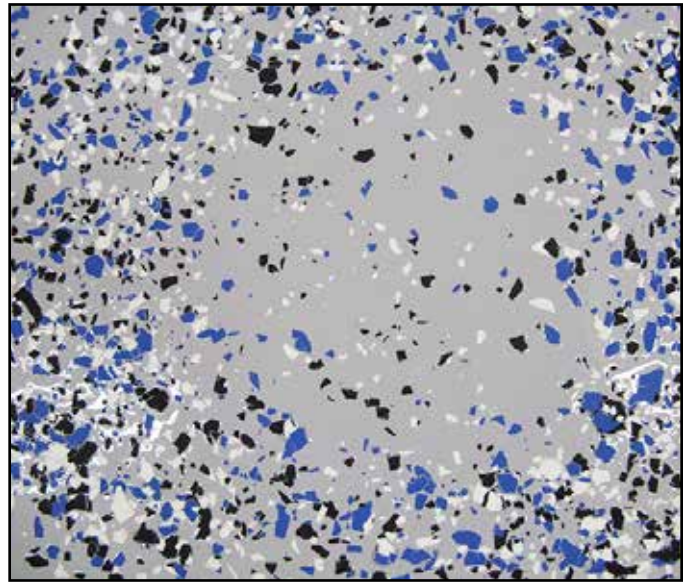
Even flake disbursement is a key factor in the aesthetics of a random flake flooring system. Having the same size and coverage of flakes is key to a uniform appearance.

- Flakes Broadcast Too Quickly: This leaves an uneven disbursement in the base coat. To ensure uniform coverage, make certain the broadcaster takes their time.
- Flakes Crushed During Broadcast: This causes variations in the size of flakes. Size variation of flakes in the floor is caused by crushing the flakes in hand as they are broadcast. Also, reaching for the flakes in the bucket, they are inadvertently crushed.
- Clumped Flakes: If clumped flakes are introduced into the wet base coat, they will dry in a clumped formation.

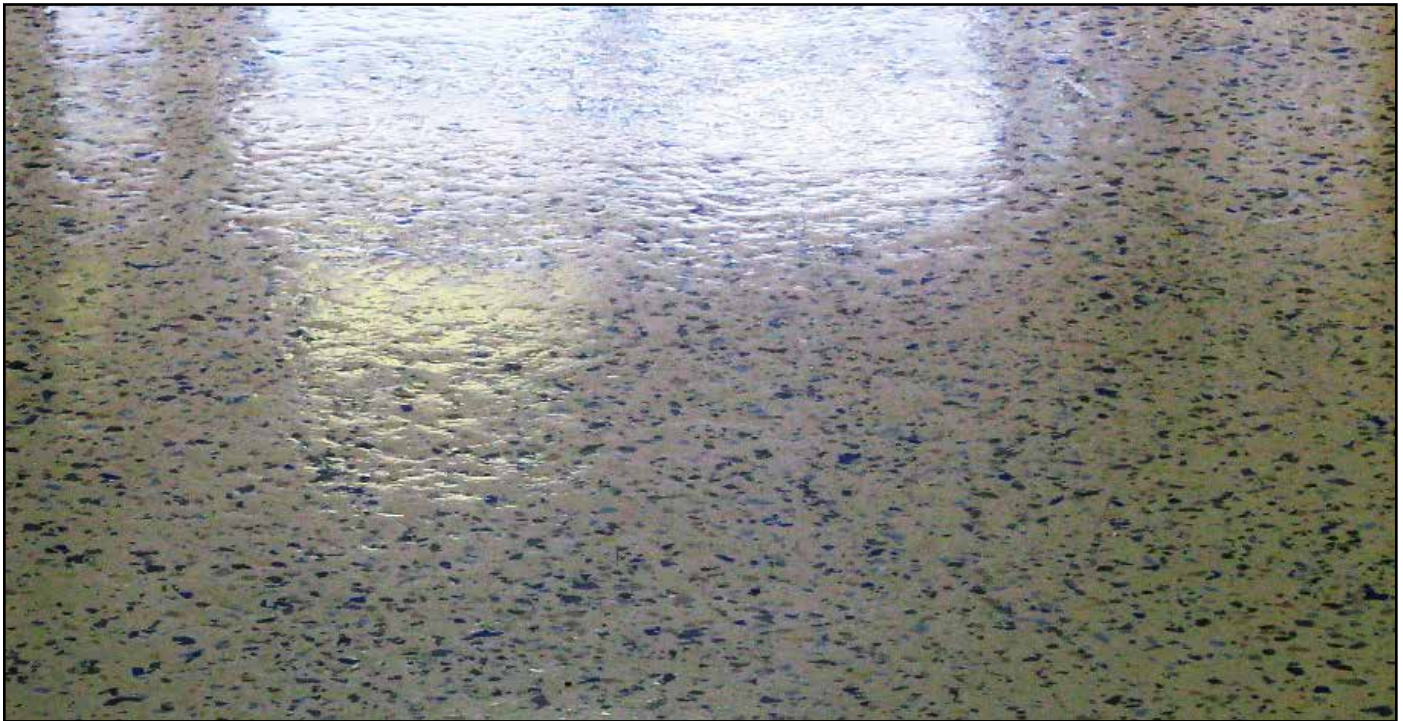
Orange peel is a stipple finish appearance in the final topcoat of epoxy or urethane flooring system. Some flooring manufacturers offer this finish; however, it is not always desirable to the customer.

- **Cold Substrate/Materials:** If the substrate temperature is below 50°F/10°C, the epoxy or urethane will not flow and level out, and can produce the orange peel finish. This will be more prevalent if the topcoat is applied in a thin layer, somewhere between 3–6 wet mils. The combination of a cold substrate and cold materials can readily produce this type of finish.
- **Hot Substrate/Materials:** Hot temperatures can also result in an orange peel finish. If the substrate is above 90°F/32°C, the topcoat may cure too quickly. This rapid curing will cause the material not to flow and level out. Just as in cold temperatures, thin topcoat layers, hot substrate temperatures and hot material can produce an orange peel finish.

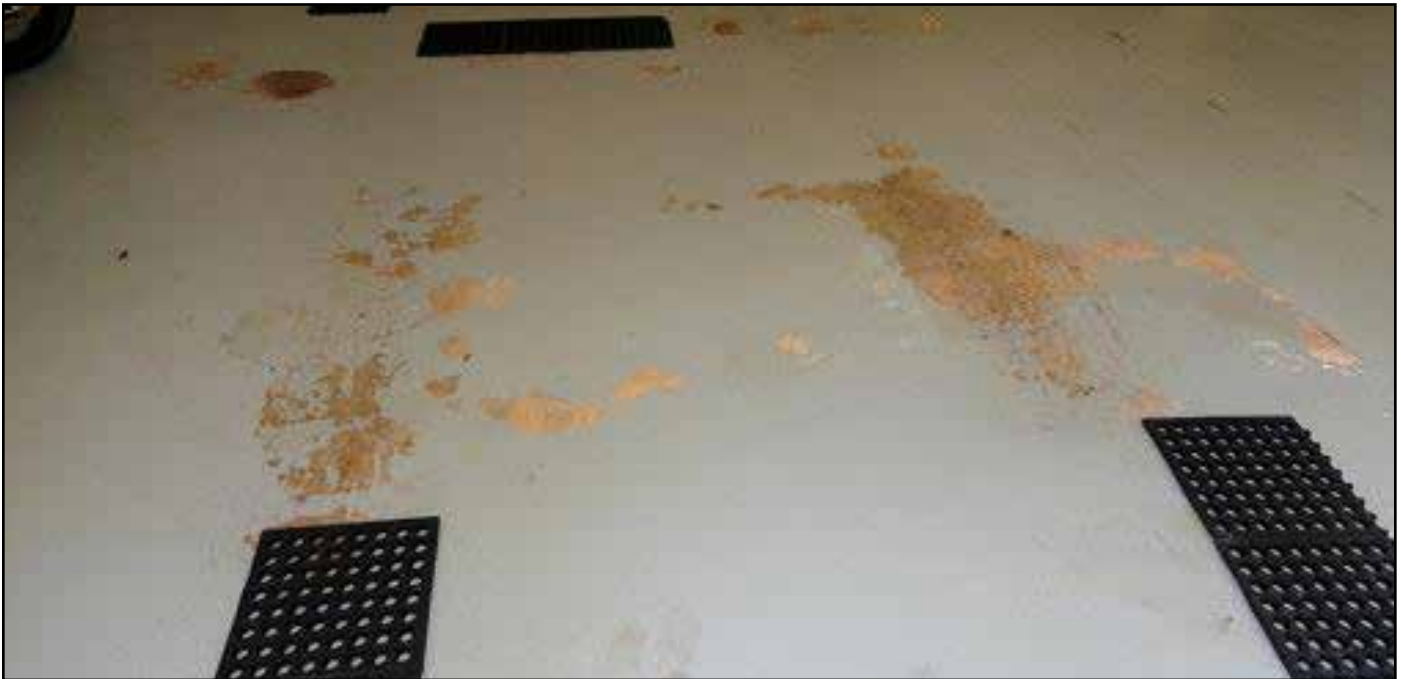
Flooring system is delaminating and peeling in areas where tires are consistently in contact with the coating.

- Thin System Application: A floor coating system applied at insufficient coverage rates may delaminate.
- Project Specification: The applied system was not designed for project conditions.
- Poor Surface Preparation: Substrate was not properly prepared for acceptance of coating system.
- Improper Cure Time: Coating was not fully cured.

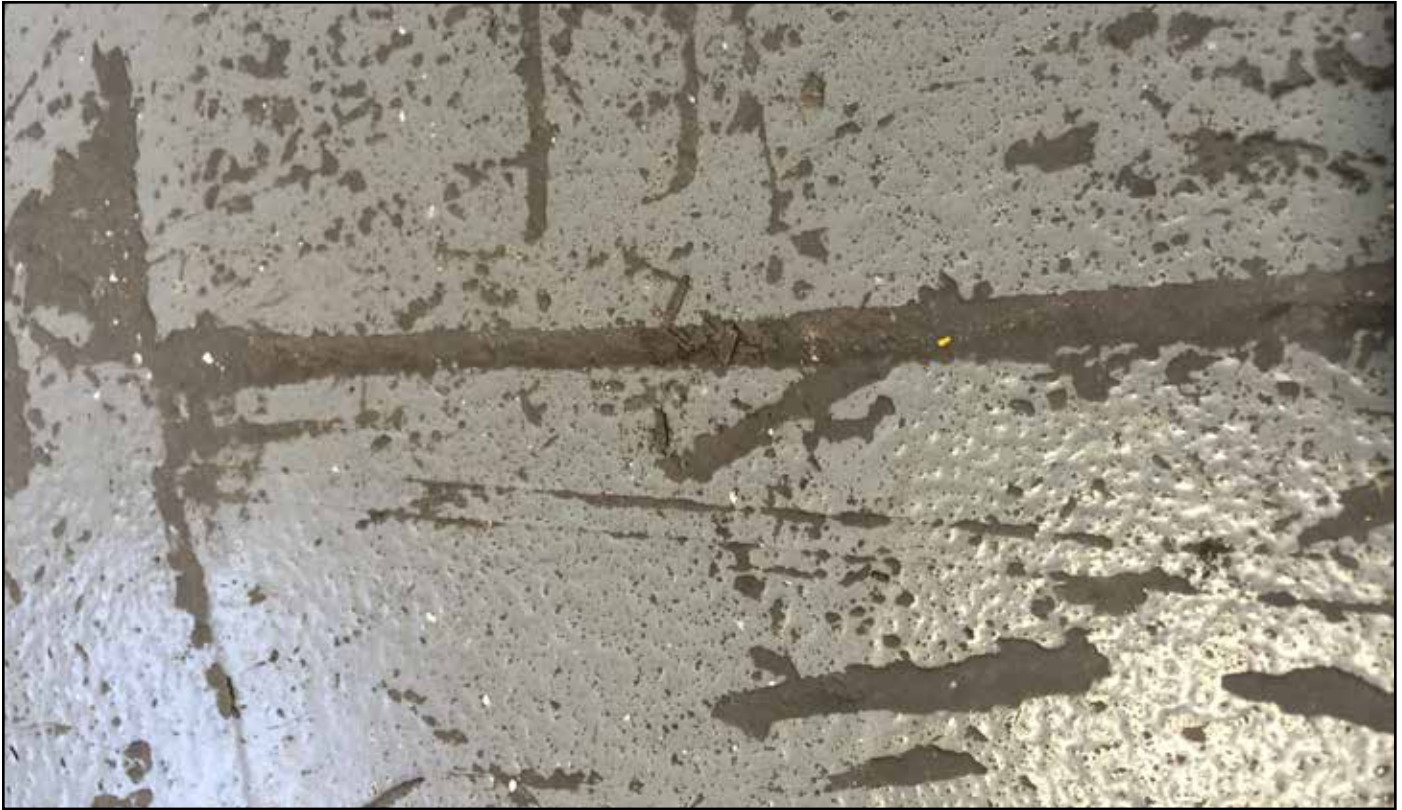
Flooring system has been scratched and/or gouged.

- Pallets have been dragged or pushed across the floor.
- Heavy loads have been dropped onto the floor.
- Forklift forks have scraped the floor.

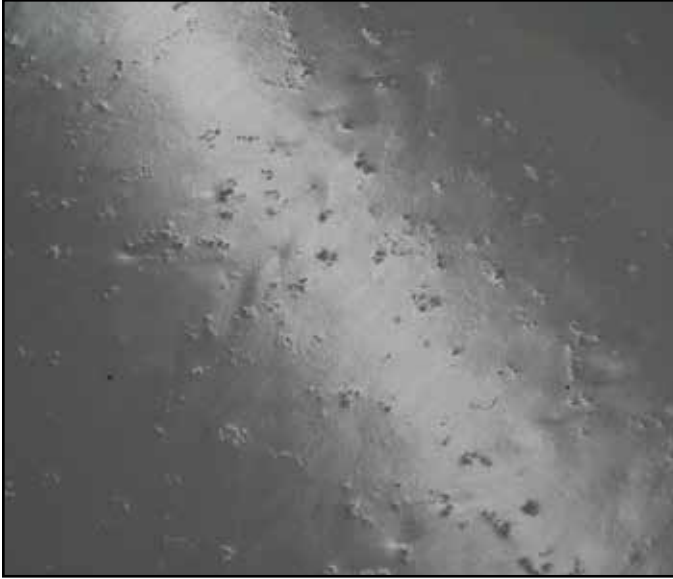
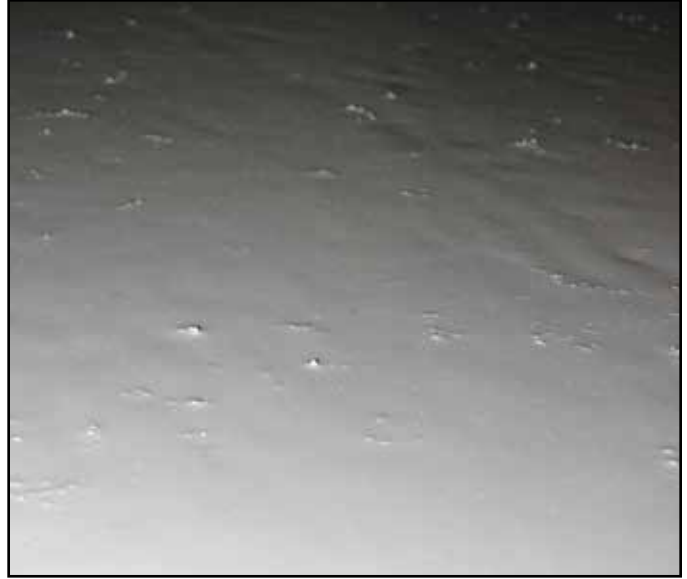
Roller lint is embedded in the coating after application.

- Low-quality roller covers were used.
- Roller nap was too long.

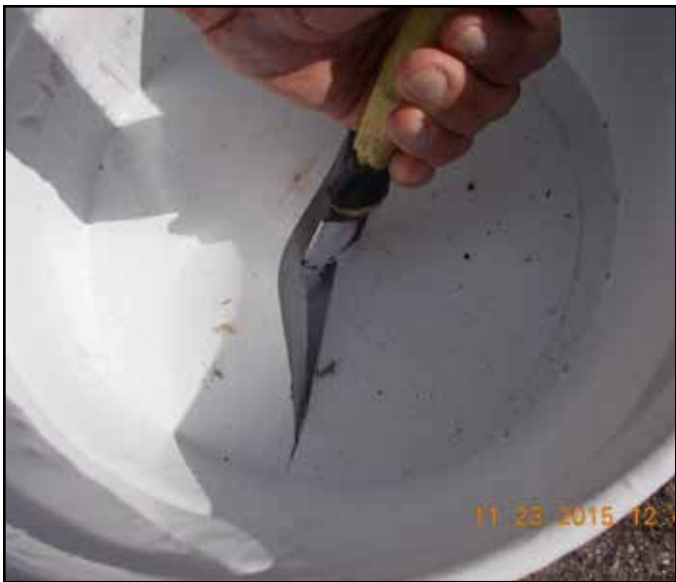
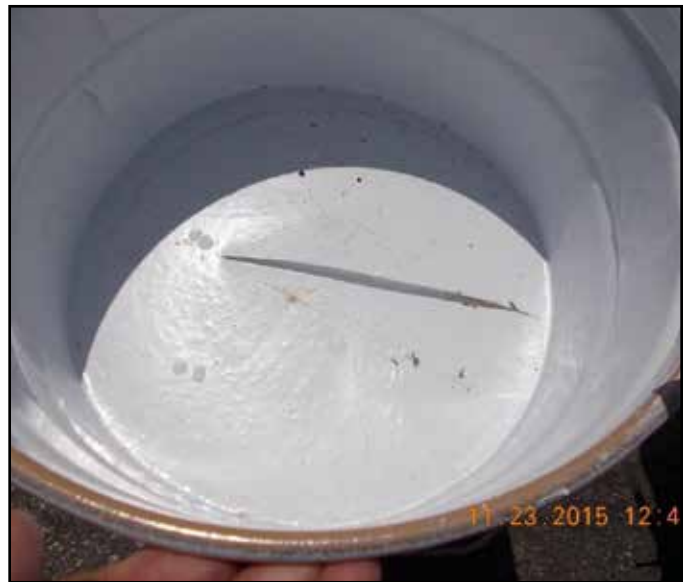
A skin forms on the top of the Material in a pail or barrel.

Single-component urethanes are moisture-cured. The pail or barrel has been opened, allowing moisture to be introduced to the coating material, and the curing process begins.

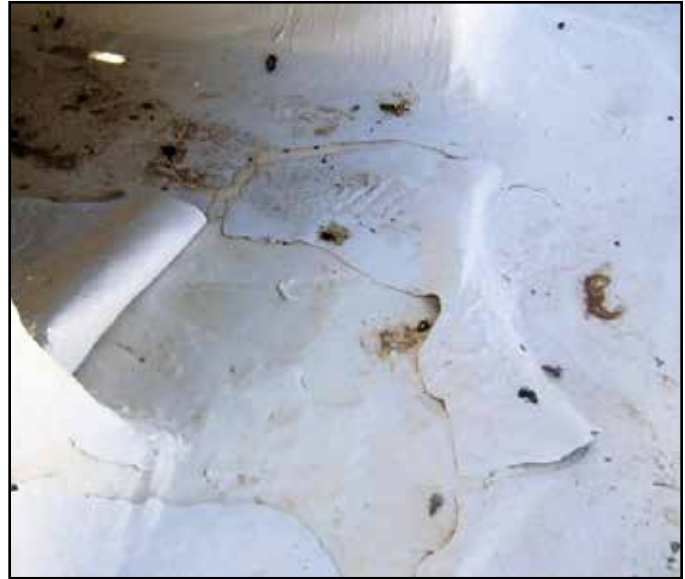
**Delamination due to thin topcoat and ponding**

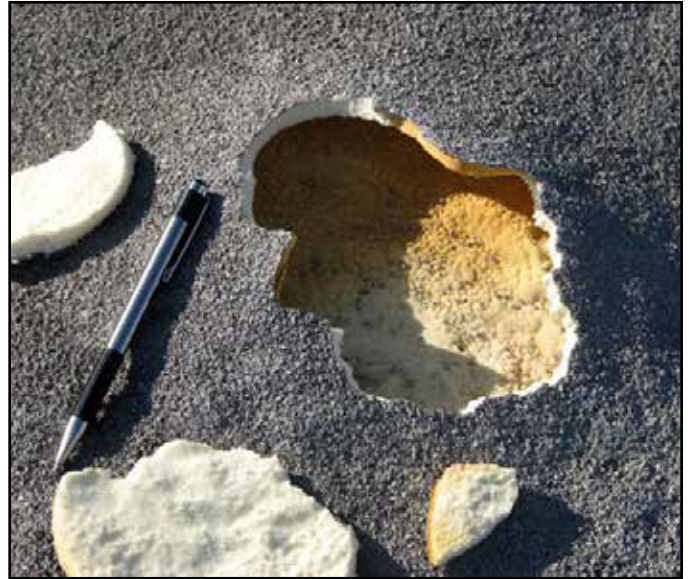
**Typical unopened foam blister**

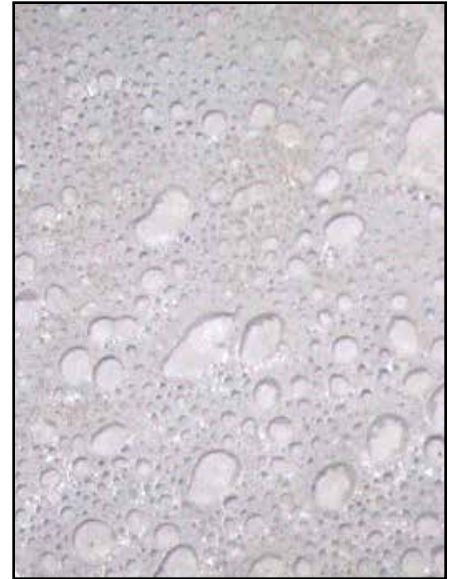
Roof with moisture contamination

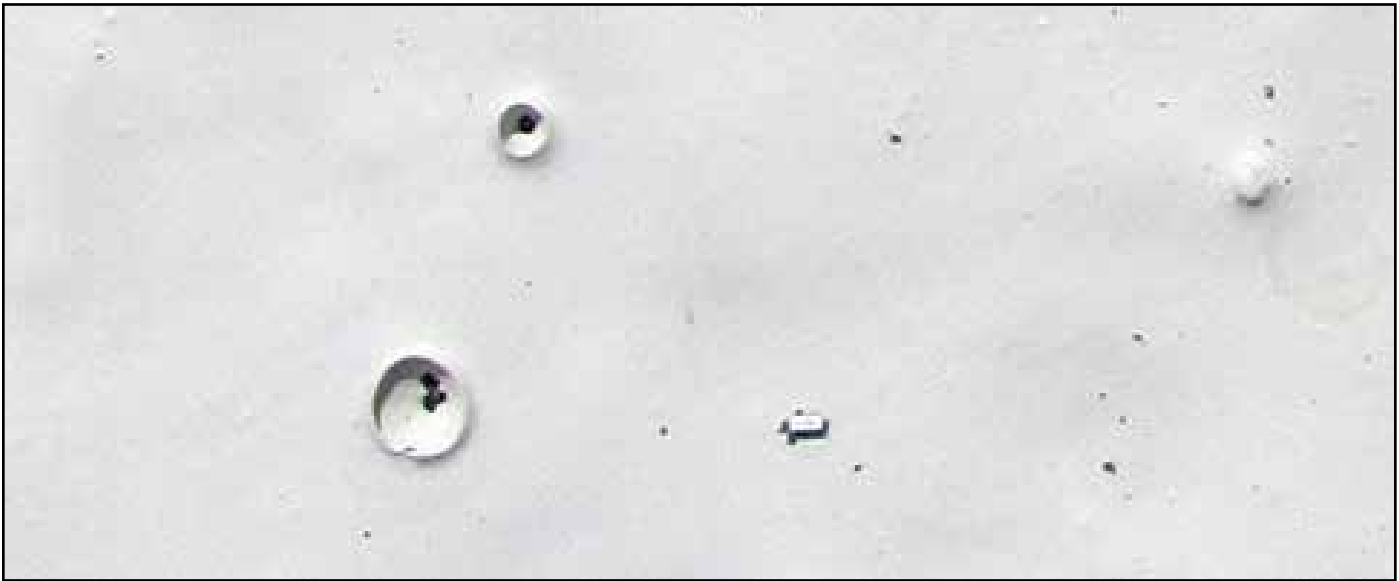
Appear as tiny blisters or bubbles. When these blisters pop they usually leave a round crater. The pinhole should be easily seen through the film. Concrete decks are susceptible to this condition.

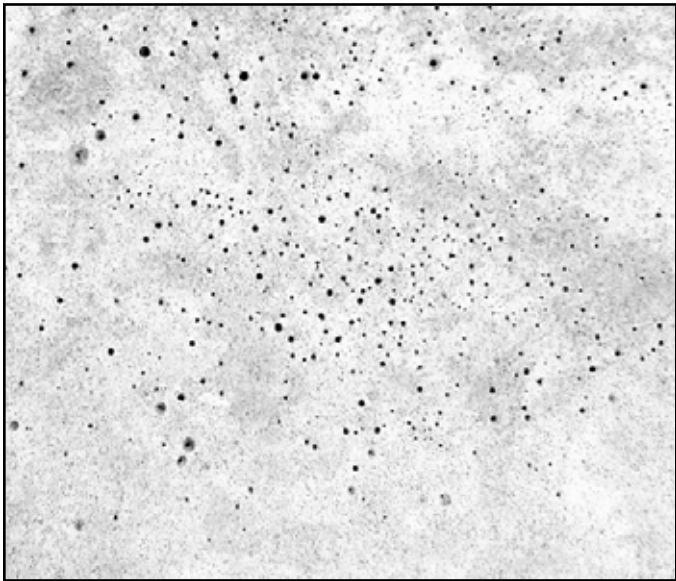
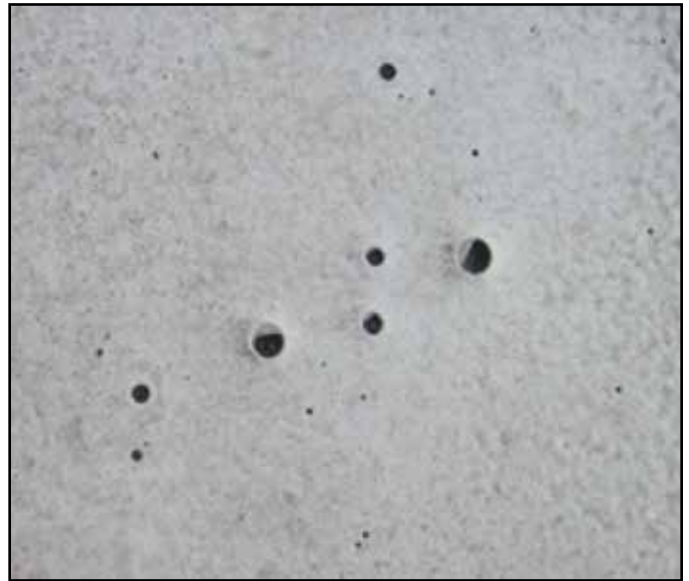
Small voids which penetrate through the coating. A crosscut will show intact base coat material, with the voids contained only in the topcoat.

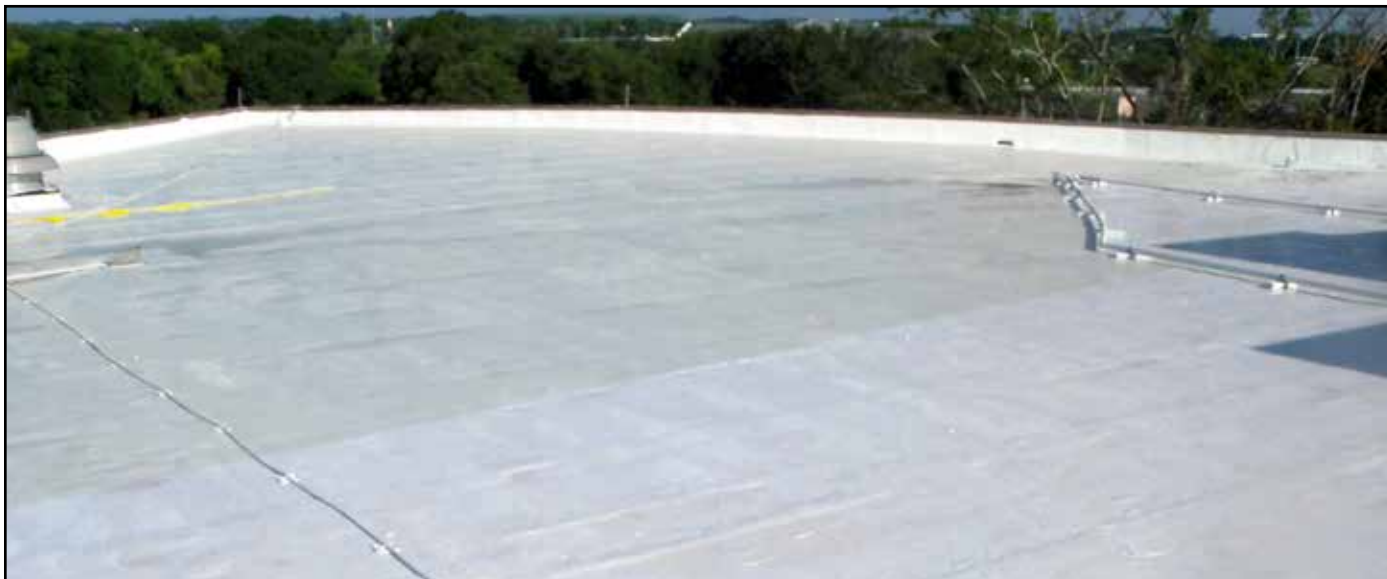
The coating appears to be different shades. This is most often noticeable in white products.

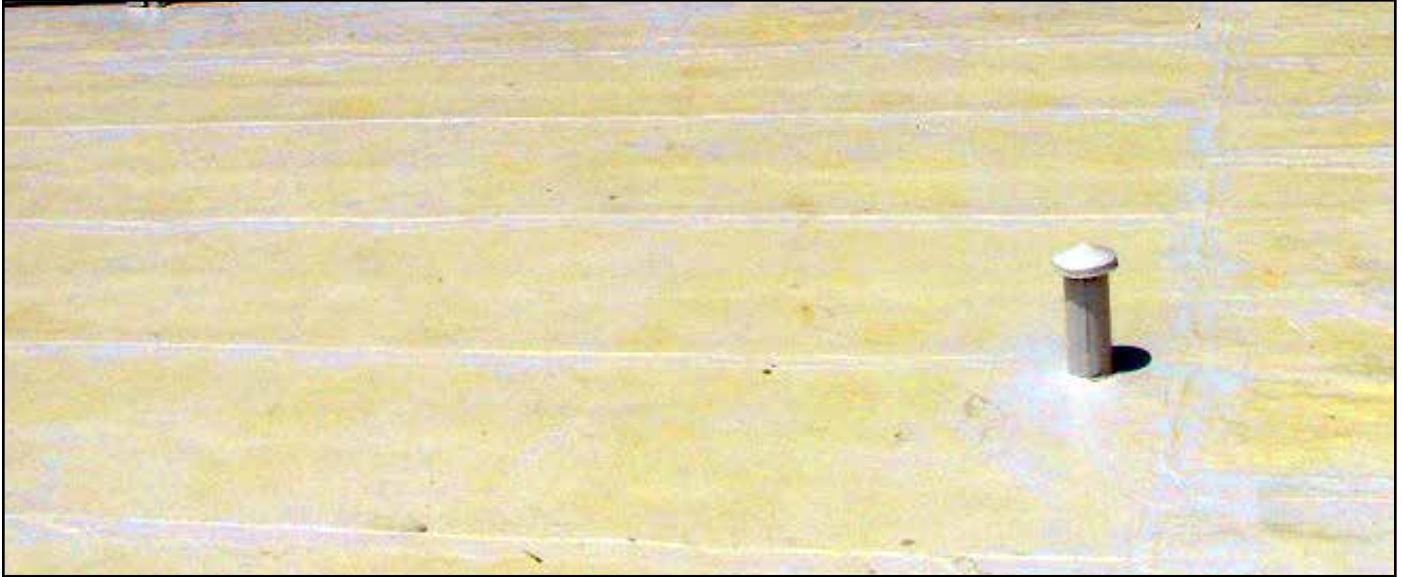
Surface of coating has taken on a yellow hue. Yellowing may be splotchy.

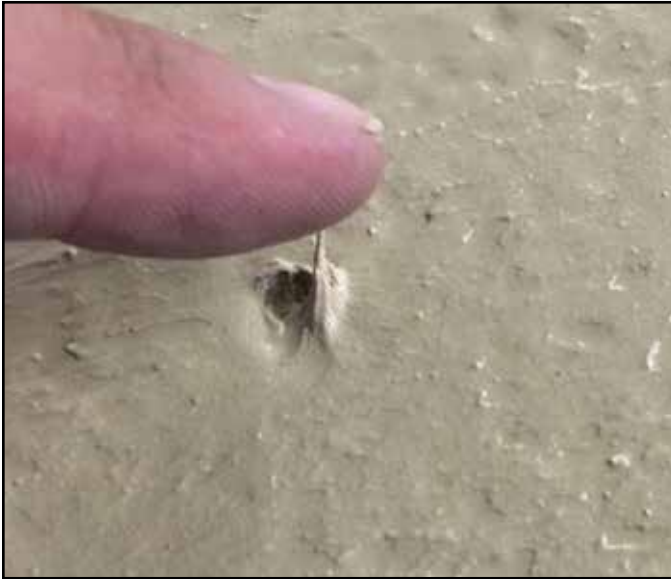
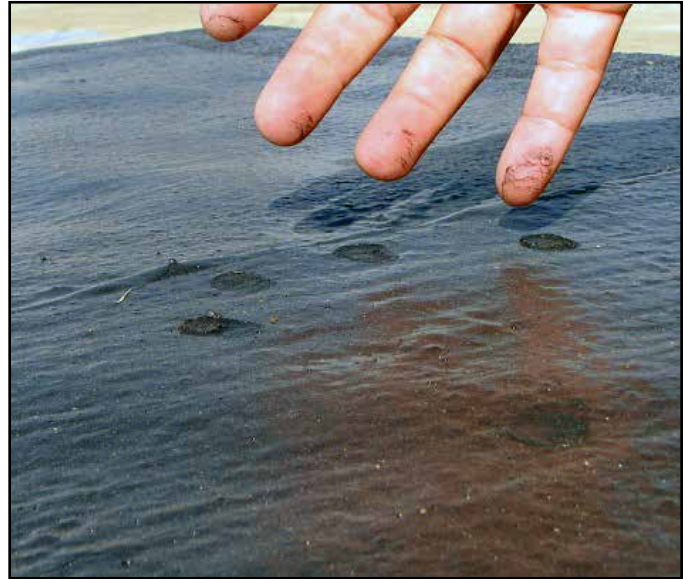
After expected curing time has elapsed, coating is still soft and may transfer when touched.

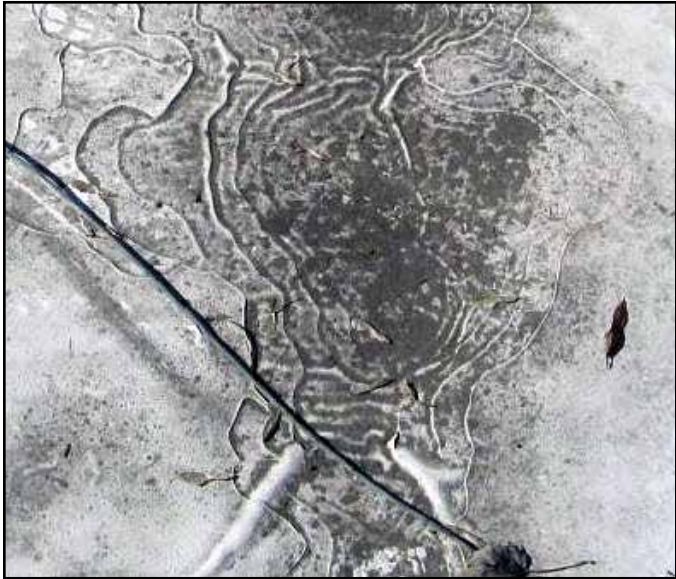
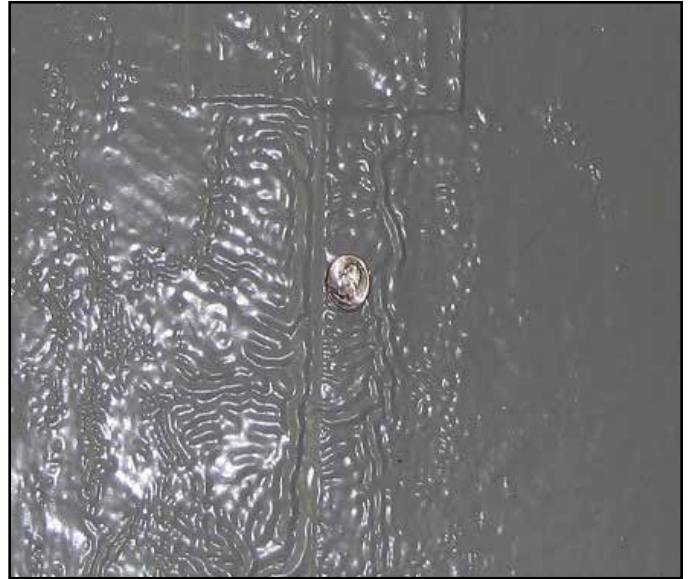
Areas of the coating appear wrinkled.

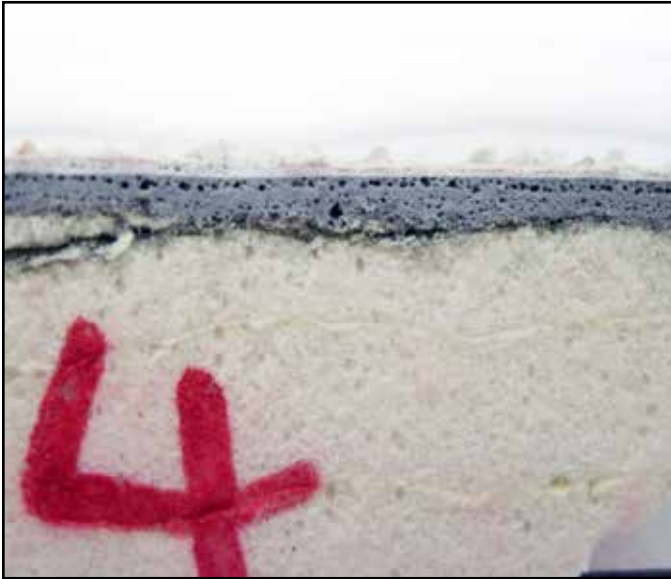
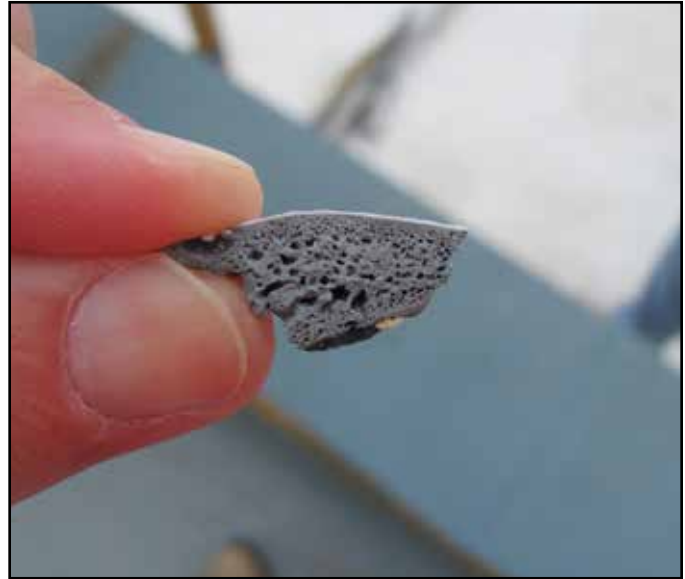
A cross section reveals a large number of open cells in the coating.

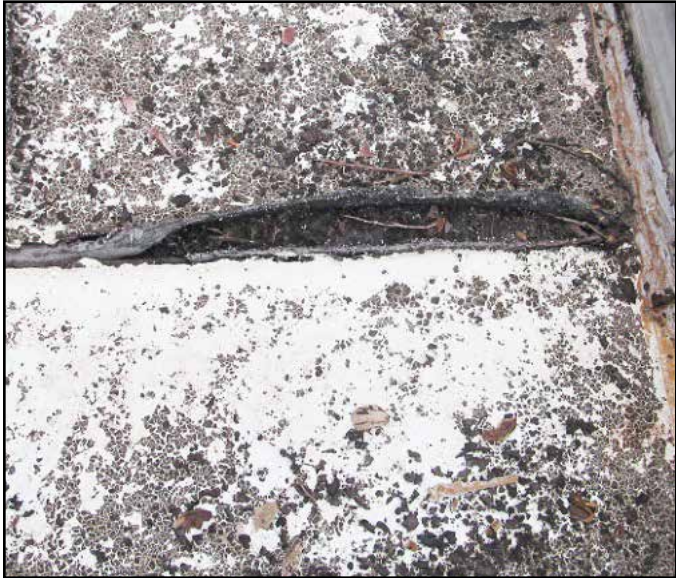
Coatings initially display a crack, transforming into a small blister-type opening. The coating will then form a fish mouth, and finally the sheet will separate and pull back to form a curled edge. Split seams typically occur in modified bitumen and asphalt cap sheets, and are compounded by ponding water.

**Curled seam edge**

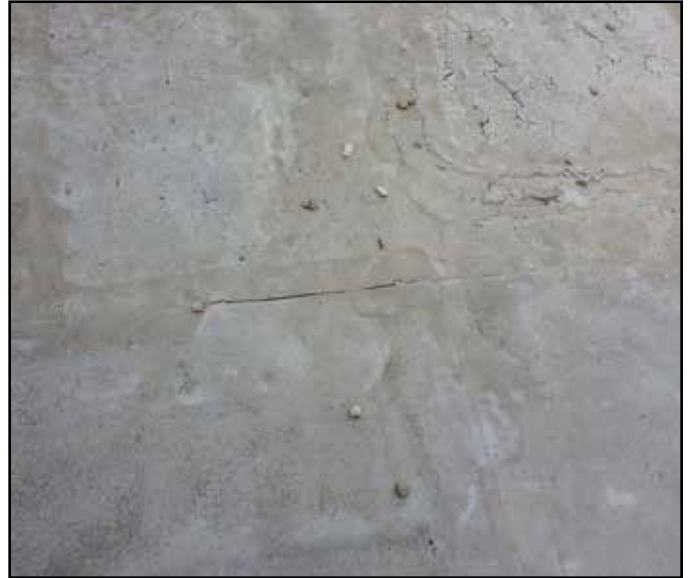
**Split seam**

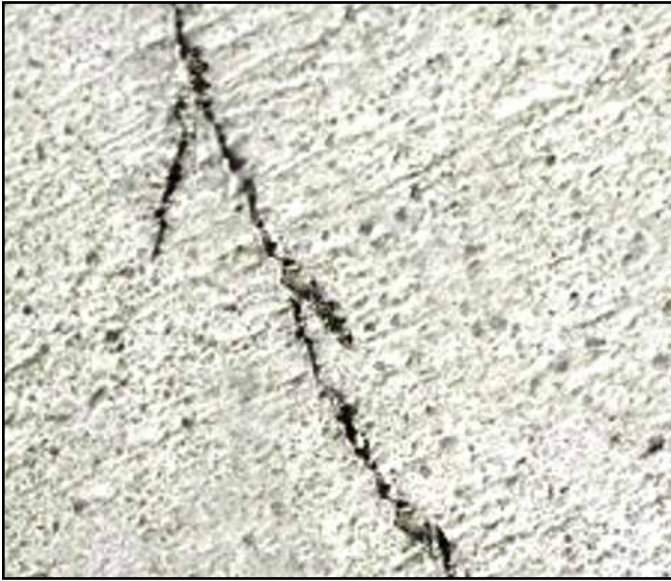
**Crack before coating**

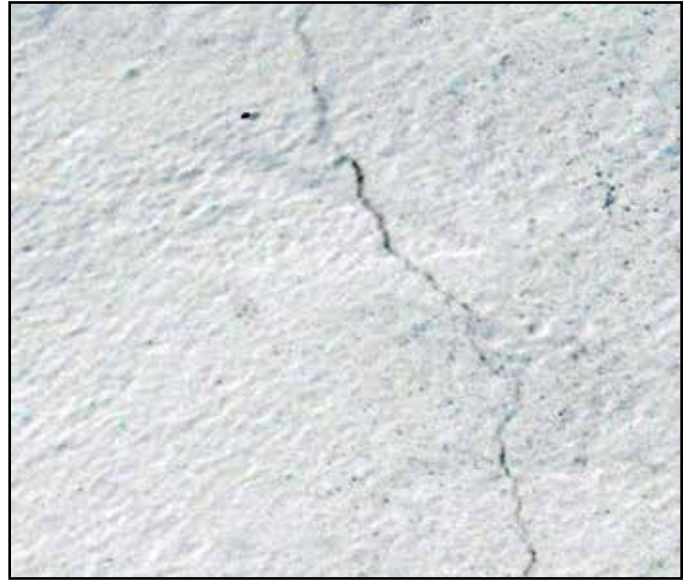
Cracks in concrete substrate may telegraph through the coating and become clearly visible. Over time, these cracks may increase in number as well as in size.

**Crack in coating telegraphed from concrete**

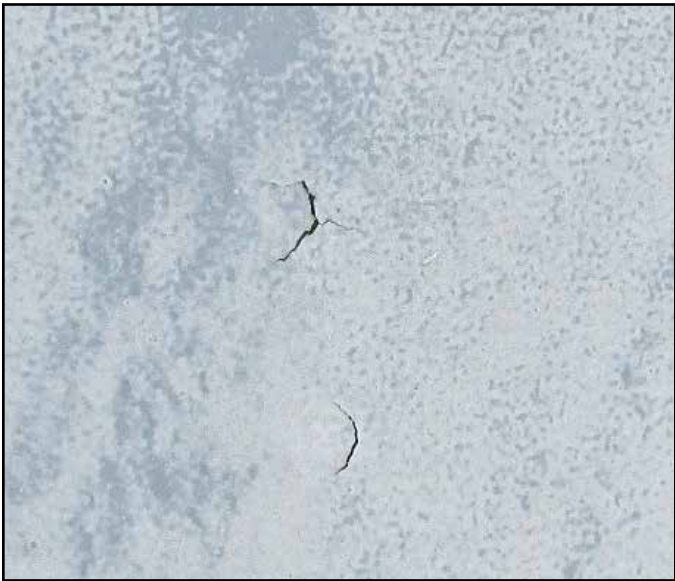
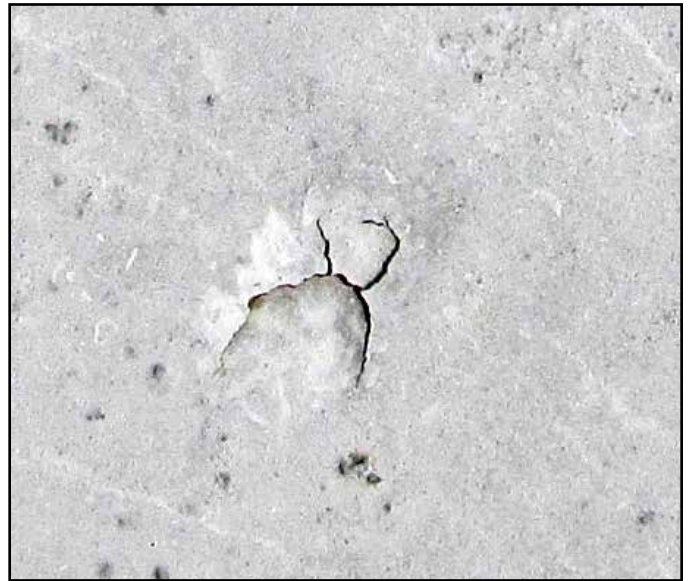
A random pattern of damage which ranges in size from ½–1", repeated throughout large areas of the roof and not limited to single occurrences.

Hail stones impacting the roof. Roofs should be inspected for this type of damage after reports of hail storms in the vicinity.

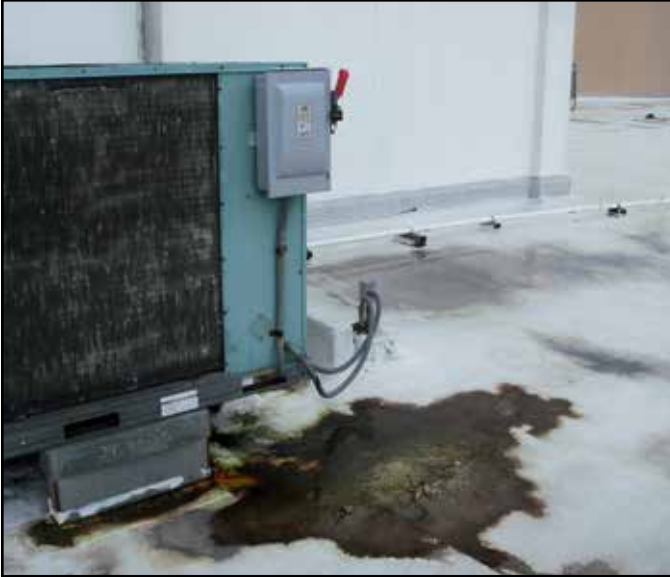
Discharge from condensation lines of rooftop equipment causes contamination of the coating.

**Disconnected condensate drain lines**

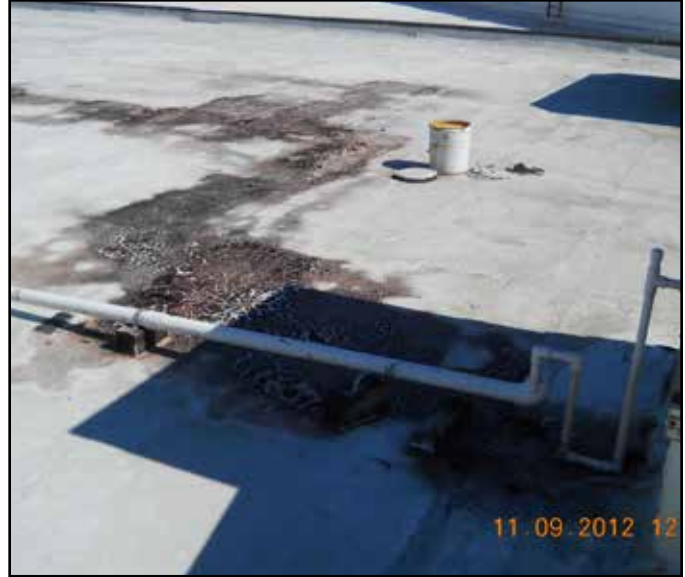
**Poorly maintained condensate drain lines**

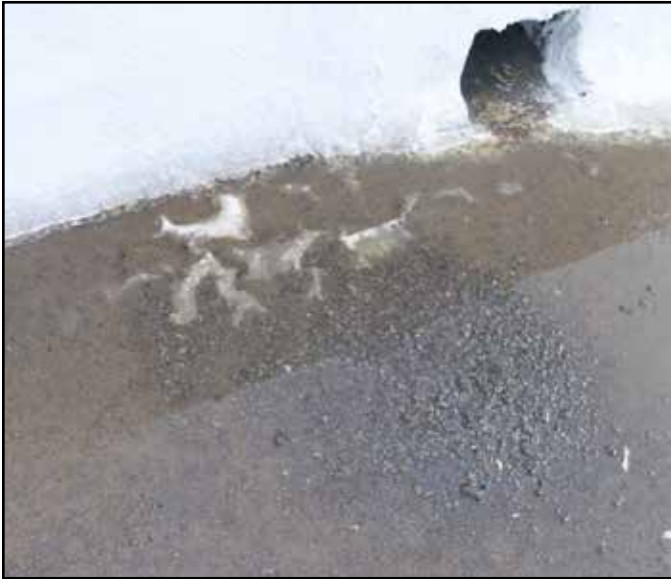
Water has ponded on the roof and has damaged the coating.

**Scupper installed too high**

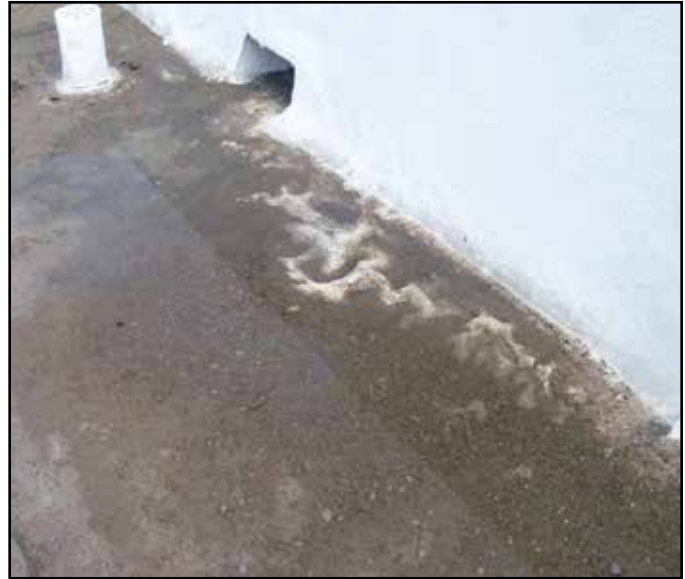
**Clogged roof drain**

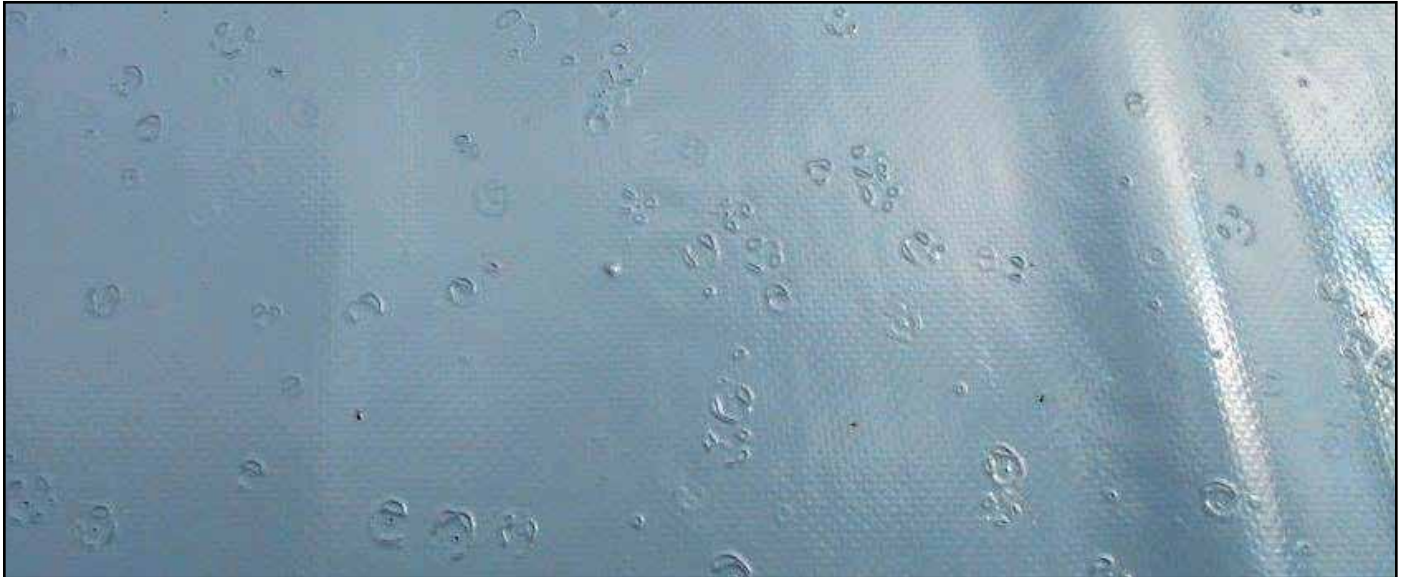
Surface has craters or dimples where rain has fallen on uncured coating.

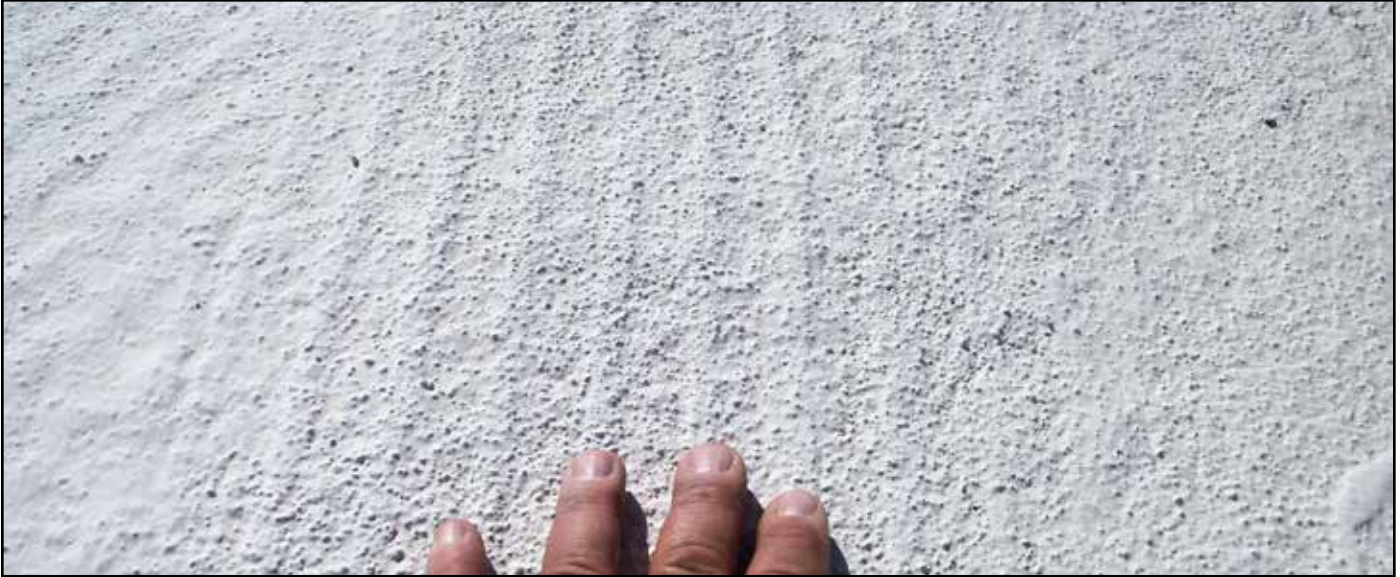
A 1/4" notched squeegee was used to apply coating, and the coating was not backrolled.
