# Troubleshooting Guide

Causes, Repair  
& Prevention

December 2023

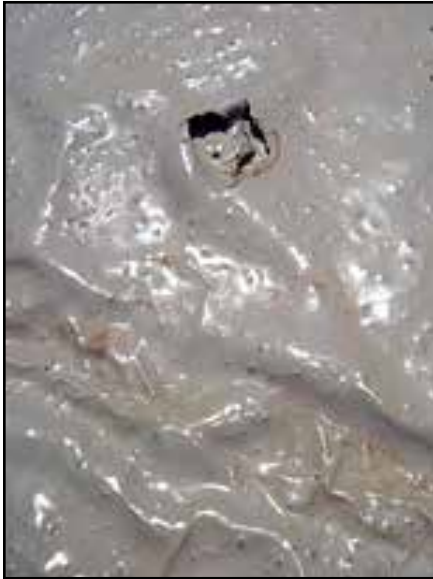
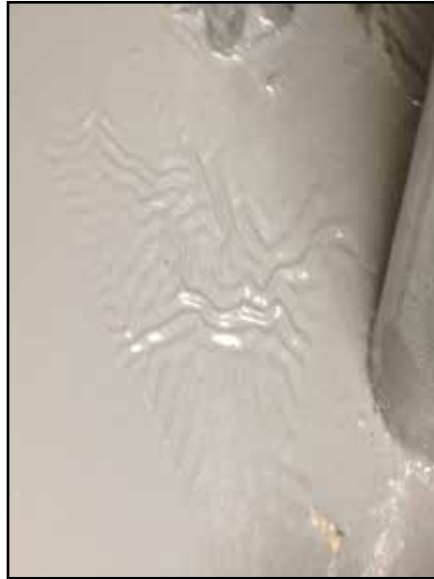
Coating is wrinkled in appearance. Multiple lines of parallel wrinkling may occur.

- Previous Coat is Uncured or Off-Ratio: Material applied over uncured or off-ratio coating, causing stress on topcoat.
- Coating Too Thick: Coating applied at a thickness that exceeds application instructions.

- Previous Coat is Uncured: Ensure that coatings are completely cured before applying additional coats.
- Previous Coat is Off-Ratio: Mix all materials thoroughly, following mix ratios printed on product labels or the Product Data Sheet. See Product Mixing Instructions in the Support Information section of this guide.
- Coating Too Thick: Apply coatings at recommended coverage rates.

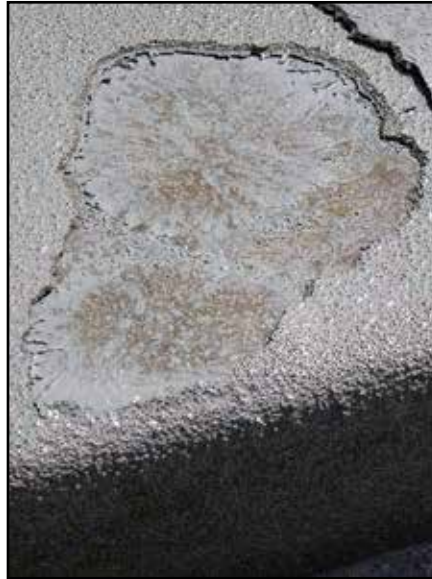
Area underneath removed blister

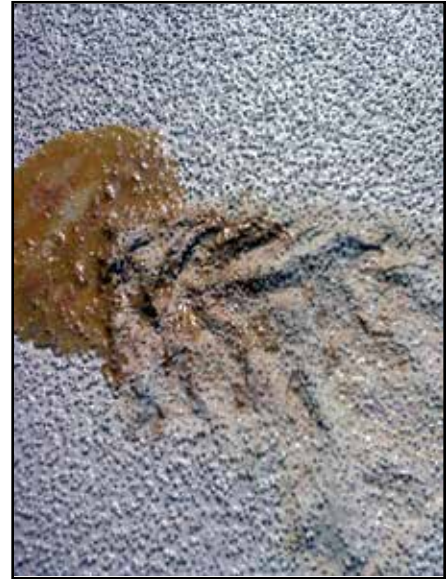
Off-ratio coating

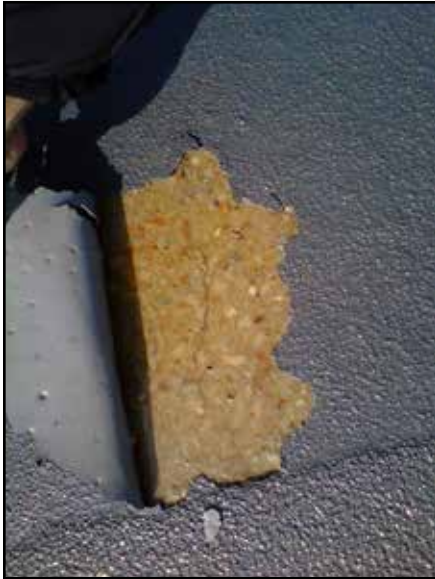
Coating may peel off in places and show signs of concrete laitance or other contaminants on the backside.

**Delamination due to moisture**

- **Improper Surface Profile:** Surface was not shot-blasted or abraded prior to applying membrane, or the base coat was applied over epoxy primer after the 24-hour window.
- **Contamination from Moisture:** There was dew or other moisture on the surface that was coated.
- **Contamination from Dust, Dirt, Etc.:** Coating over contaminated surfaces will lead to coating failures such as loss of bond.
- **Incompatible Materials:** Materials that are incompatible with the coating will cause many issues including delamination.
- **Thin Topcoat Application:** A final topcoat applied too thin may delaminate and peel from the coating system.

1. Remove all loosely bonded material.
2. If substrate is exposed, abrasion may be necessary.
3. Clean repair area.
4. Re-apply material as specified and per Neogard recommendations.

- **Improper Surface Profile:** Substrate should be shot-blasted or abraded and cleaned prior to application of primer. Shot-blast surface ICRI CSP3 to CSP4 to remove contamination or laitance, and for optimal bonding. Base coat must be applied within 24 hours of primer application. If base coat cannot be applied within 24 hours, clean and re-apply primer.
- **Contamination:** Ensure deck is clean and dry prior to application of material.
- **Incompatible Materials:** Perform field adhesion test prior to application of the coating when installing coating over existing coating system. See the Field Adhesion Testing section of this guide.
- **Apply coating at specified rates and per Neogard recommendations.**

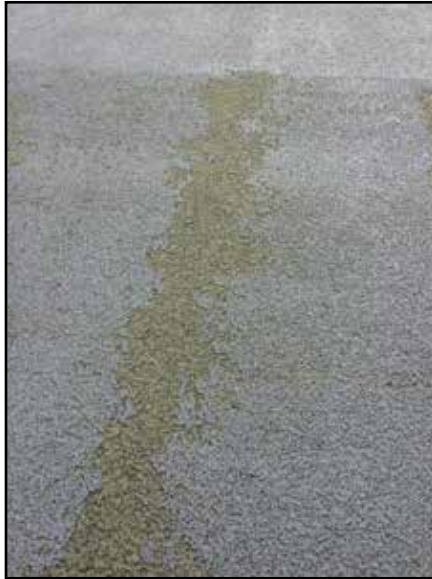
**Delamination due to incompatible materials**

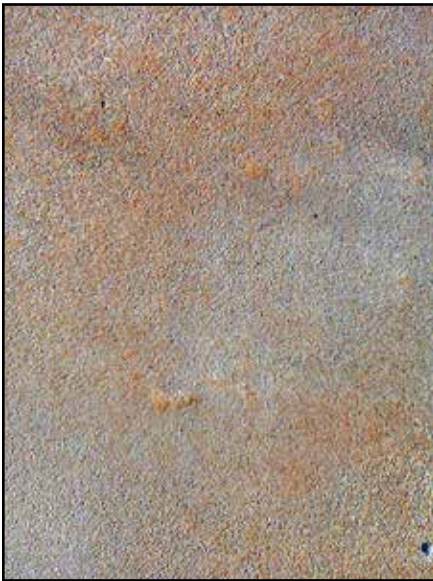
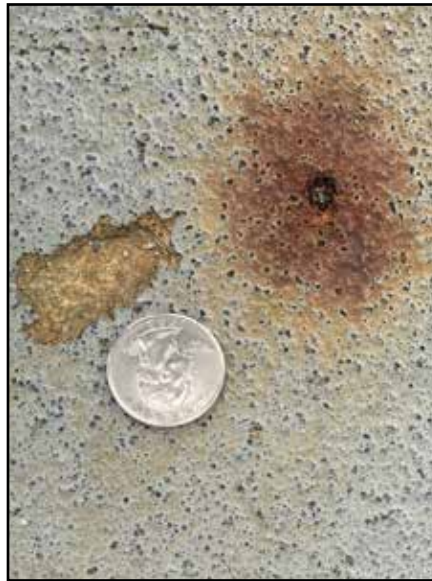
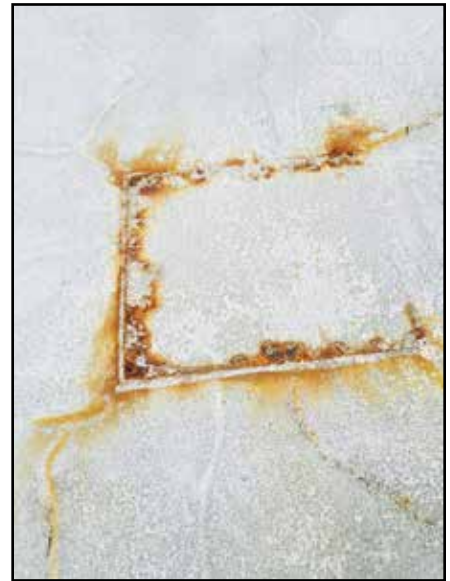
There are rusty, reddish-brown stains in the coating. The presence of rust can be purely aesthetic, or it may indicate a condition which affects the integrity of the coating system.

- Shotblast Beads: Rust stains develop when shot-blast beads utilized during surface preparation are not properly removed. Rust stains will bleed through the entire system if metal is not removed prior to applying the coating system.
- Metal in Aggregate: Rust may also develop from metal fines contained in the aggregate.
- Rebar or Mesh: Rust from rebar or mesh too close to the surface can also appear.

If the contamination source is from the surface, power washing along with the use of a rust neutralizer may remove stained area.

1. If the contamination source is located in the substrate, remove the coating down to the substrate and abrade the surface to remove all rust.
2. Apply Ureprime HS2 or HS4 at a rate of 300 sf/gal to properly prepared area and allow to cure.
3. Apply 70714/70715 Series epoxy at a rate of 100 sf/gal (16 WFT/16 DFT).
4. Re-apply coating per specifications and Neogard recommendations in the Waterproofing Application Manual.

- Shotblast Beads: Remove all iron and metal residue from the substrate, including cracks and joints.
- Metal in Aggregate: Use Neogard or Neogard-approved aggregates.
- Rebar or Mesh: After the deck is cleaned and shot-blasting completed, inspect for rebar and/or mesh near the surface. If rebar or mesh is near the surface, it may be necessary for the owner to consult with a structural engineer.

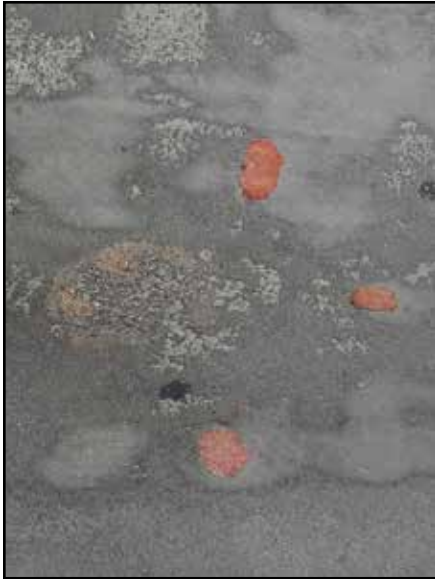
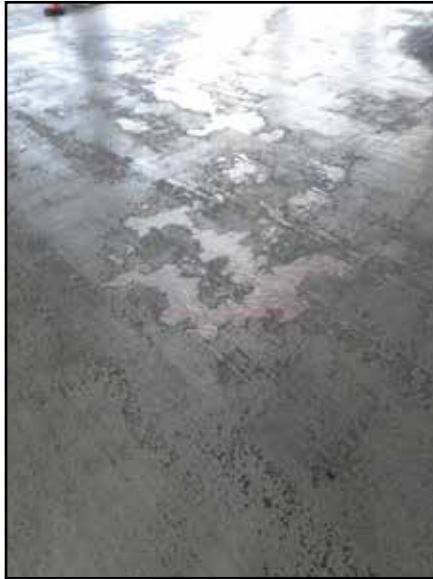
Coating is worn, exposing primer and bare concrete.

- Inappropriate Application: Excess aggregate in wear coat and insufficient topcoat material led to premature wear.
- Wrong System Specified: Applied system not designed for heavy duty areas such as drive lanes, turns, ticket splitters, etc.
- Moisture Contamination: Premature wear due to moisture contamination during application.
- Improper Mixing: Failure to mix components properly prior to installation, scraping unmixed material from walls of buckets, insufficient mixing time for proper dispersion, or a contaminated mixing paddle, resulting in off-ratio components and poor physical properties.

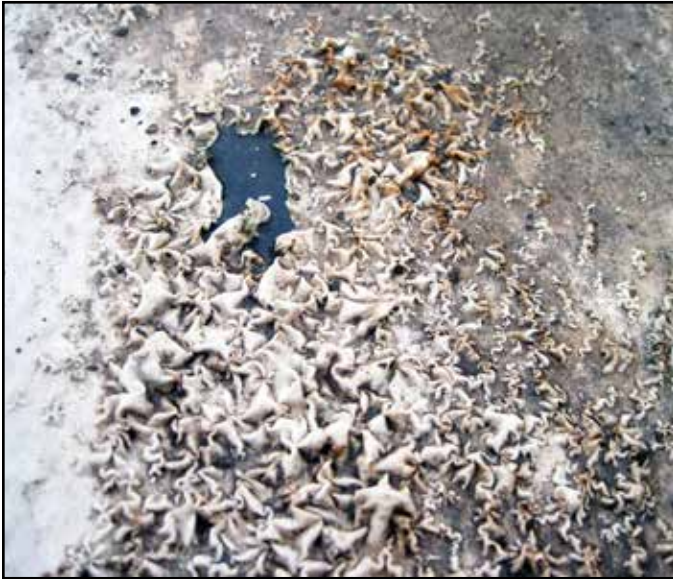
The coating material loses bond between coats, or between the coating and the substrate.

**Delamination due to thin topcoat and ponding**

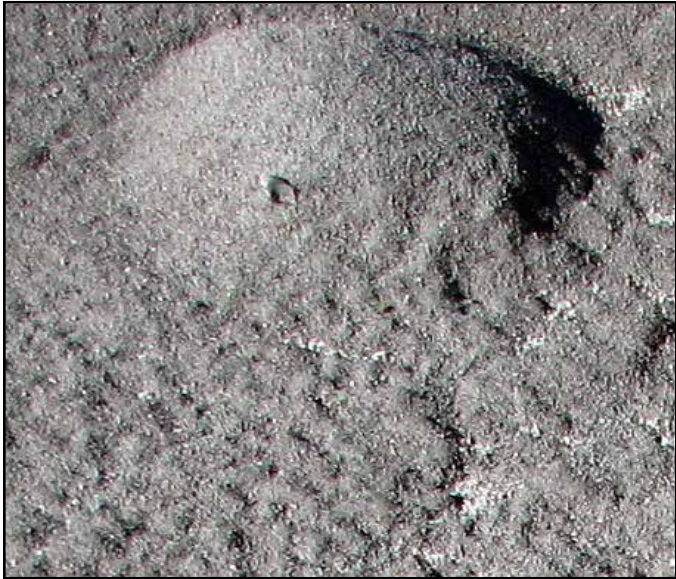
Medium to large bubbles on the surface of the foam. They are typically randomly dispersed.

**Typical unopened foam blister**

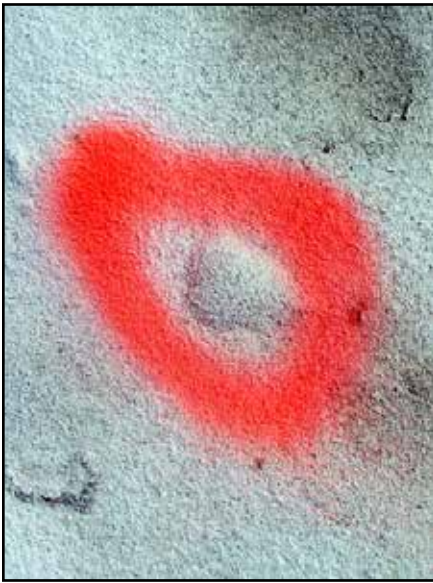
Small to medium bubbles in the coating surface. They can be randomly dispersed or centralized in one location. Open blisters will typically be a single smooth bubble with no pinholes or multi-chambered cells.

**Blister due to contamination**

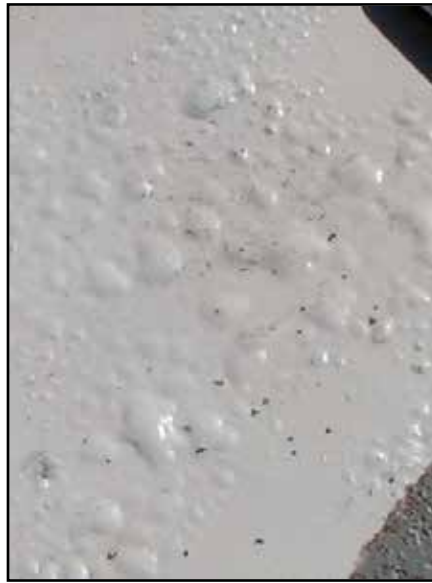
**Trapped solvent blisters**

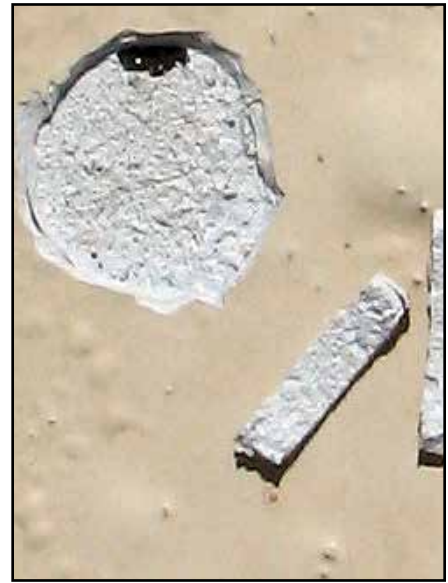
**Removed blister**

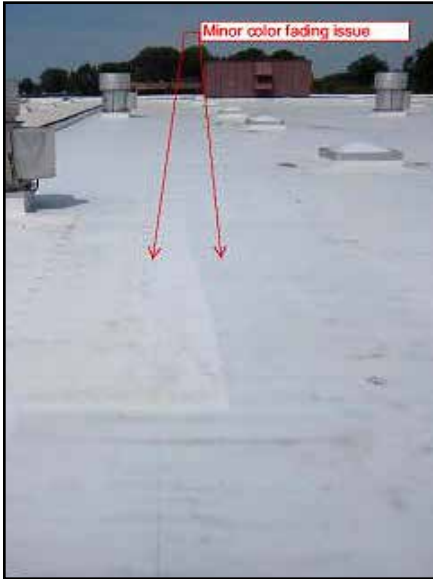
Surface of coating does not cure to a glossy finish and reflect light, which is ideal for a roofing topcoat.

Roof with shade variation

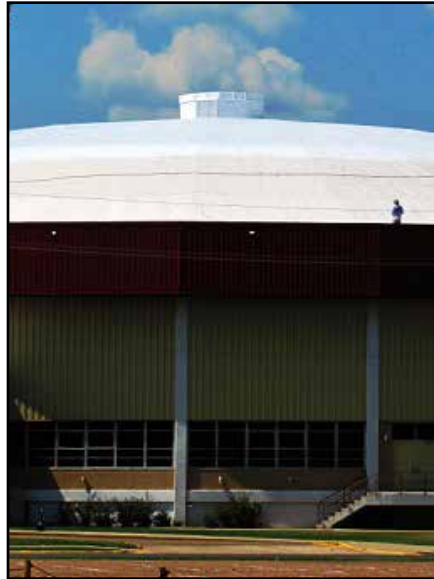
Roof with moisture contamination

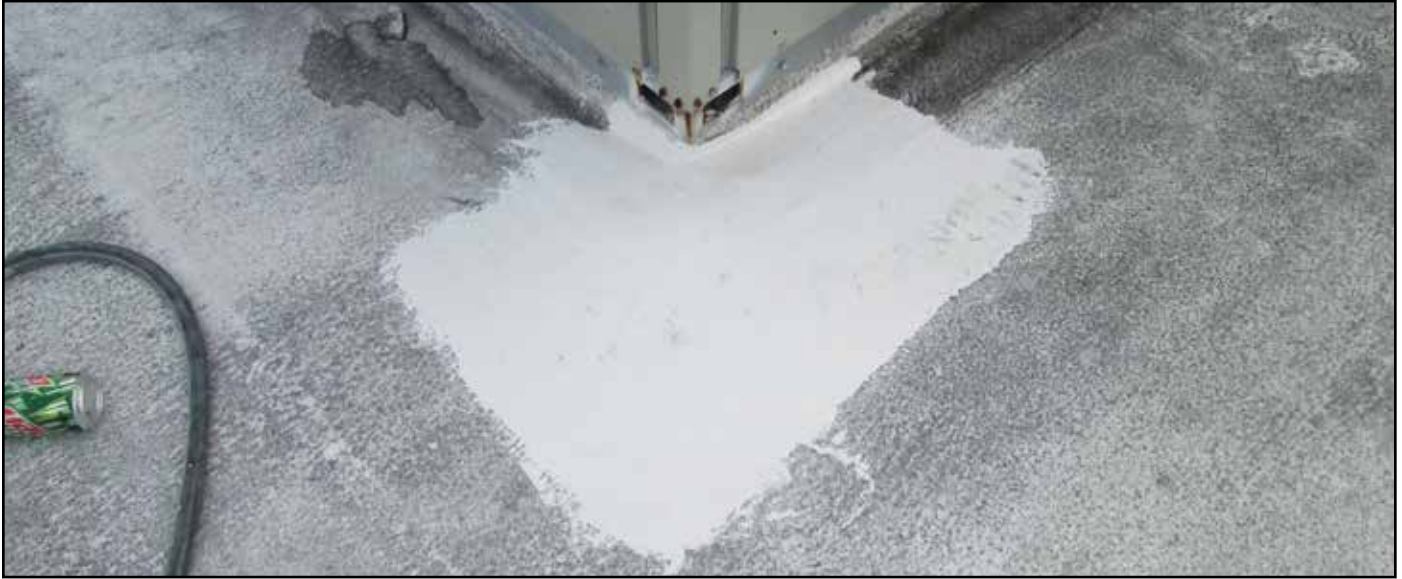
Surface not cleaned properly and does not extend 6”–8” beyond the affected area.
