Project:
Crack Treatment, Concrete Substrate

Drawn by: KSK	Scale: NTS	Date: 08/16/2021	Drawing/Index No. ROOF-C_cracks-08162021
------------------	---------------	---------------------	---

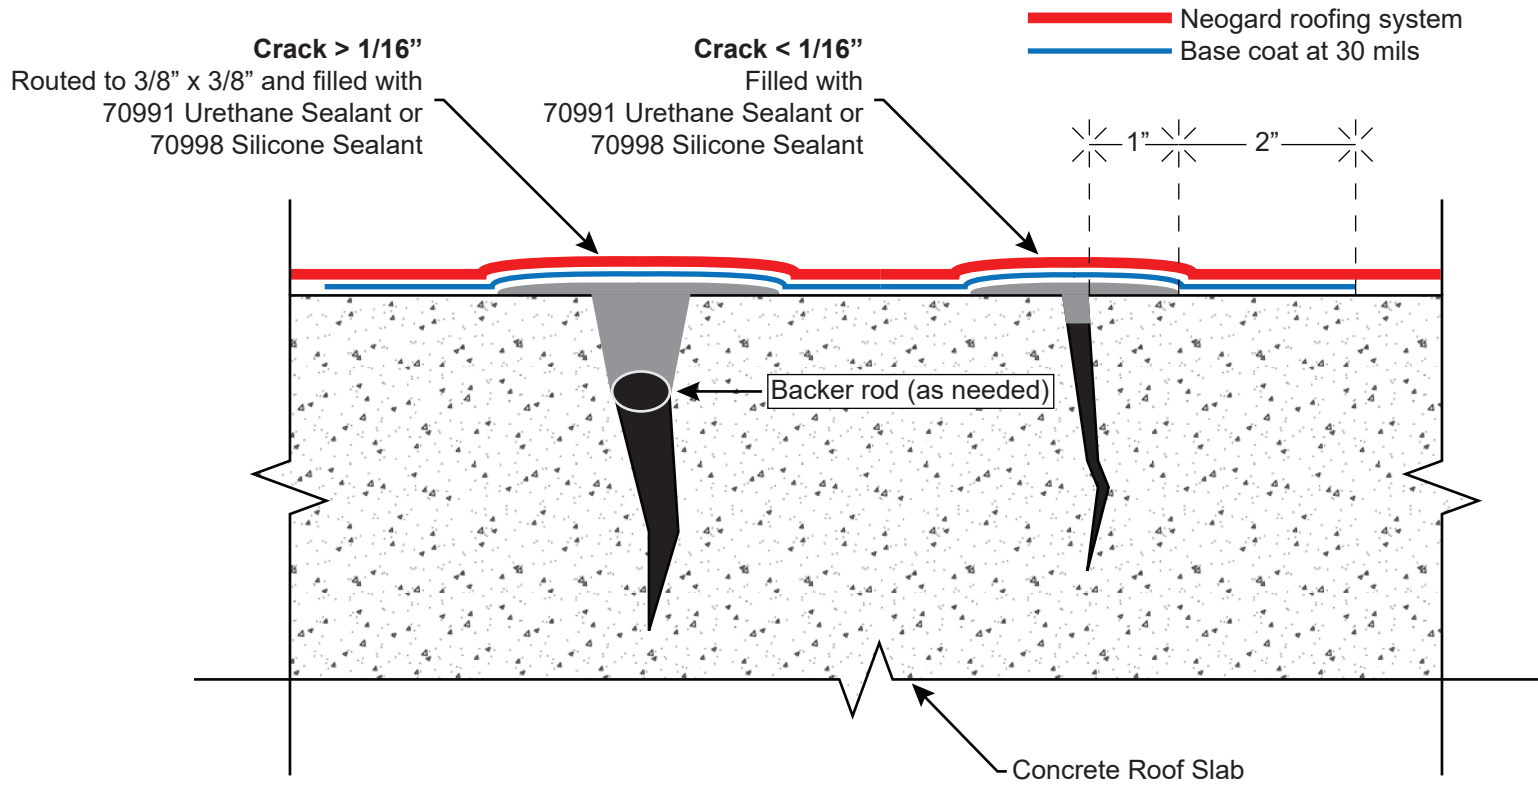
Note: This detail is utilized in the specification and design of fluid-applied roofing, in both new and retrofit applications. It is provided to show a generally recommended procedure for dealing with the condition shown. It will not and cannot provide a specific solution for every condition likely to be encountered in field application. Where field conditions differ, the use of applicable portions of the detail shown or its adaptation by an experienced and conscientious applicator should result in a quality project.
