# Troubleshooting Guide

Causes, Repair  
& Prevention

March 2020

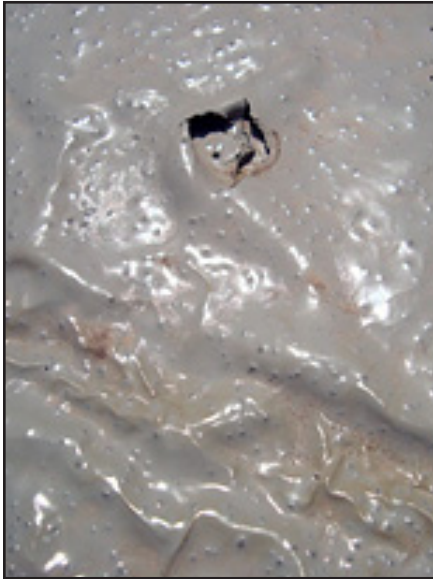
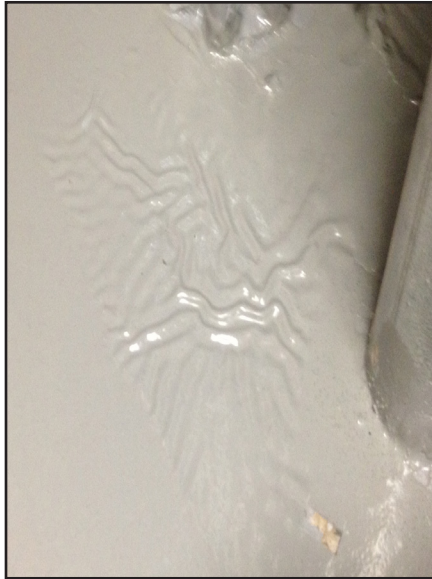
Coating is wrinkled in appearance. Multiple lines of parallel wrinkling may occur.

- Previous Coat is Uncured or Off-Ratio: Material applied over uncured or off-ratio coating, causing stress on topcoat.
- Coating Too Thick: Coating applied at a thickness that exceeds application instructions.

- Previous Coat is Uncured: Ensure that coatings are completely cured before applying additional coats.
- Previous Coat is Off-Ratio: Mix all materials thoroughly, following mix ratios printed on product labels or the Product Data Sheet. See Product Mixing Instructions in the Support Information section of this guide.
- Coating Too Thick: Apply coatings at recommended coverage rates.

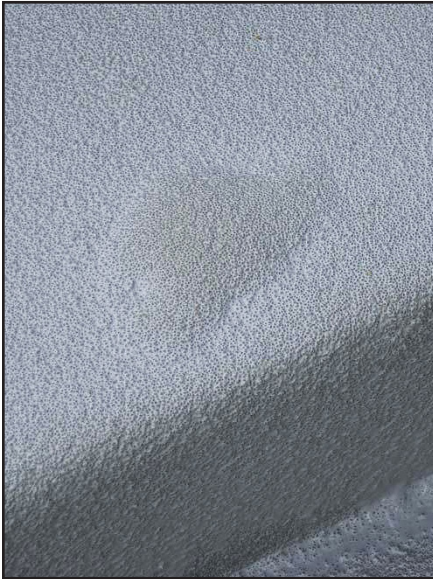
Coating is soft and may transfer when touched. Coating may also delaminate.

**Typical blister**

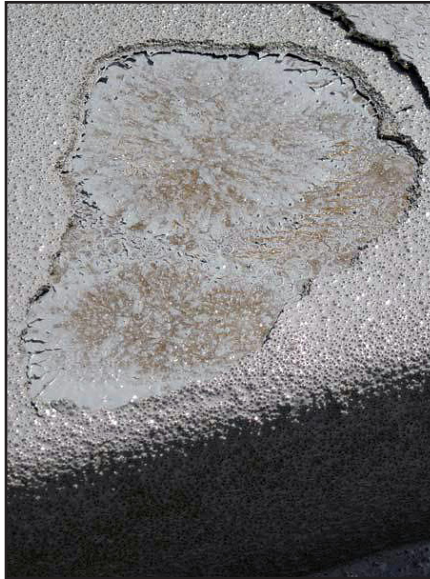
**Area underneath removed blister**

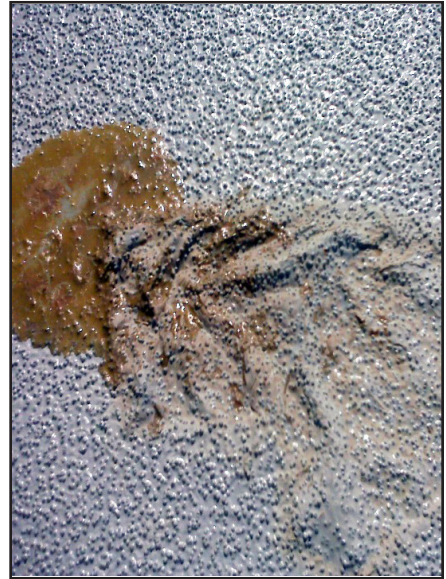
**Off-ratio coating**

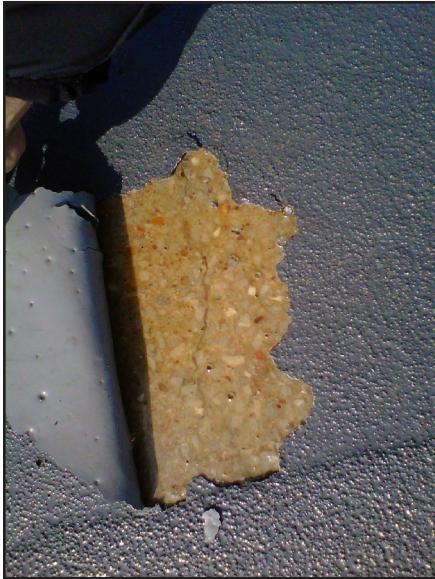
**Delamination due to moisture**

- **Improper Surface Profile:** Surface was not shot-blasted or abraded prior to applying membrane, or the base coat was applied over epoxy primer after the 24-hour window.
- **Contamination from Moisture:** There was dew or other moisture on the surface that was coated.
- **Contamination from Dust, Dirt, Etc.:** Coating over contaminated surfaces will lead to coating failures such as loss of bond.
- **Incompatible Materials:** Materials that are incompatible with the coating will cause many issues including delamination.
- **Thin Topcoat Application:** A final topcoat applied too thin may delaminate and peel from the coating system.

1. Remove all loosely bonded material.
2. If substrate is exposed, abrasion may be necessary.
3. Clean repair area.
4. Re-apply material as specified and per Neogard recommendations.

- **Improper Surface Profile:** Substrate should be shot-blasted or abraded and cleaned prior to application of primer. Shot-blast surface ICRI CSP3 to CSP4 to remove contamination or laitance, and for optimal bonding. Base coat must be applied within 24 hours of primer application. If base coat cannot be applied within 24 hours, clean and re-apply primer.
- **Contamination:** Ensure deck is clean and dry prior to application of material.
- **Incompatible Materials:** Perform field adhesion test prior to application of the coating when installing coating over existing coating system. See the Field Adhesion Testing section of this guide.
- **Apply coating at specified rates and per Neogard recommendations.**

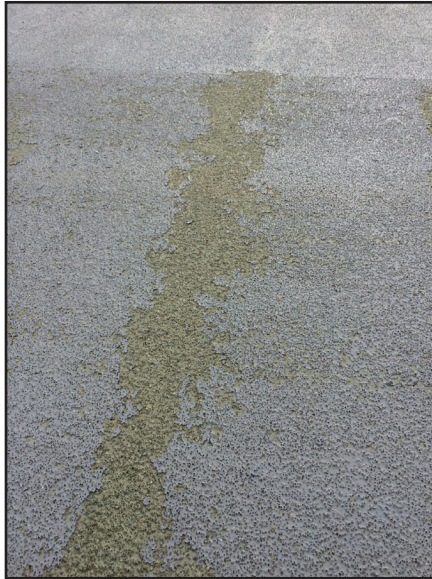
**Delamination due to incompatible materials**

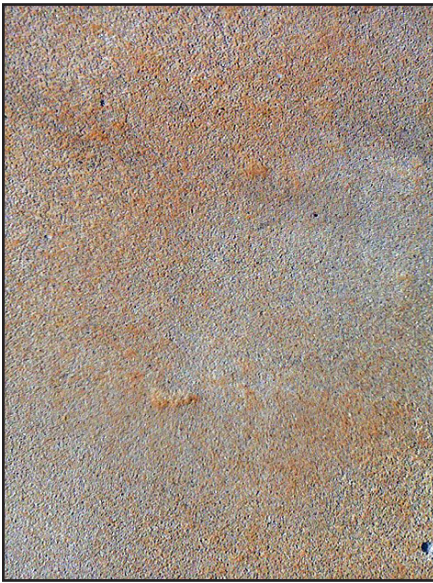
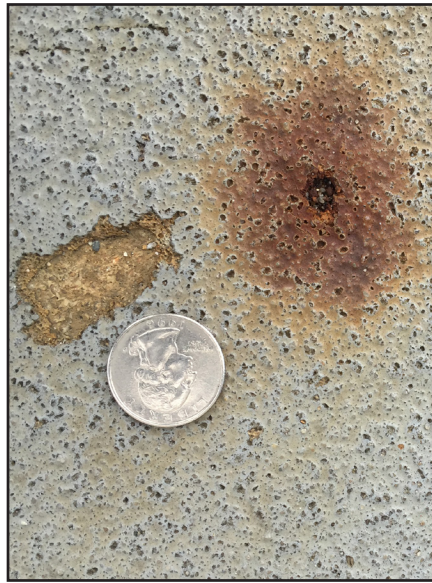
There are rusty, reddish-brown stains in the coating. The presence of rust can be purely aesthetic, or it may indicate a condition which affects the integrity of the coating system.

- Shotblast Beads: Rust stains develop when shot-blast beads utilized during surface preparation are not properly removed. Rust stains will bleed through the entire system if metal is not removed prior to applying the coating system.
- Metal in Aggregate: Rust may also develop from metal fines contained in the aggregate.
- Rebar or Mesh: Rust from rebar or mesh too close to the surface can also appear.

If the contamination source is from the surface, power washing along with the use of a rust neutralizer may remove stained area.

1. If the contamination source is located in the substrate, remove the coating down to the substrate and abrade the surface to remove all rust.
2. Apply Ureprime HS2 or HS4 at a rate of 300 sf/gal to properly prepared area and allow to cure.
3. Apply 70714/70715 Series epoxy at a rate of 100 sf/gal (16 WFT/16 DFT).
4. Re-apply coating per specifications and Neogard recommendations in the Waterproofing Application Manual.

- Shotblast Beads: Remove all iron and metal residue from the substrate, including cracks and joints.
- Metal in Aggregate: Use Neogard or Neogard-approved aggregates.
- Rebar or Mesh: After the deck is cleaned and shot-blasting completed, inspect for rebar and/or mesh near the surface. If rebar or mesh is near the surface, it may be necessary for the owner to consult with a structural engineer.

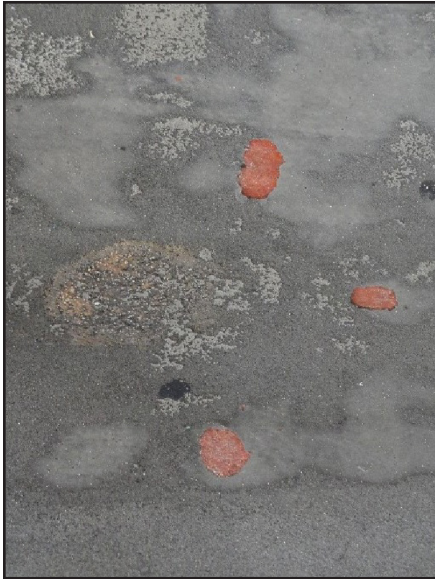
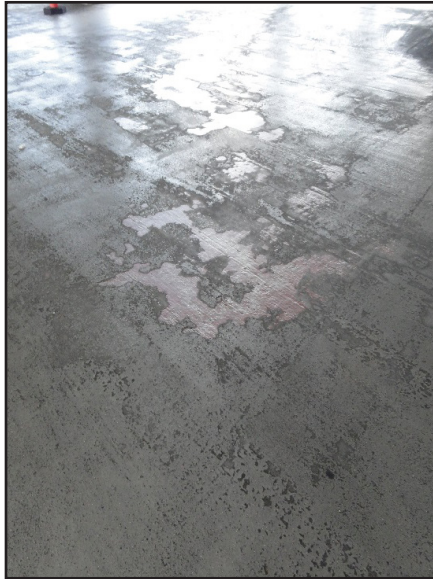
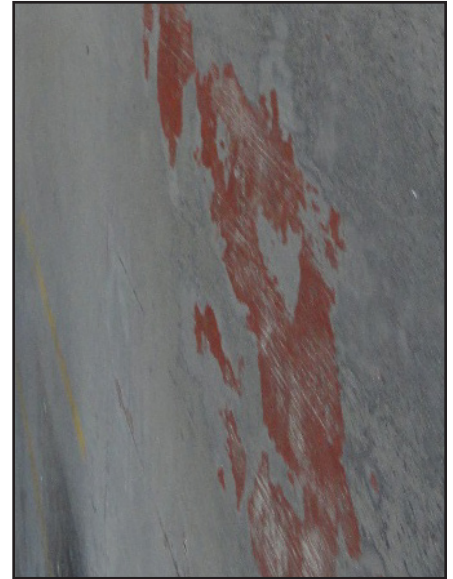
Coating is worn, exposing primer and bare concrete.

- Inappropriate Application: Excess aggregate in wear coat and insufficient topcoat material led to premature wear.
- Wrong System Specified: Applied system not designed for heavy duty areas such as drive lanes, turns, ticket splitters, etc.
- Moisture Contamination: Premature wear due to moisture contamination during application.
- Improper Mixing: Failure to mix components properly prior to installation, scraping unmixed material from walls of buckets, insufficient mixing time for proper dispersion, or a contaminated mixing paddle, resulting in off-ratio components and poor physical properties.

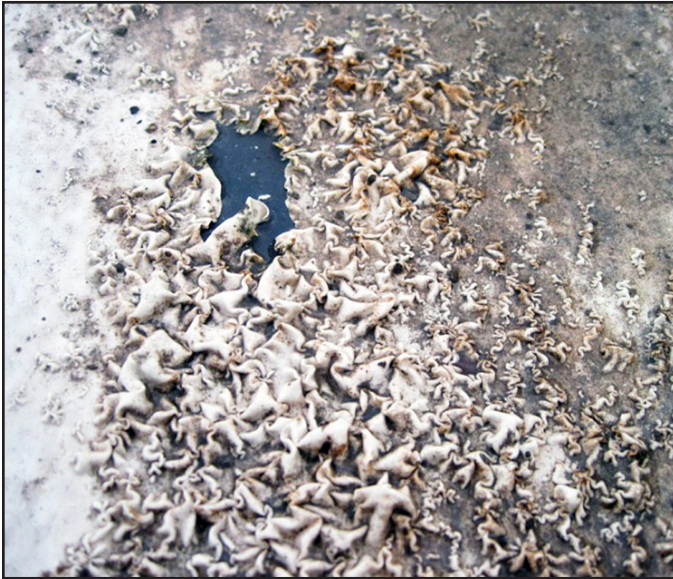
The coating material loses bond between coats, or between the coating and the substrate.

**Delamination due to thin topcoat and ponding**

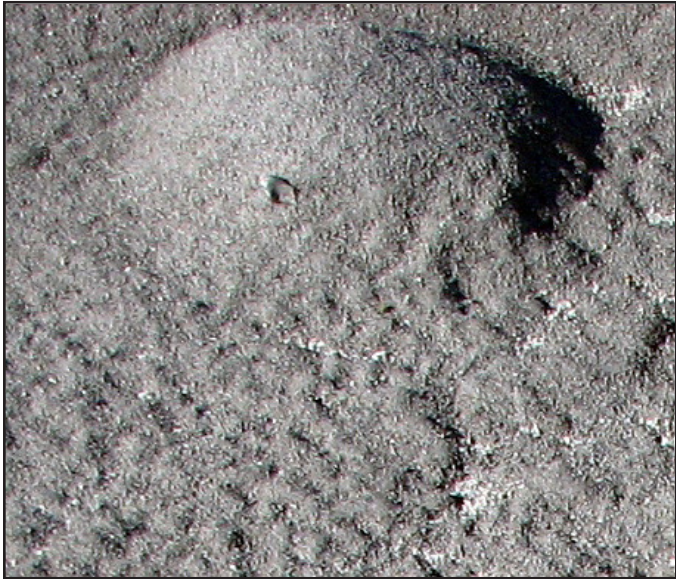
Medium to large bubbles on the surface of the foam. They are typically randomly dispersed.

**Typical unopened foam blister**

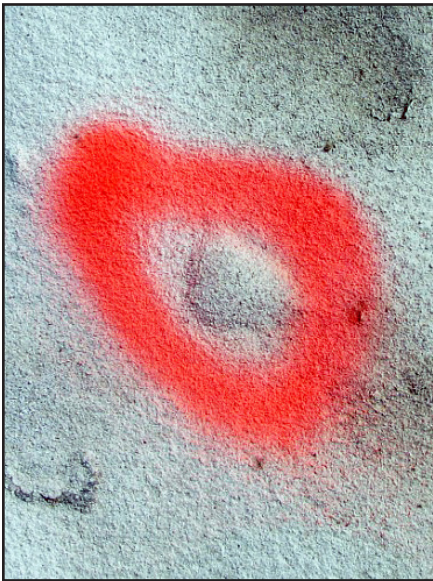
**Blister due to contamination**

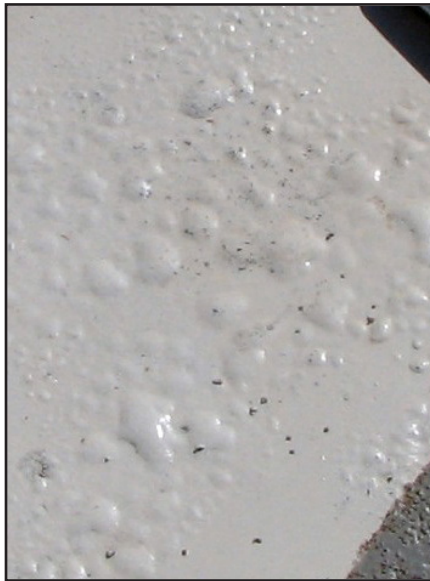
**Trapped solvent blisters**

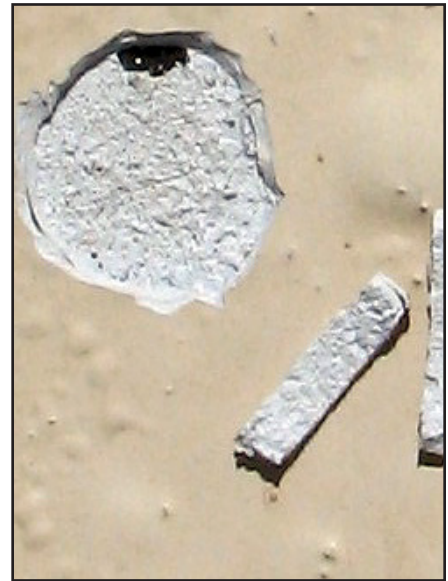
**Removed blister**

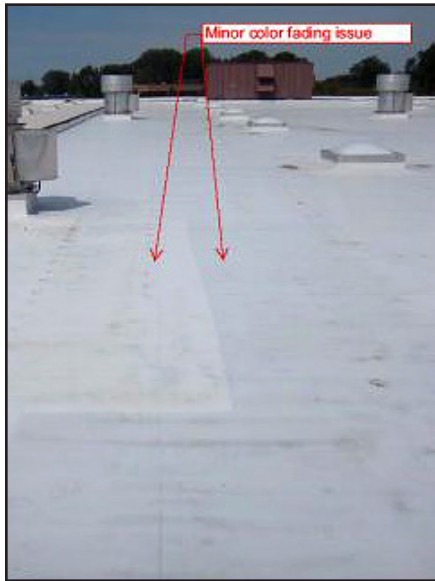
Surface of coating does not cure to a glossy finish and reflect light, which is ideal for a roofing topcoat.

Roof with shade variation

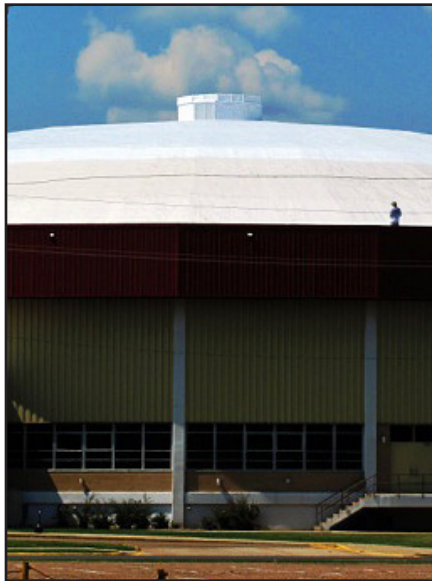
Roof with moisture contamination
